WAIOURU SEWAGE TREATMENT PLANT UPGRADE

Warren McKenzie, Pattle Delamore Partners Ltd (PDP)
Rob Docherty, Pattle Delamore Partners Ltd (PDP)

ABSTRACT

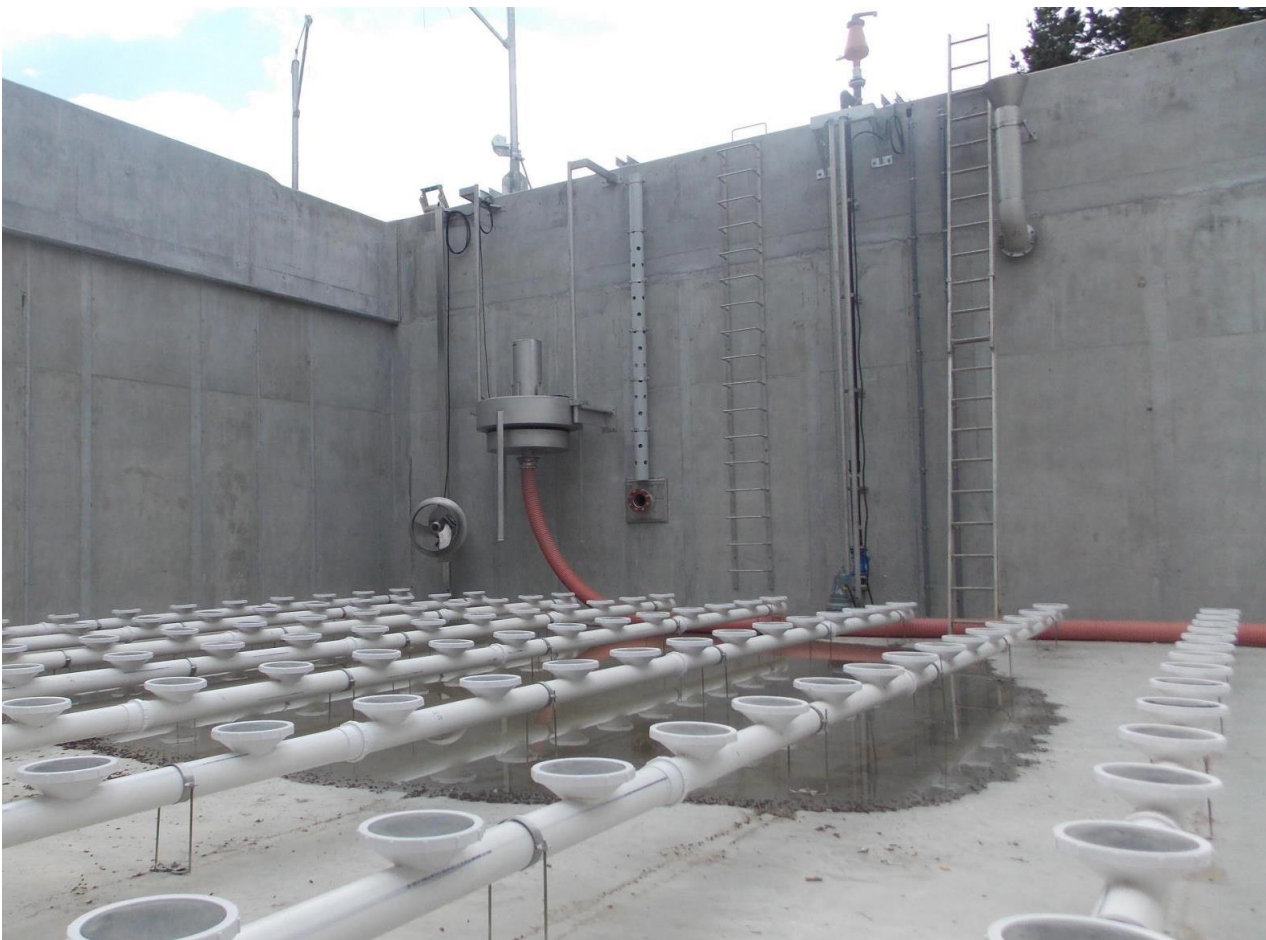
Photograph 1: SBR Fitout

- Inlet works, with grit chamber and step screen
- Primary clarifier
- **SBR Lift Pumpstation with 40L/s capacity.**
- **2 x 800m³ SBR tanks (400m³ live volume per cycle) with diffused aeration, submersible mixers, sludge wasting pumps, floating decants and monitoring probes.**
- **Caustic dosing to increase alkalinity prior to nitrification in SBRs (alkalinity deficient wastewater).**
- **Carbon dosing to assist denitrification (due to an inadequate C:N ratio).**
- Trickling filters (2 of, working in parallel).

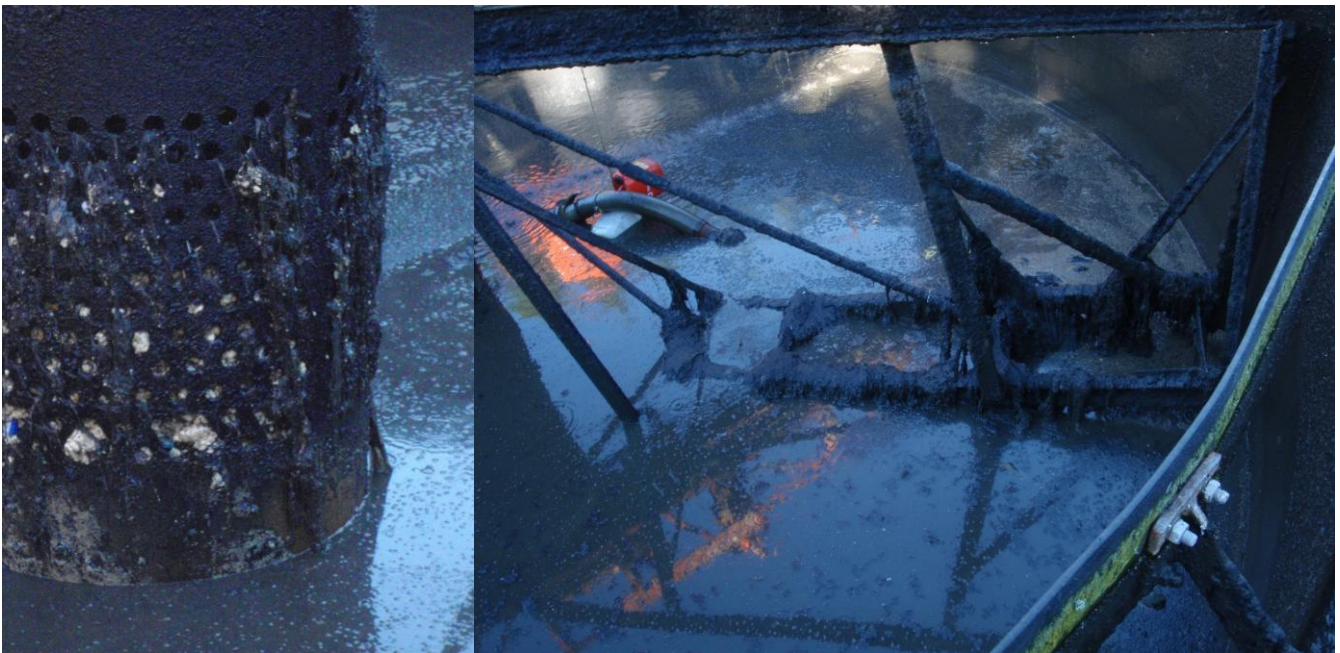
Photograph 1: The Sludge Merry-go-round

The primary clarifier steelwork was in a heavily deteriorated condition and a significant rebuild of the scraper mechanism and central column was required. Concrete work was, however, in very good condition for its age.

The primary clarifier was the first existing treatment process to be drained, photographs of which are shown below.

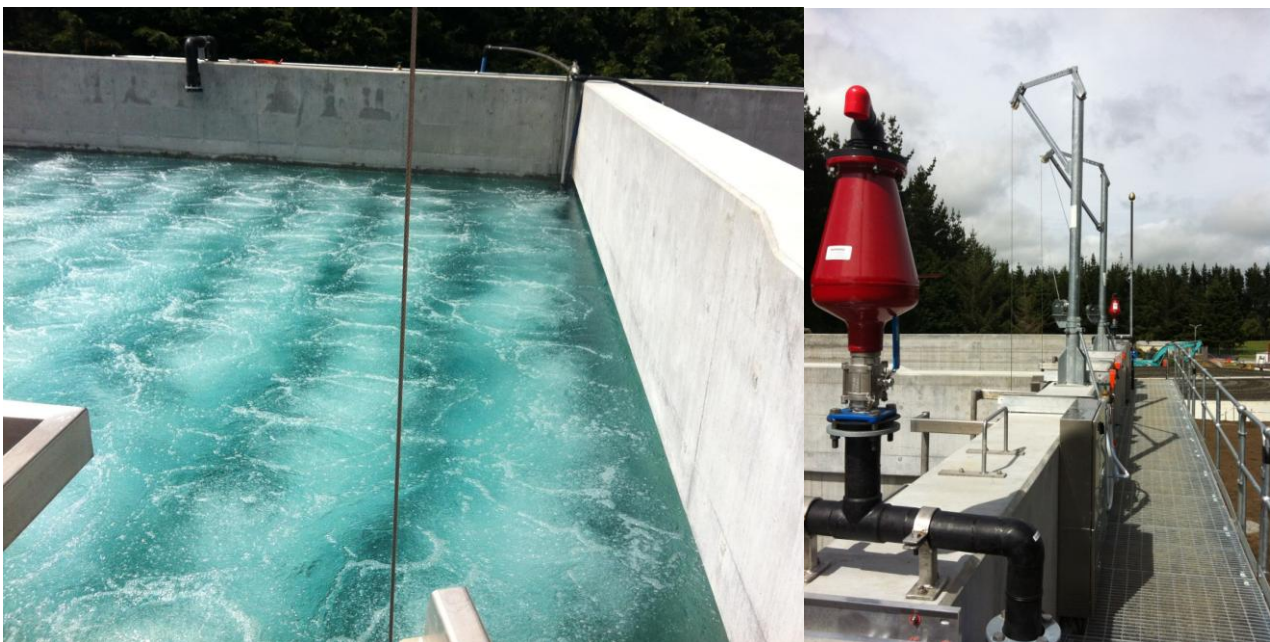
Photograph 2: Water testing of the SBR tanks

The SBR tanks were commissioned in December 2013. Each tank was filled with fresh water (for a full-scale water test) and every item of mechanical equipment was tested thoroughly prior to introducing wastewater into the tanks for the first time. As the individual tanks filled, an activated sludge seed (from Acacia Bay WWTP near Taupo) was added together with molasses as a supplementary food source. The activated sludge volumes grew quickly to target levels.

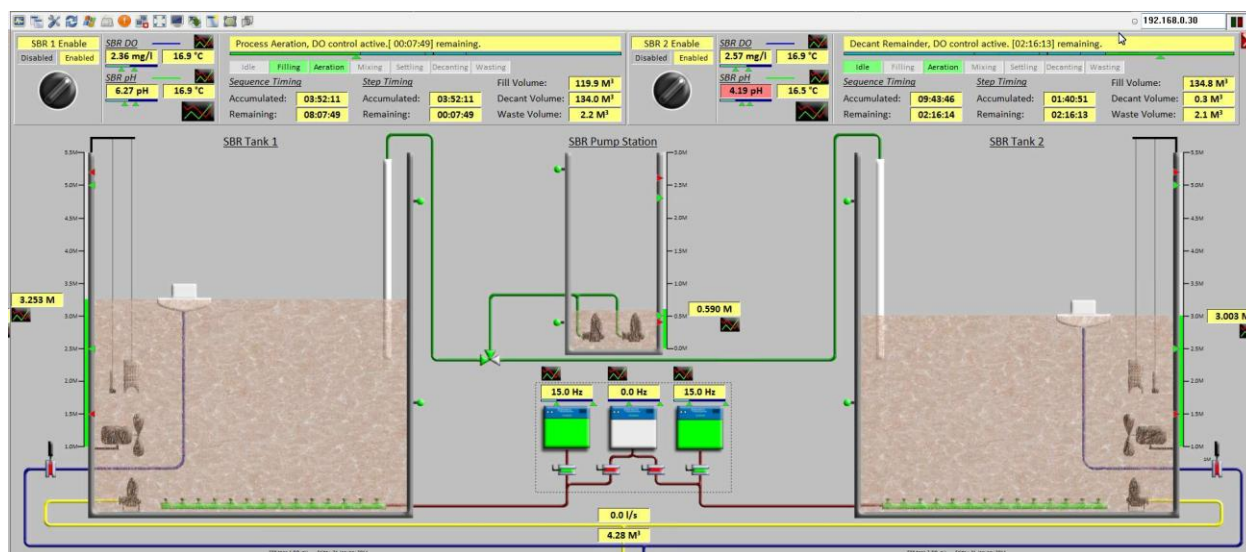
Figure 1: SBR SCADA Screenshot

A SCADA link is used by PDP staff from the Auckland and Tauranga offices to remotely access key information from the plant; flows, DO, pH, temperature, valve positions, equipment status and tank wastewater levels. The development of the SCADA system was discussed in some detail within the construction contract documents and with the contractor’s programmer throughout construction to ensure it provides the correct level of detail in an “easy to use” format. The SCADA link also provides plotting ability for each of the measured parameters which is invaluable for troubleshooting purposes. A well performing SCADA link is a key requirement in providing operational assistance to any technologically advanced WWTP such as this.

Figure 1 shows a screenshot of the SCADA link to the SBR tanks.
