# LIFE IN THE FLOODPLAIN – FLOOD MITIGATION CONCEPT TO CONSTRUCTION

*Louann Hurrell, Harrison Grierson, Environmental Scientist, Whakatane*

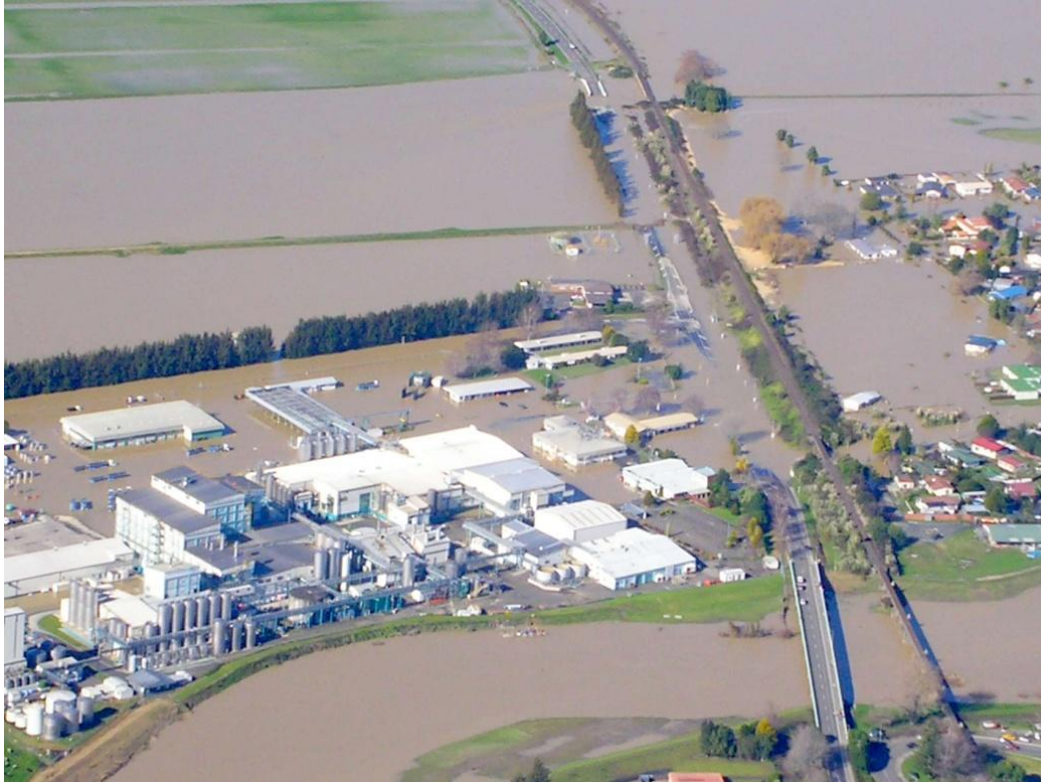
*Figure 2 –Flood looking towards the Fonterra dairy factory*

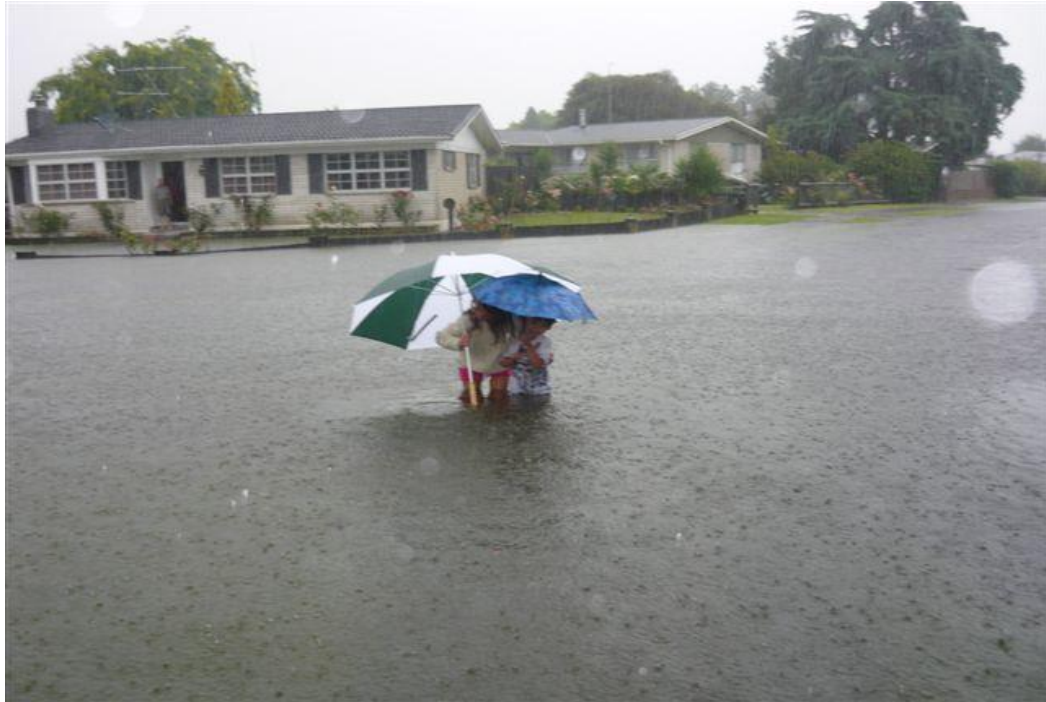
*Figure 3- Children wading in urban flooding in January 2011 on Matipo Place in the study area.*

At an early stage of the investigation we spoke to several home owners who were affected by the urban flooding and confirmed our modelled flood extent was correct. This was a great experience talking with land owners and get an outside perspective of how the flood affects their daily life. Land owners also provided us with some footage and photographs of property that was flooded in the township, as presented below.

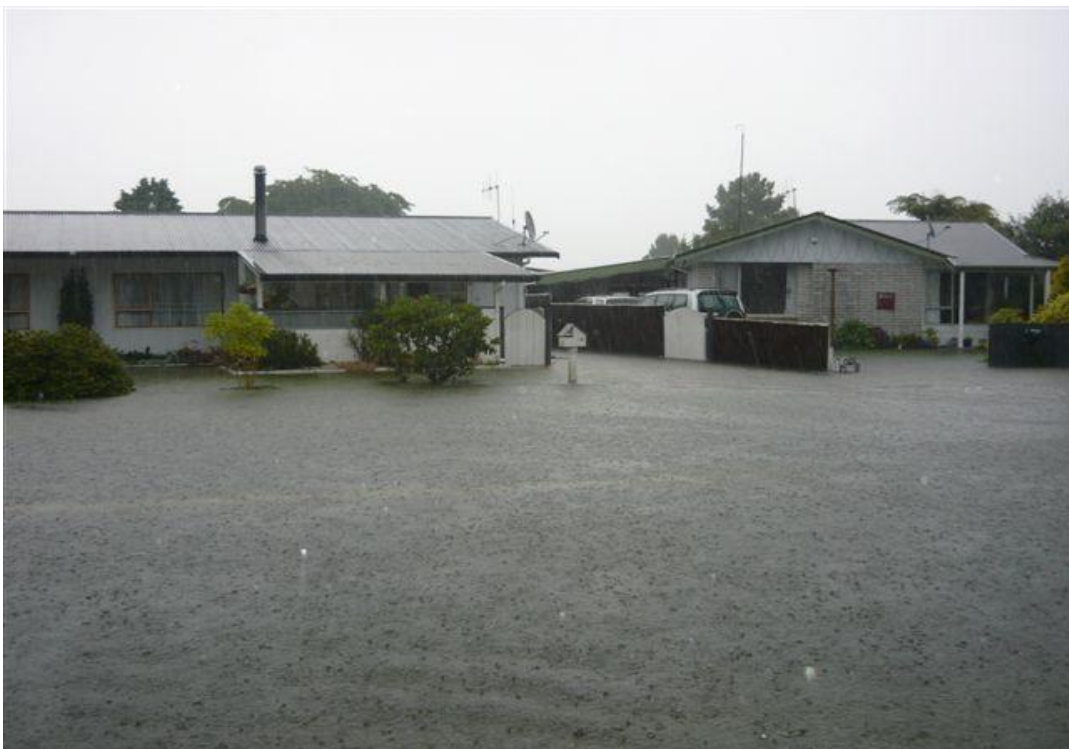
*Figure 4 – Flooded properties on the corner of Puriri Crescent during January 2011 urban floods*

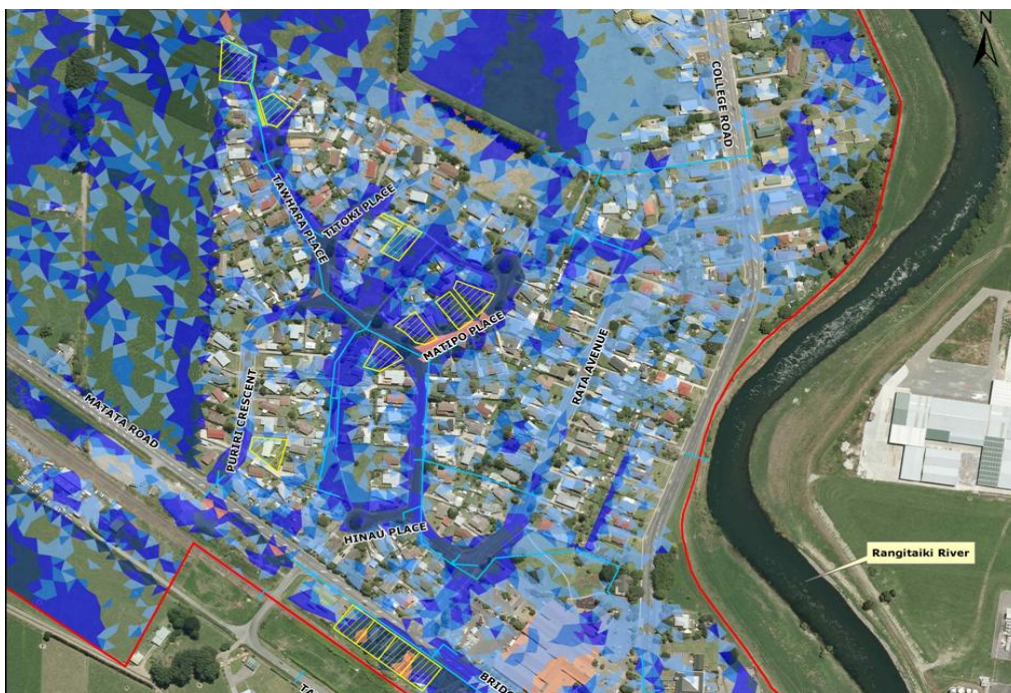
The maximum modelled water depth for the 10-year '2090' design rainfall event is shown in figure 5. There are three main areas of inundation:

1. In the northern extent of the study area, at Tawhara Place, Titoki Place and Matipo Place.
2. Further south around the intersections of Hinau Place, Rata Avenue, and Puriri Crescent.
3. Properties on the southern side of Bridge Street.

Figure 5 – Maximum Modelled Depth, Existing Pipe Network, 10-year '2090' Rainfall event, and Flooded Habitable Floors.

With the current pipe network configuration, nineteen houses were modelled as being flooded from urban rainfall runoff during the 10-year '2090' rainfall event on flooding. Habitable floor flooding was identified as follows:
