# On Lot Stormwater... A lot to learn

Presented by Andrea Phillips (Hamilton City Council), supported by Nick Young (Hamilton City Council), Stu Joyce & Stu Farrant (Morphum)

# What: On-Lot Audit Process

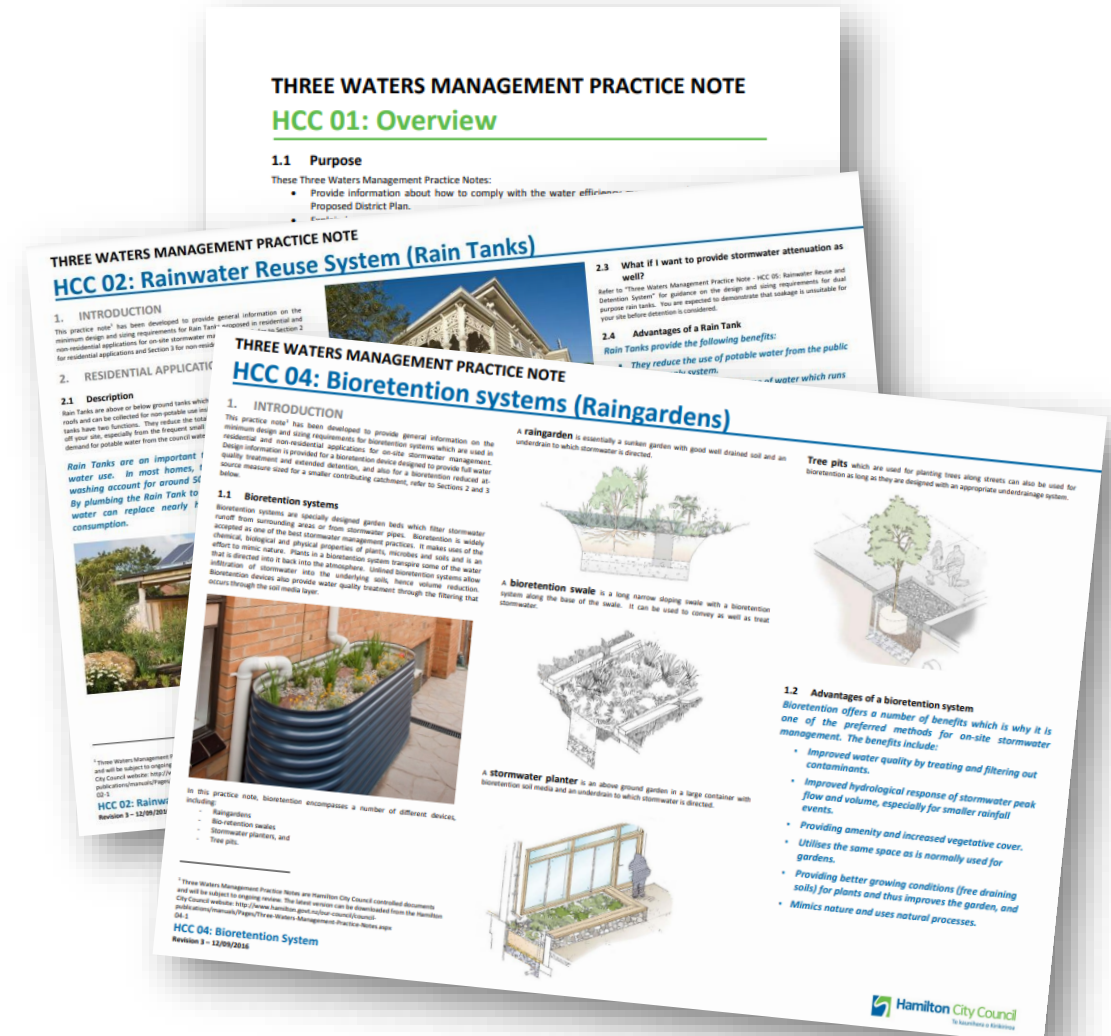
# Residential stormwater management in Hamilton

## Rain tank and soakage

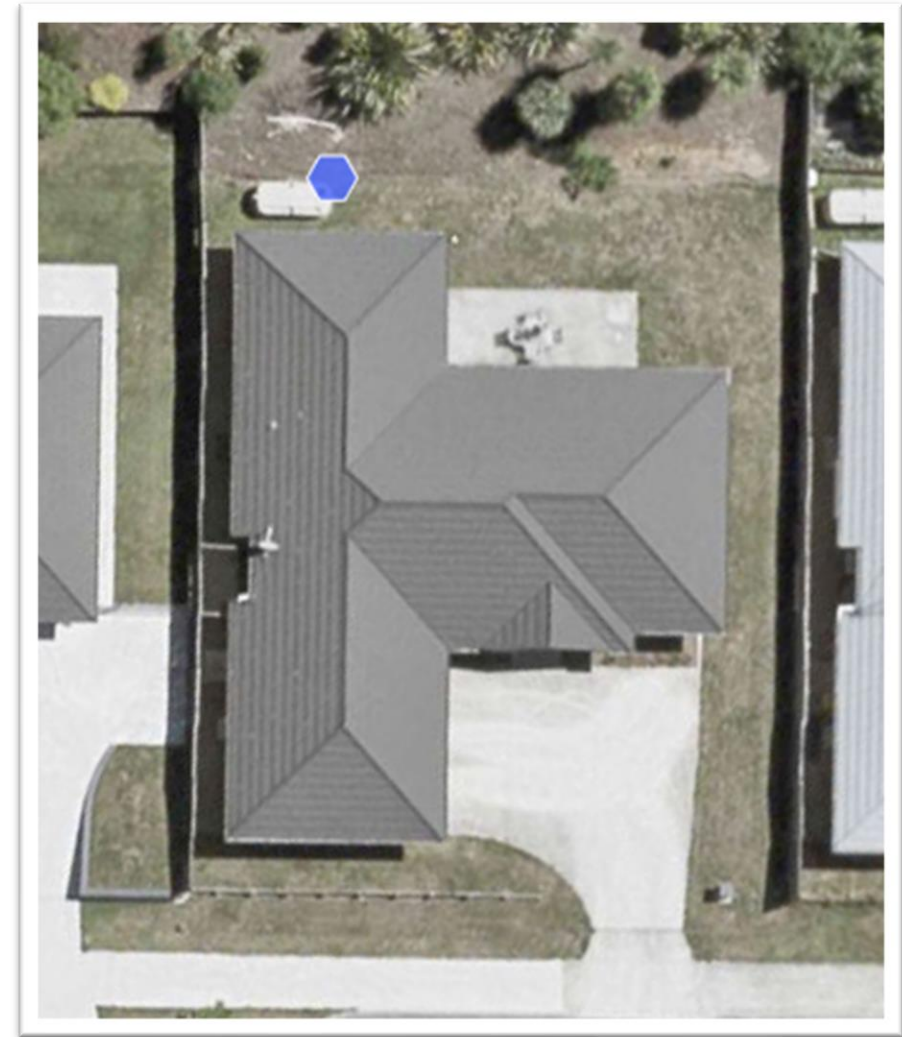
# On site Assessment

- On site, auditors seek to gain access to each property on the assessment list
- The audit is undertaken utilising Field Maps application, available on smart phones and tables.
- The audit forms utilise conditional formatting to allow the assessor to select the type of asset being assessed, and then only answer the relevant questions relating to it.

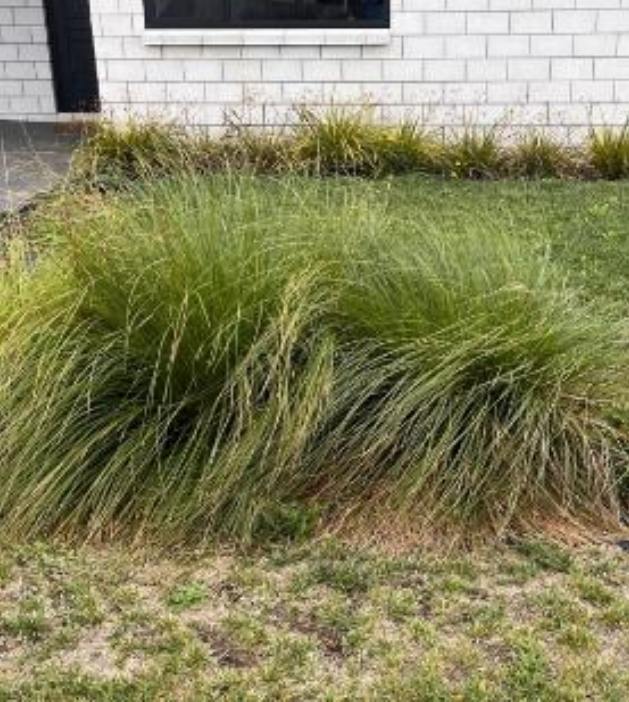
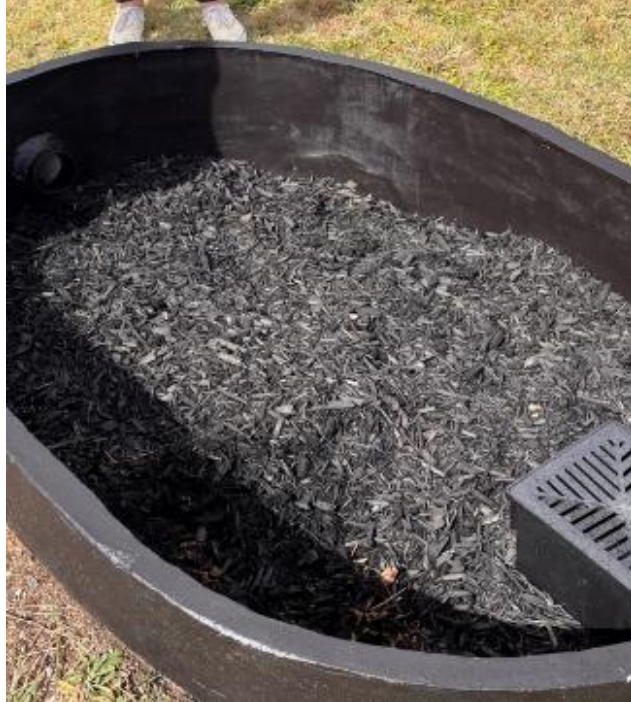
# RainGardens

- Raingardens were the most complicated assets both from an assessment and a maintenance perspective.
- Residents had limited understanding of the purpose
- Key scoring criteria included:
  - State of vegetation (Good, Fair, Poor) was determined by:
    - Were the correct plants used?
    - Planting Density?
  - Was the correct media used, and was it level?
  - Were the inlets and outlets functioning?

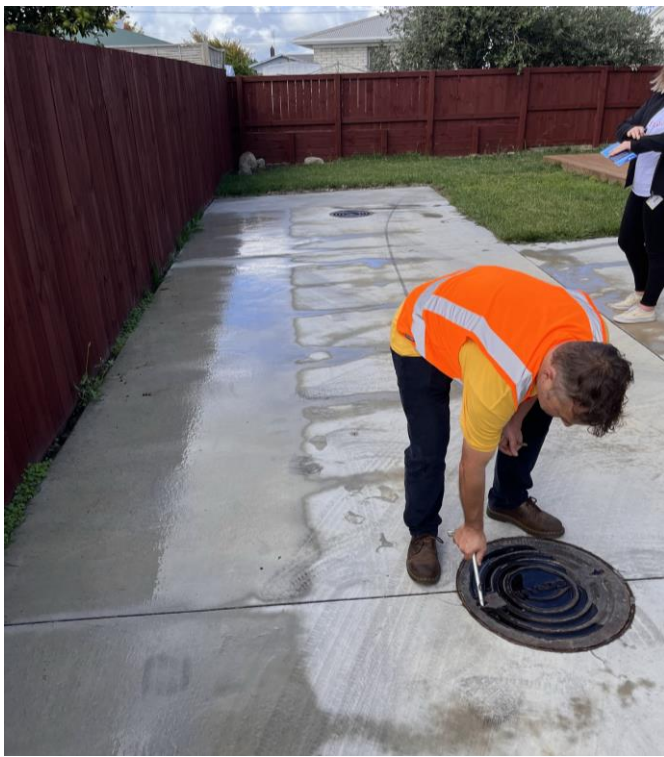
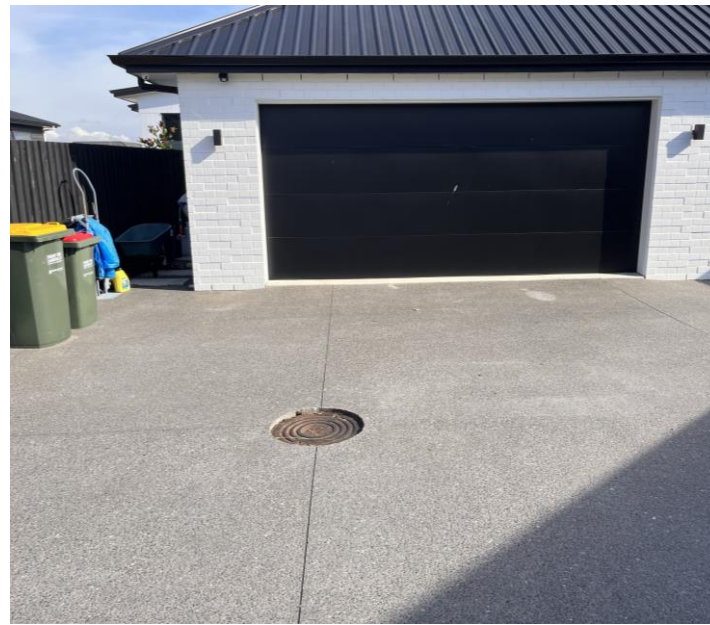
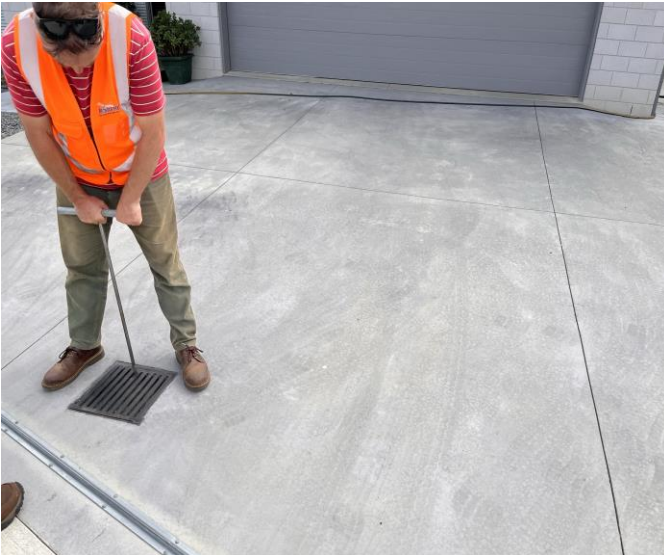
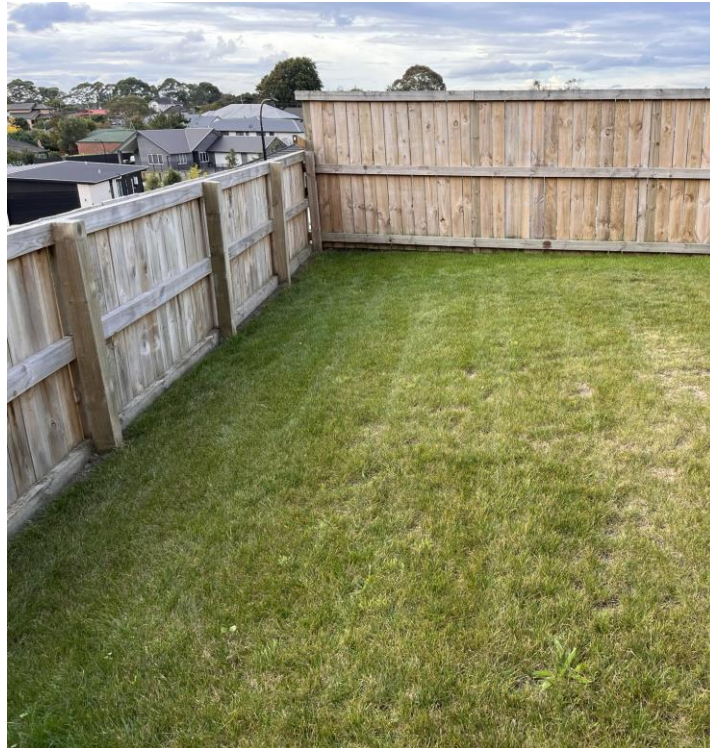
# Soakage

- Soakage assets installed prior to the recent updates to HCC Practice Notes were very difficult to find and/or access due largely to:
  - Buried soakage devices with no easy inspection point; or
  - Poor workmanship around manhole lids
- Of the 23 soakage devices assessed, 17 were unable to be assessed due to the lack of access chambers for any of the assets.
- Most residents had no idea that there was a soakage device within their property.
- Findings have been conveyed to HCC's building officers to reiterate to use the new design.

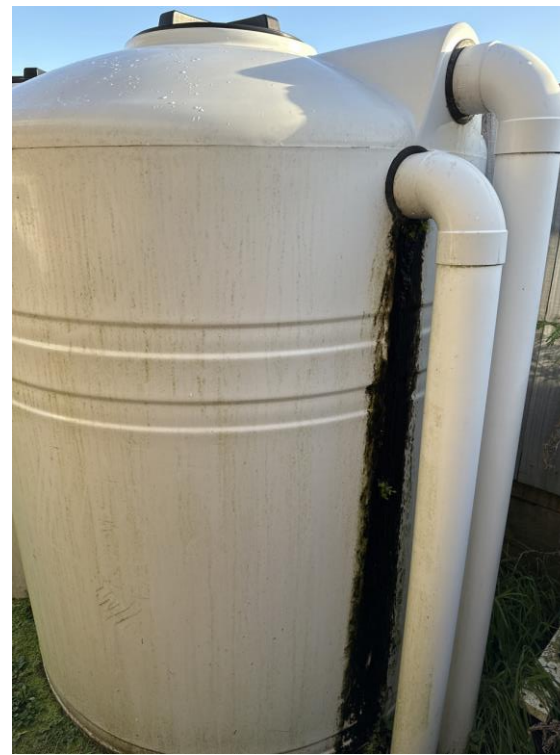
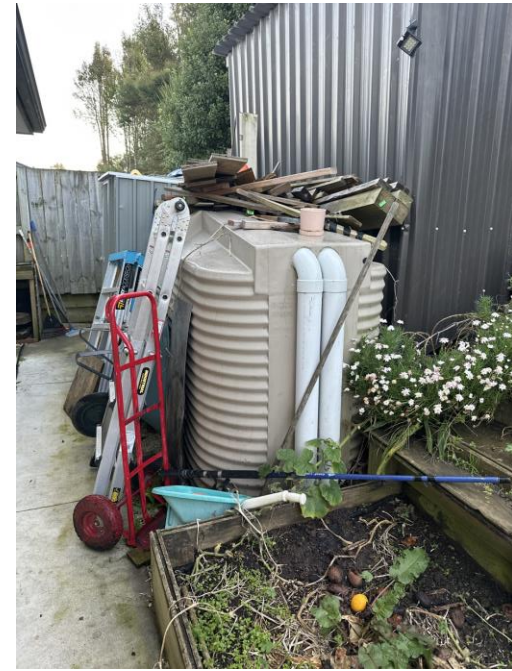
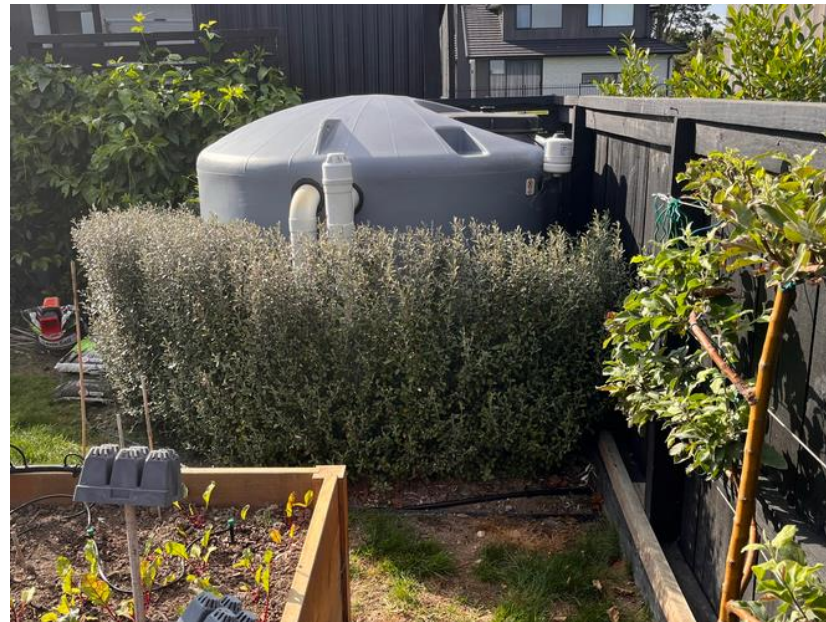
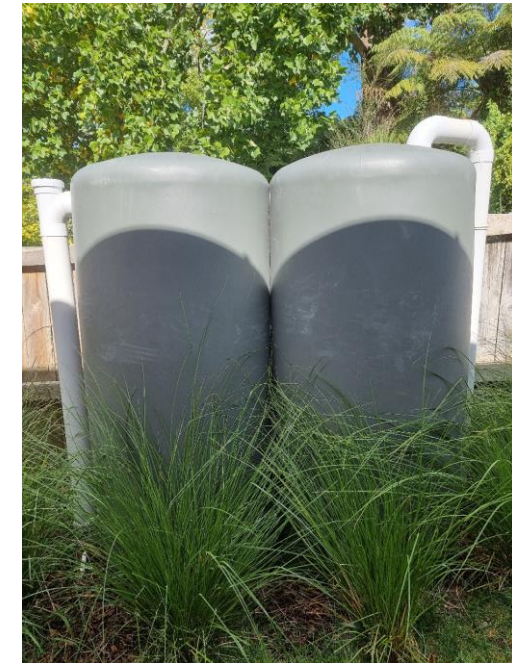
# Detention & Retention Tanks

- The nine tanks that could be assessed in the pilot study, were all compliant.
- Good level of pride from residents with working tanks- felt like they were “doing their bit” for the environment
- Five tanks were unable to be assessed as they were buried and didn’t have visible access points
- 33 tanks have been assessed in May 2023, with only 4 unable to be assessed (findings still pending)
- 3 tanks had no working pumps
