# Evacuation & Rescue from a Deep Tank

*Jonthan Piggot, BE (Enviro), CPEngNZ, Watercare Services Limited, NZ*

## ABSTRACT

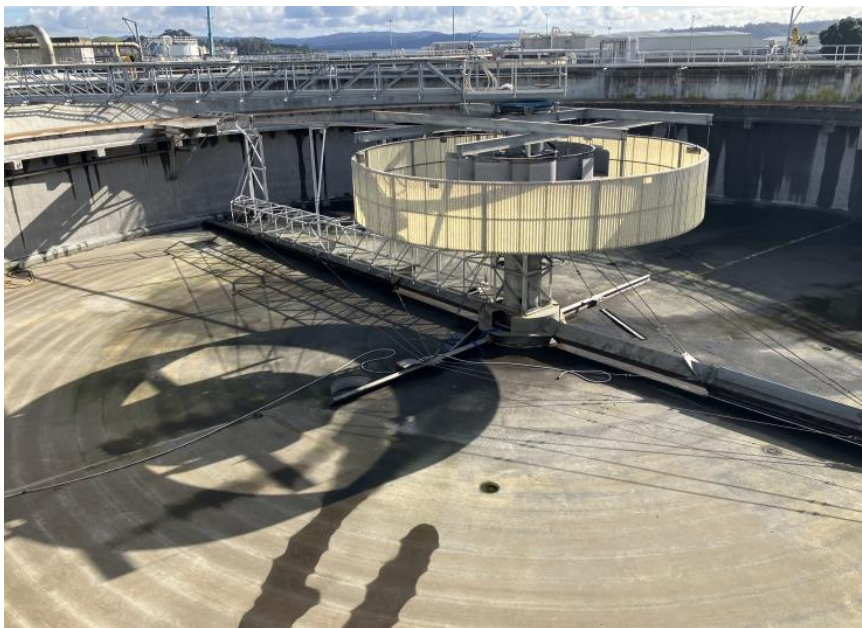
Picture 1. Empty Reactor Clarifier

The secondary treatment stage utilises biological nutrient removal (BNR) and is performed within nine reactor clarifiers (RCs) on site. The RCs are 77m in diameter, six metres deep and hold 32 million litres. The reactor surrounds the clarifier with a common wall between the two.

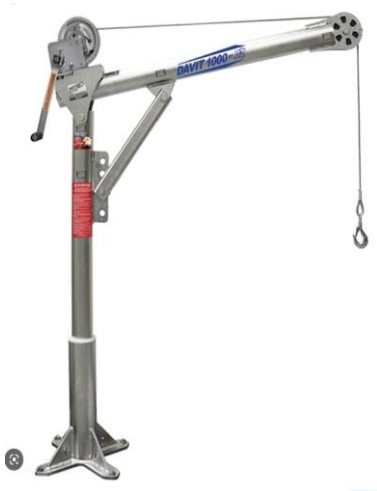
Picture 2. Davit Arm System.

Some had used minimum cost solutions to provide cost-effective pricing such as davit arms with winches (\$1,000-\$1,500) or narrow scaffold towers with ladders and platforms (\$5,000-\$7,000), while others selected costly options with a fast rescue in mind such as a crane with a man cage on standby (\$20,000-\$30,000).

The use of existing davit arm equipment was excluded as an option as they are designed for a certain purpose, lowering, suspending, and raising a large mixer. Trying to repurpose for an emergency winch would not be appropriate, as it only reached into the reactor, and again had obstacles in the way that would affect the smooth elevation of a stretcher.

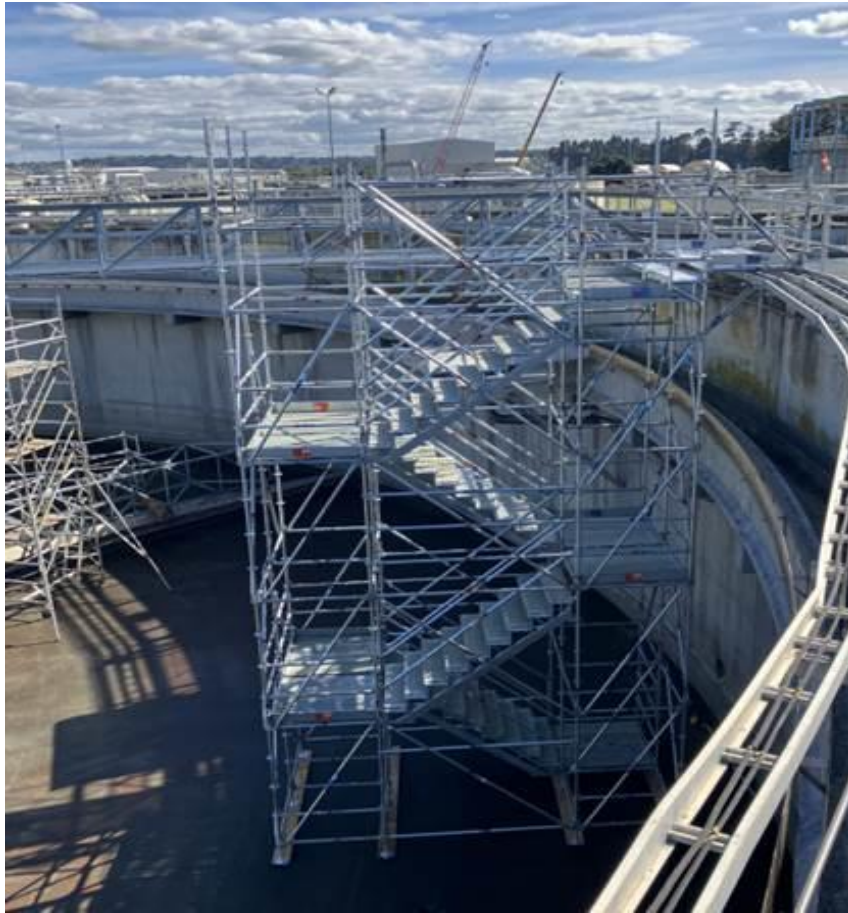
Picture 5. Scaffold tower with stairs installed in RC.

The best practical, and most simple, option chosen was the scaffold tower with stairs.

Two towers would be needed, one for access into the reactor zone and one for the clarifier section.

Building them outside the RC and craning them in, and then out at completion of the overhaul, was the agreed installation method. This met the entry and exit needs of all individuals who would work within the units, reducing time anyone would be inside the RC before a practical rescue option was in place. This option landed midway on expenditure at \$20,000 for building, placement, six weeks' hire, removal and dismantle of the scaffold tower with stairs.

The handrails of the RC walkway, where the towers connected, had to be modified to allow a smooth transition from the top platform of the tower stairway onto the RC walkway. The modification produced a removable section of handrail that unclipped and lifted out providing a level transition from scaffold to walkway and could be replaced afterward so the safety provided by the handrail was not compromised.

Access into and out of the RC interior has been greatly improved, and now resembled a simple walk down and back up a flight of stairs rather than climbing ladders and traversing through platform hatches.

Navigation around the corner of each stairwell platform was tight. If people didn't take their time and communicate with each other, pinch and crush points were created for individuals carrying the stretcher. Four people worked reasonably well although even 80kgs was heavy, six people made the carried weight easier but it was a tighter squeeze around corners.

Where the scaffold connected to the walkway there were some slight height differences and minor gaps which created the potential for a trip hazard, especially when carrying a stretcher and concentrating on that activity rather than one's footing.

The design of the scaffold tower stairwell had structural poles installed across the width of the top and bottom of the stairs at a head height of around 180cm, which caused a potential head impaction hazard for anyone at or above that height.

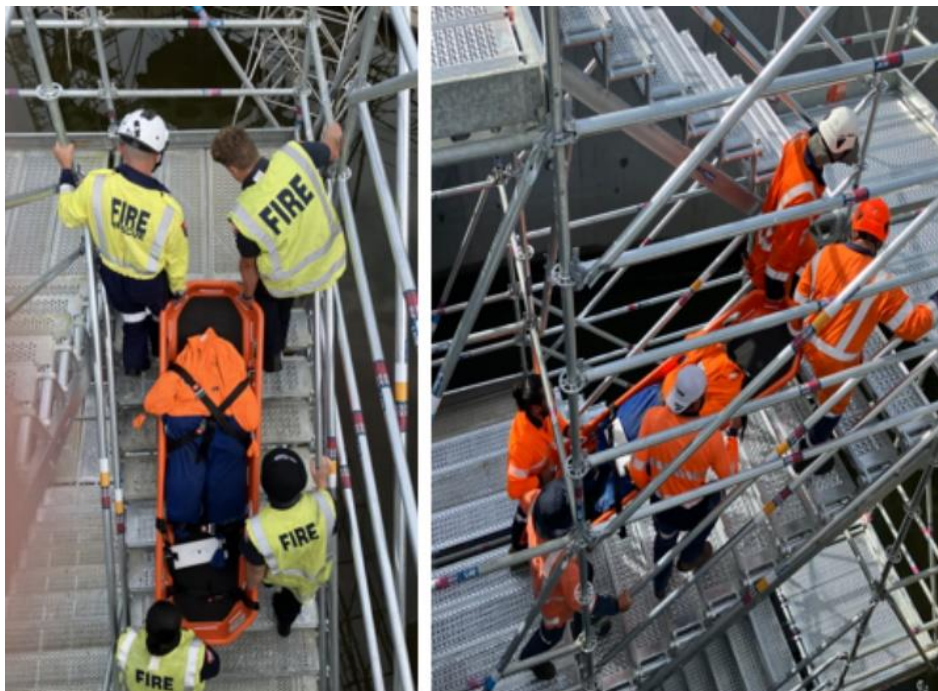
Picture 6. FENZ & WSL staff performing rescue exercise.

Once everyone had reached the RC walkway, the guides made them familiar with the set-up. Then participants were asked to take the emergency stretcher down the tower scaffold and rescue/evacuate unresponsive Sandy, as though it was a fellow colleague who had experienced a medical event.

Lifting 80kgs on the stretcher was heavier than people expected. Two people couldn't carry this weight comfortably or safely on the stretcher. At least four people were required to adequately elevate and move the 80kg laden stretcher.

Having FENZ at some of the first exercises was advantageous as they were able to give direction on how the restraint straps of the stretcher needed to be crossed over at the chest and the plastic block at the bottom end of the stretcher was meant for bracing a patient's feet to stop them slipping down the stretcher. Seeing FENZ in action showed how quickly and smooth a rescue via stretcher could be performed, providing an example to follow.

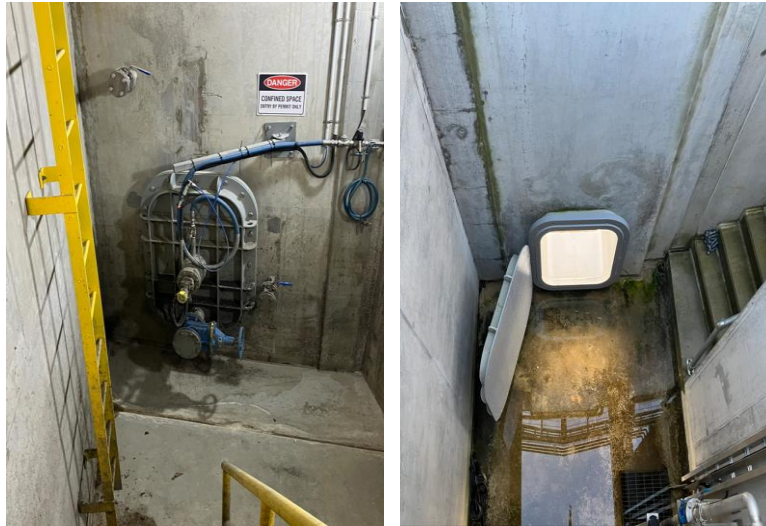
Picture 7 & 8. Access hatches designed into large tanks.

In addition, you cannot just have one access, you really need one at each end of the tank. However, if you do include these hatchways, it does provide an easier entrance and exit/rescue and evacuation point and means you don't need to build large scaffold towers. Some water reservoirs will have stairways built within the tanks for future access. This is possible as it contains clean water, which is not quite the same with an activated sludge reactor or digester.
