# **ASSET MANAGEMENT OF BROWNFIELD RESERVOIRS - OPPORTUNITIES/LESSONS FROM A COMPREHENSIVE CONDITION ASSESSMENT AND REMEDIATION PROGRAMME**

*Stephen Molineux (WSP Ltd), Timbi Poon (Beca Pty Ltd),*

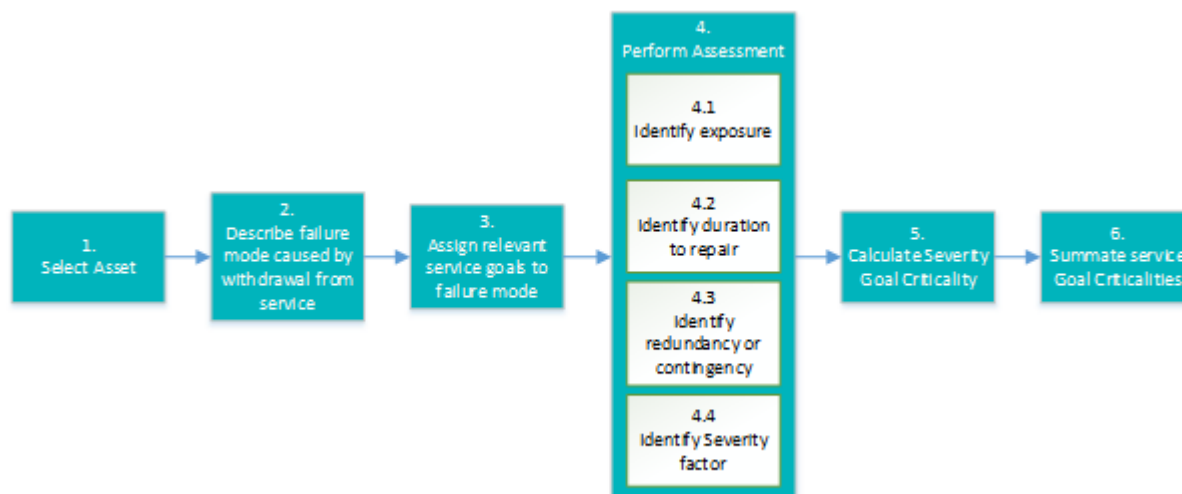
Figure 1 - Wellington Water Flow Chart for assessment of asset criticality

The process for determining the criticality index is summarised in Figure 2. It involves:

1. Identification of all possible failure modes associated with the asset.
2. Assign relevant service goals to the failure mode. Key service goals that reservoirs affect are:
  - a. The provision of safe and healthy drinking Water
  - b. The operation of assets that are safe for our people and customers.
  - c. The provision of regional wide firefighting supply
  - d. The provision of reliable service to customers
3. Assess the severity of failure based upon the impact of the failure against customer service goals accounting for; the exposure of the failure, the duration to complete a repair and any asset redundancy or contingency.

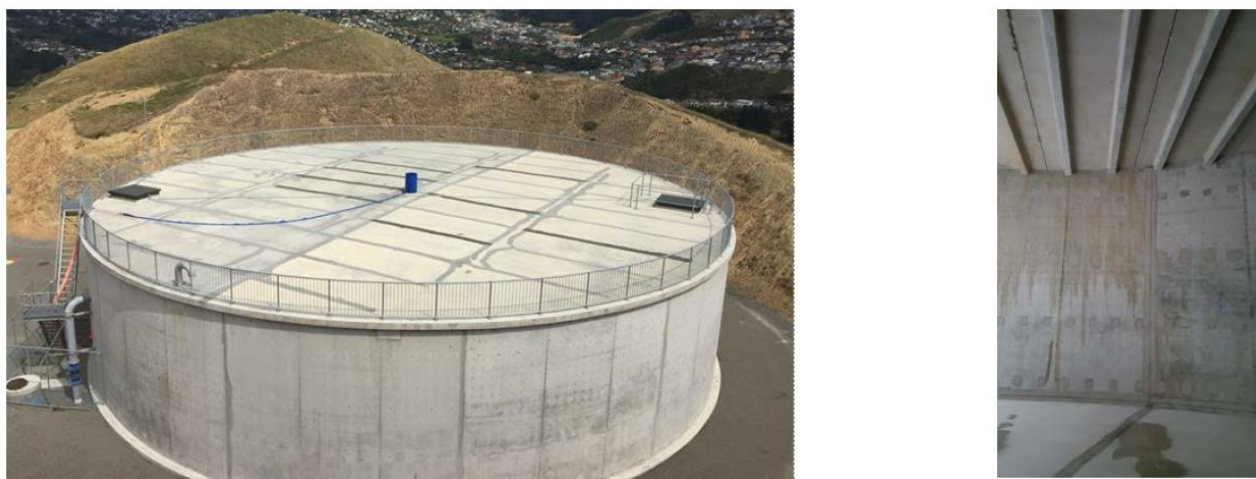
Figure 2 – A new reservoir may score well from a condition rating perspective but may score poorly when subjected to a failure mode assessment due to the roof leakage shown in the photograph on the right.

This approach moved the focus away from the condition of the reservoir as a whole to assessment of key components and their ability to deliver the service goals. As an example of how this altered the condition assessment grading, the new reservoir shown in Figure 2 scored well from an overall condition rating perspective but scored poorly when subjected to a failure mode assessment due to roof leakage.

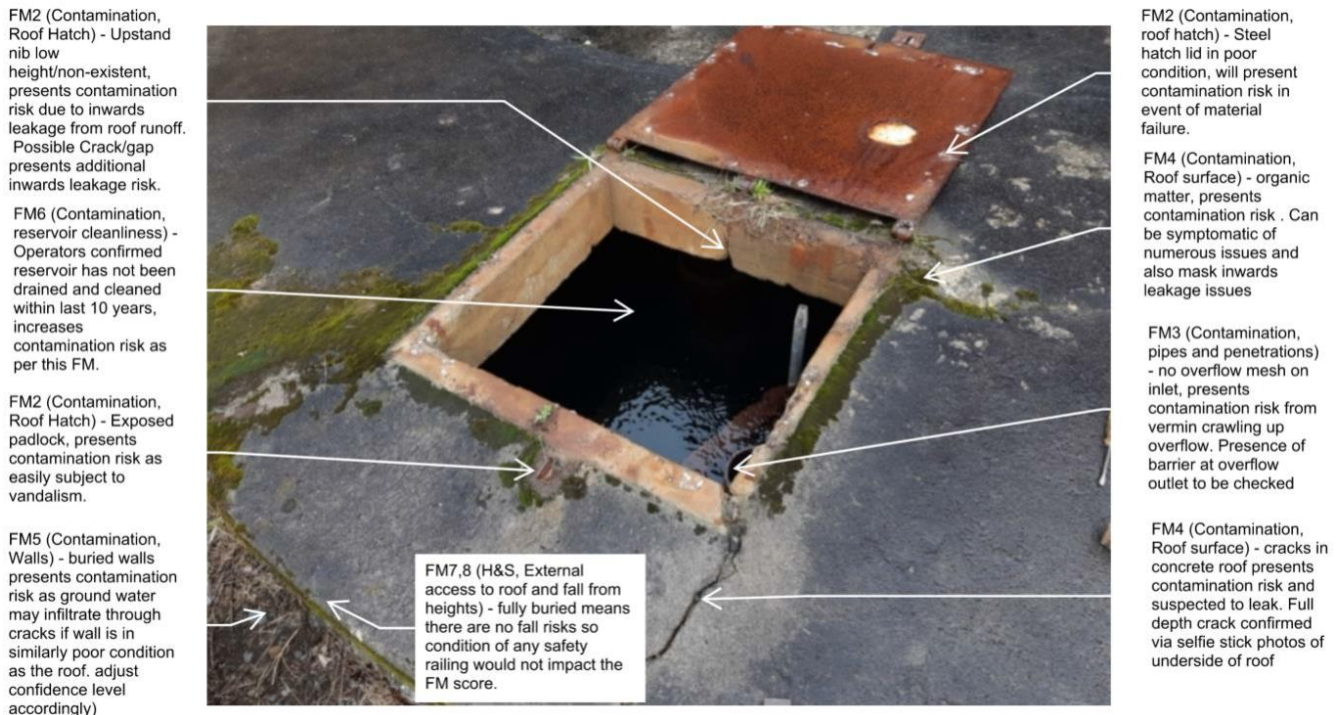
Figure 4 - Example of the typical 'thought process' that the field assessors needed to follow,

Figure 4 shows an example of the typical ‘thought process’ that the field assessors needed to follow, highlighting both the need, as well as the value of the Visual Assessment Guidelines for Failure Mode Assessment.

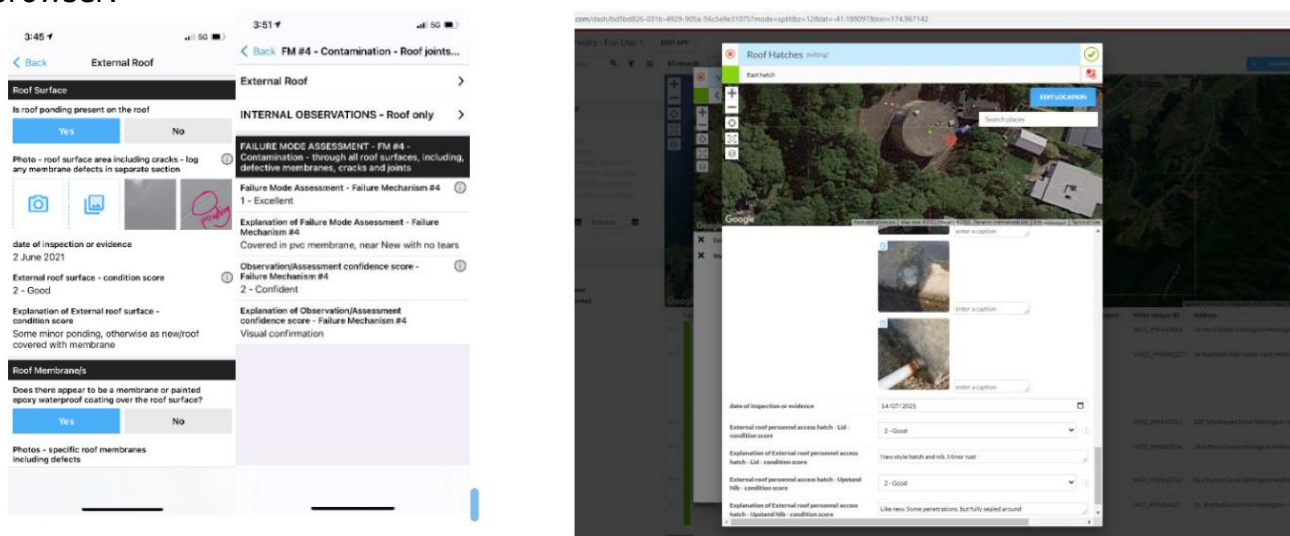
Figure 5 - Inputs could be provided at any time via mobile app interface or desktop via web browser

The inspection tool asked leading questions and requested photographic input so that senior team members could provide any necessary support. Figure 5 shows a screenshot of the inspection tool which could be accessed via mobile app interface or desktop via web browser.

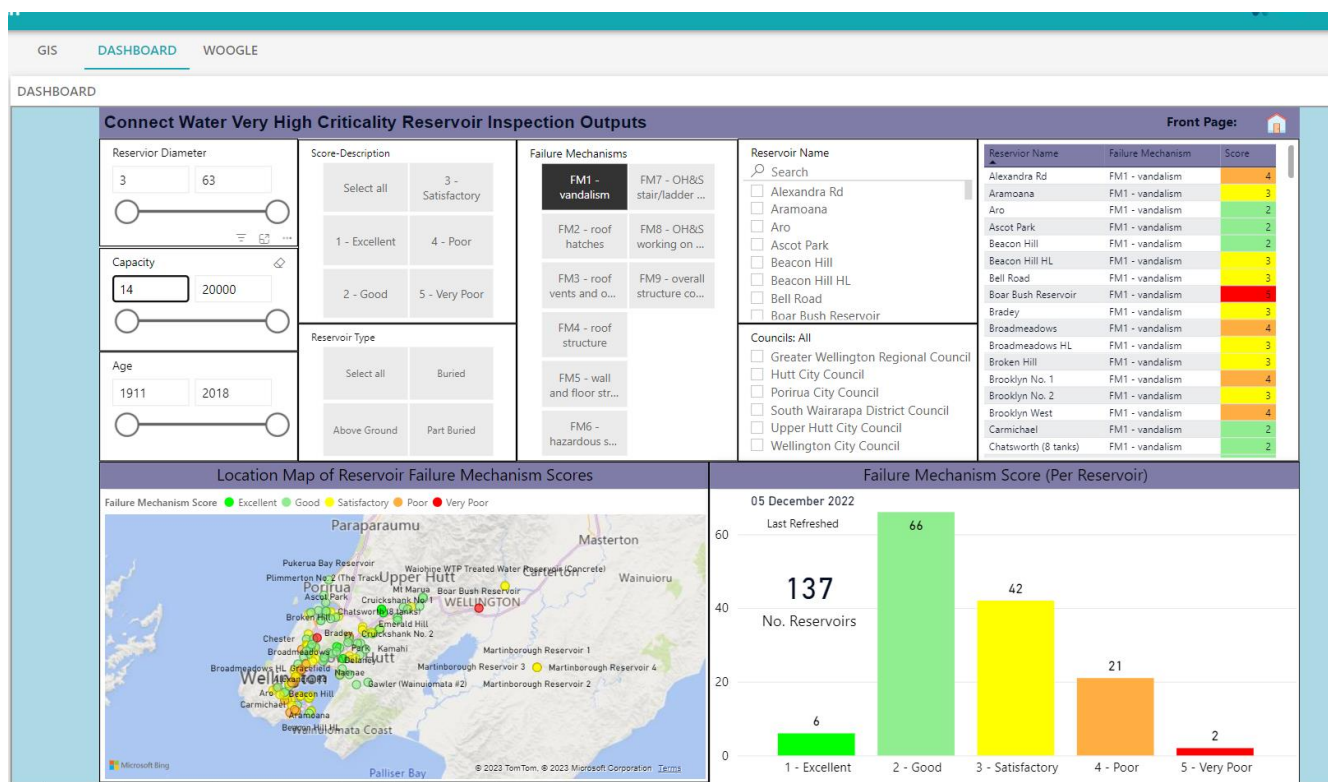
Figure 6 – Interactive Dashboard

The dashboard was designed to maximise aesthetics and usability, see Figure 6. The dashboard displays an interactive map showing colour-coded representations of reservoirs with issues, representing the scale of the problem. Reviewing and editing live source data was initially unfamiliar territory for the technical reviewers, who are typically accustomed to bleeding over pages and pages of A4 reports with their trusty red pens.

Using prepopulated construction rates and reservoir roof areas, the tool automatically calculated costs associated with each of the required remedial works. This allowed automatic manipulation of data to provide budget estimates for a range of client requirements and situations to ensure funding is available to deliver these works.

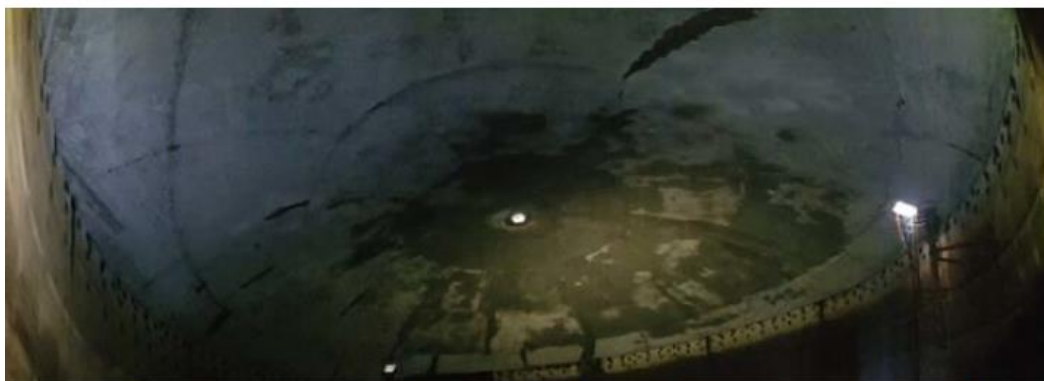
Figure 15: Pre-construction roof leak test, 11 April 2019. Significant dampness around crown and multiple leaks on radial joints.

Figure 7 – Example of 'offline' roof leakage testing

Leakage testing is undertaken using either sprinklers, or a prolonged and heavy rainfall event to distribute water across the roof surface. For best results, leakage testing should be undertaken while the reservoir is offline, ensuring the inside of the reservoir is in a 'dry' state. This is so that any active leakage can easily and objectively be evidenced. Extractor fans can assist with drying the ceiling and floor slab prior to a test however, the atmospheric conditions can greatly influence their effectiveness. Taking a reservoir offline can cause significant operational disruption and is often uneconomical or impractical and therefore 'live' testing can be considered instead.

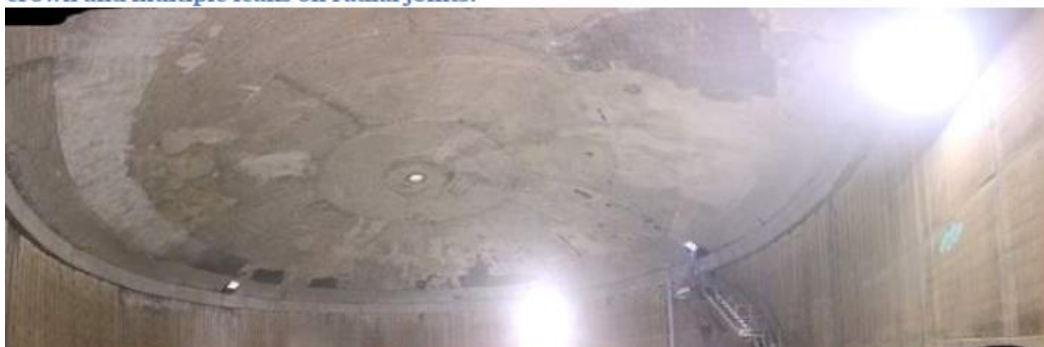
Figure 16: Post-construction roof leak test, 13 November 2019. Note the dark patch repaired areas. Very few (minor only) leaks observed.

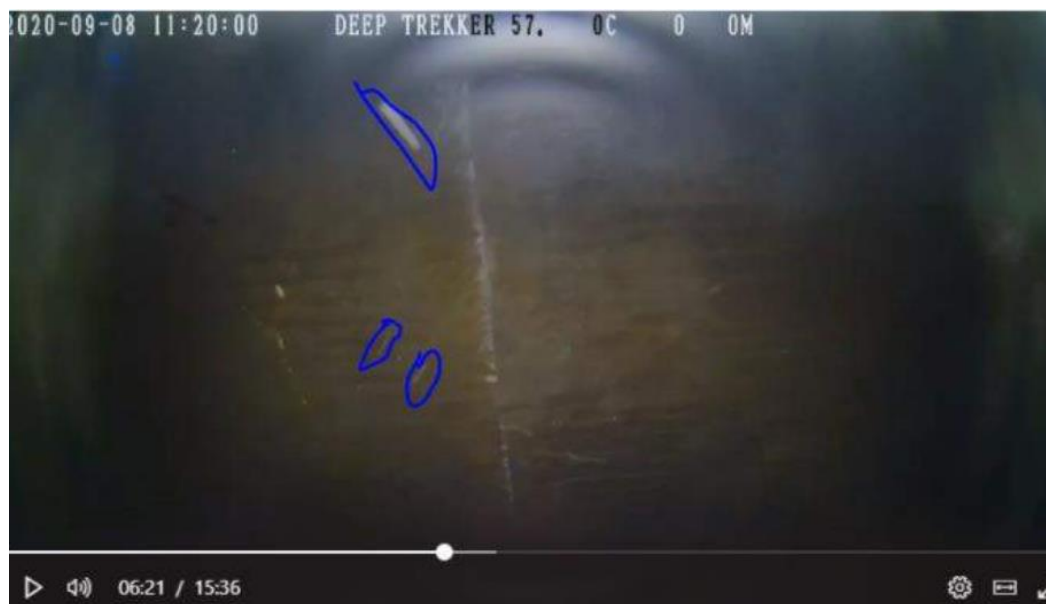
Figure 8 – Example of 'online' roof leakage testing

Roof leakage testing inside a 'live' tank environment can be completed using submersible drones or remote-controlled boats fitted with specialist lighting and recording equipment. Water 'droplets' can be recorded breaking the free water surface, to assist in identification of possible leakage locations. While testing a 'live' tank experience is key to differentiating between ceiling condensation and leakage. There are more sophisticated hi-tech options available involving mobile laser scanning units, however whether technology application meets a critical need is perhaps an opportunity that could be explored in the future.

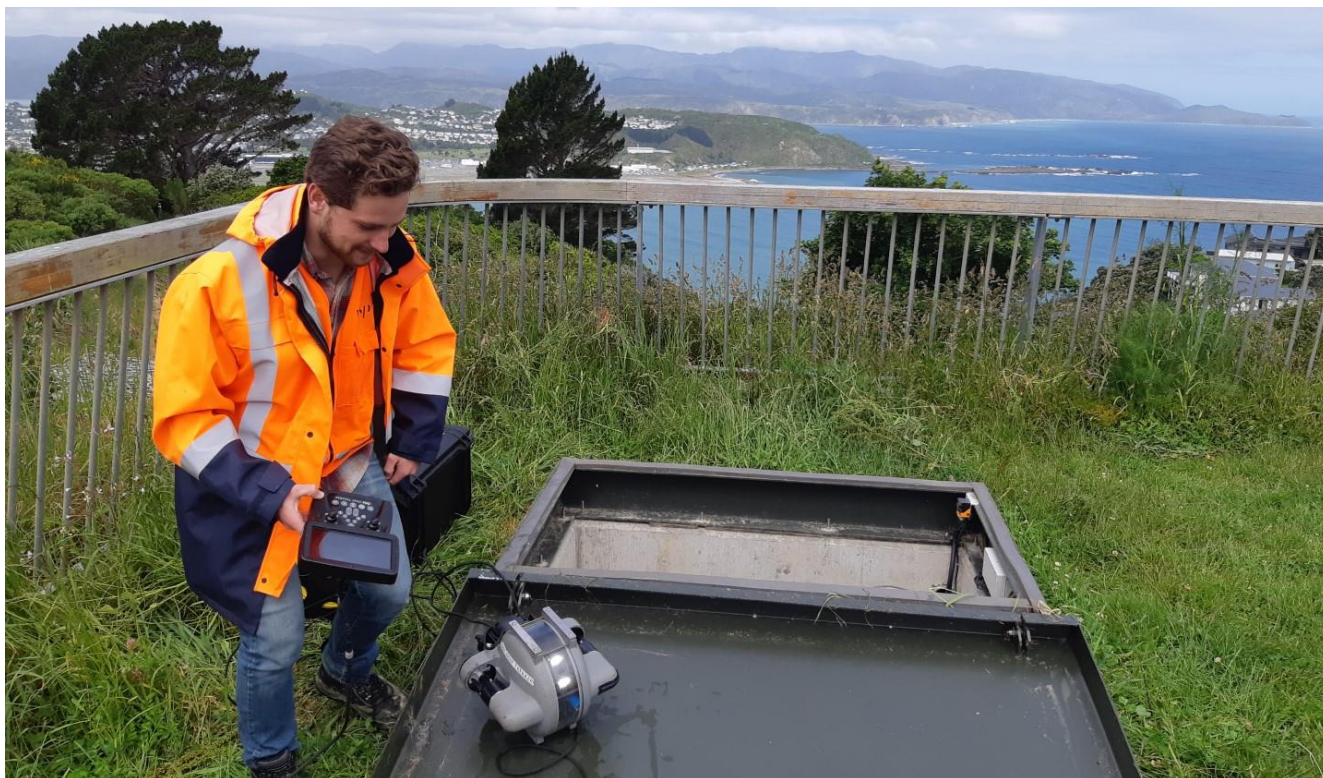
*Figure 9 – Commencement of a submersible drone inspection.*
