OUR CRITICAL ASSETS ARE AGING – A STORY OF RENEWAL OVER REPLACEMENT

Anna Gibbs (Stantec NZ)

The Featherston Street wastewater rising main is a critical pipeline that conveys wastewater flows from the Wellington Central Business District (CBD) to the main Interceptor on The Terrace. The rising main is part of a wider pressure network that services three pump stations in total. Laid in 1947, the aged rising main system had been identified by Wellington Water Limited as being in poor condition and susceptible to failure. At more than 75 years old, the Featherston Street rising main was reaching the end of its useful life and required replacement. However, renewing a 180-metre-long pipeline in the Wellington CBD comes with unique challenges. To manage the impact on businesses, traffic, and the public, the trenchless technology of slip lining was utilised to carry out a successful renewal.

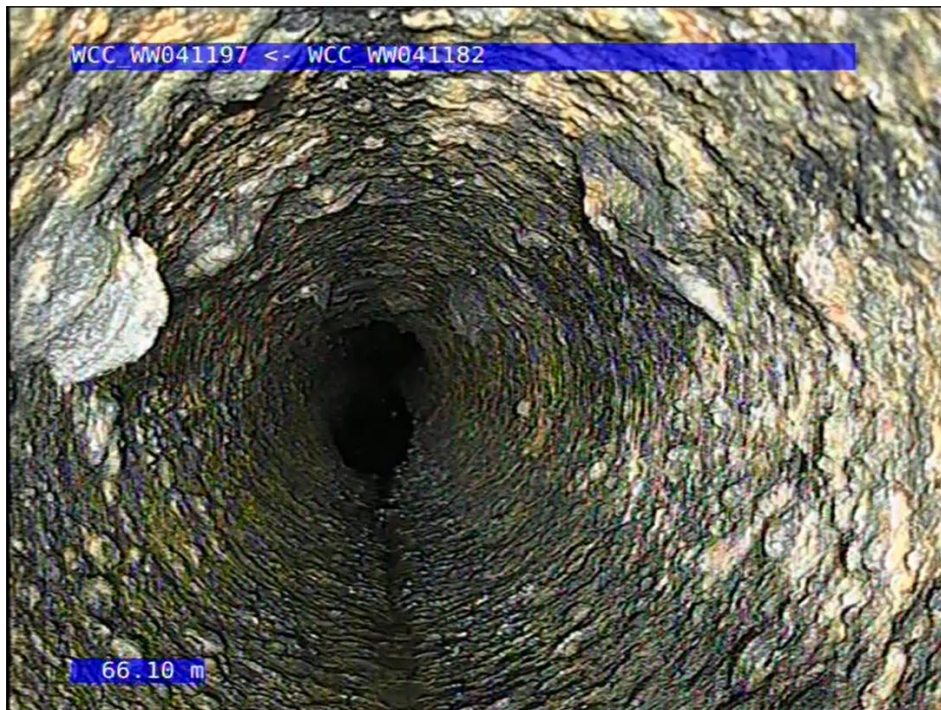
To prepare the host pipe for slip lining, it underwent several iterations of mechanical scraping, flushing, and CCTV inspections. A CCTV inspection of the pipe was carried out before cleaning commenced. The internal diameter was measured at 350mm. The annular gap the host pipe would form when slip lined with a 315mm OD pipe would therefore satisfy the limits recommended by Plastics Pipe Institute. However, as shown in Figure 3, tuberculation was present inside the existing cast-iron rising main, to a degree where damage to the new pipe could be expected.

Figure 3: Internal condition of the existing cast-iron Featherston Street rising main prior to cleaning.

To remove the tuberculation nodules from the internal walls, the contractor, G P Friel Ltd, first pulled a mechanical scraper through the host pipe using a winch. The scraper used, as shown in Figure 4, was not commercially sourced but fabricated by G P Friel Ltd for this cleaning. G P Friel Ltd continued pulling the scraper through the pipe until the winch's pressure log indicated that the instrument was no longer meeting any major resistance. This was achieved after two passes of the pipe's full length. Figure 5 shows that the scraper successfully removed the large tuberculation nodules from the pipe's full circumference, however, tuberculation debris remained on the pipe invert. This was flushed from the pipe using high-pressure jets, which simultaneously removed the layer of corrosion deposit that was still present on the walls. Several passes of the jet were required to flush the pipe clean in preparation for renewal. The host pipe's internal condition after cleaning was inspected via CCTV and, as can be seen in Figures 6 and 7, no significant defects were identified.

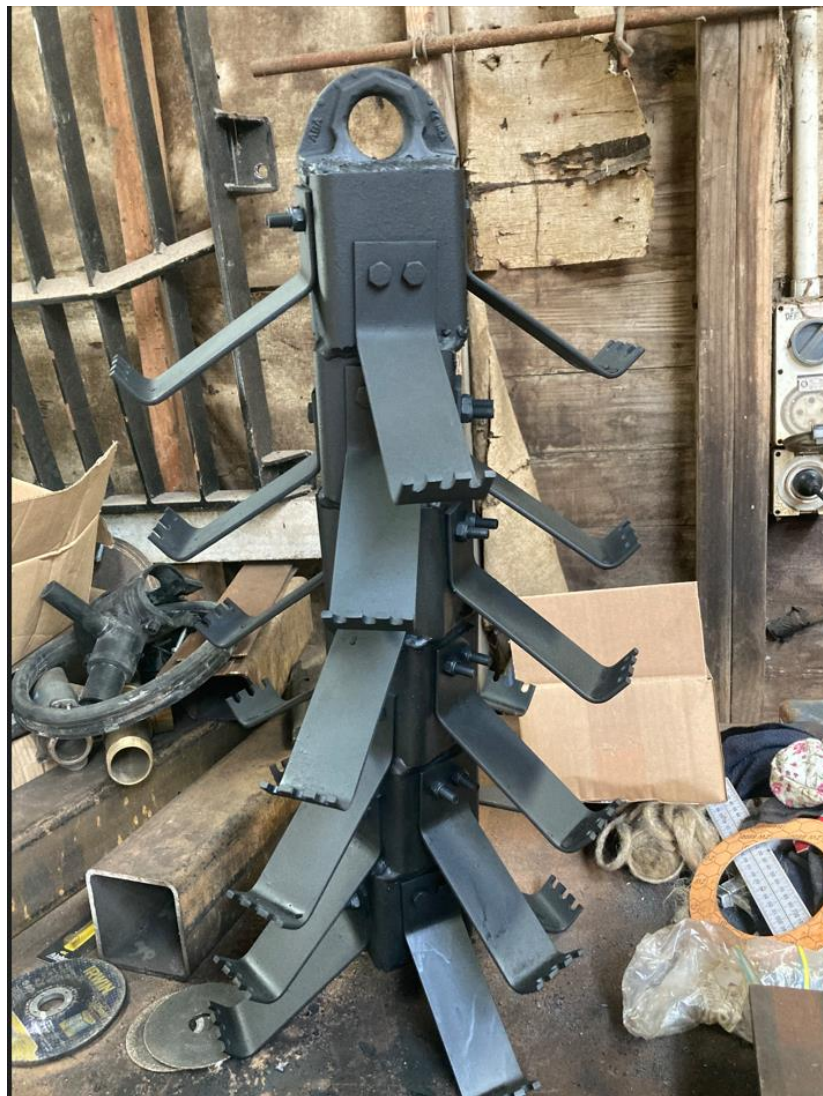
Figure 4: Mechanical scraper fabricated by G P Friel Ltd.

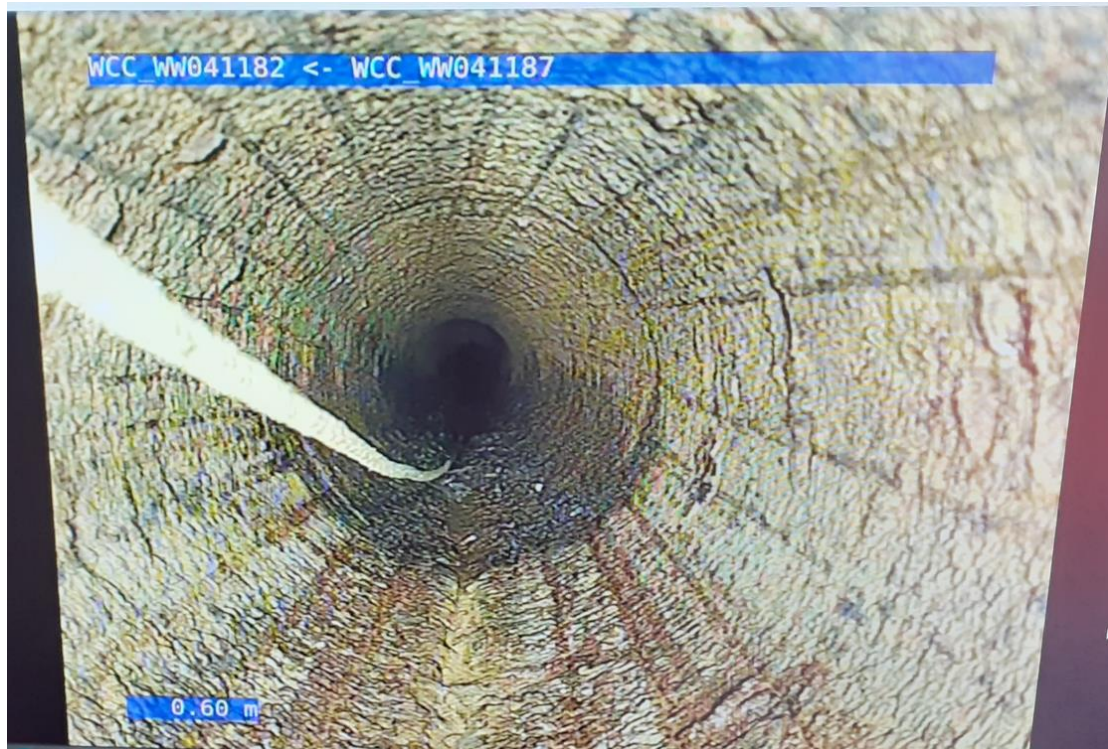
Figure 5: Internal condition of the existing cast-iron Featherston Street rising main after two passes of the mechanical scraper.

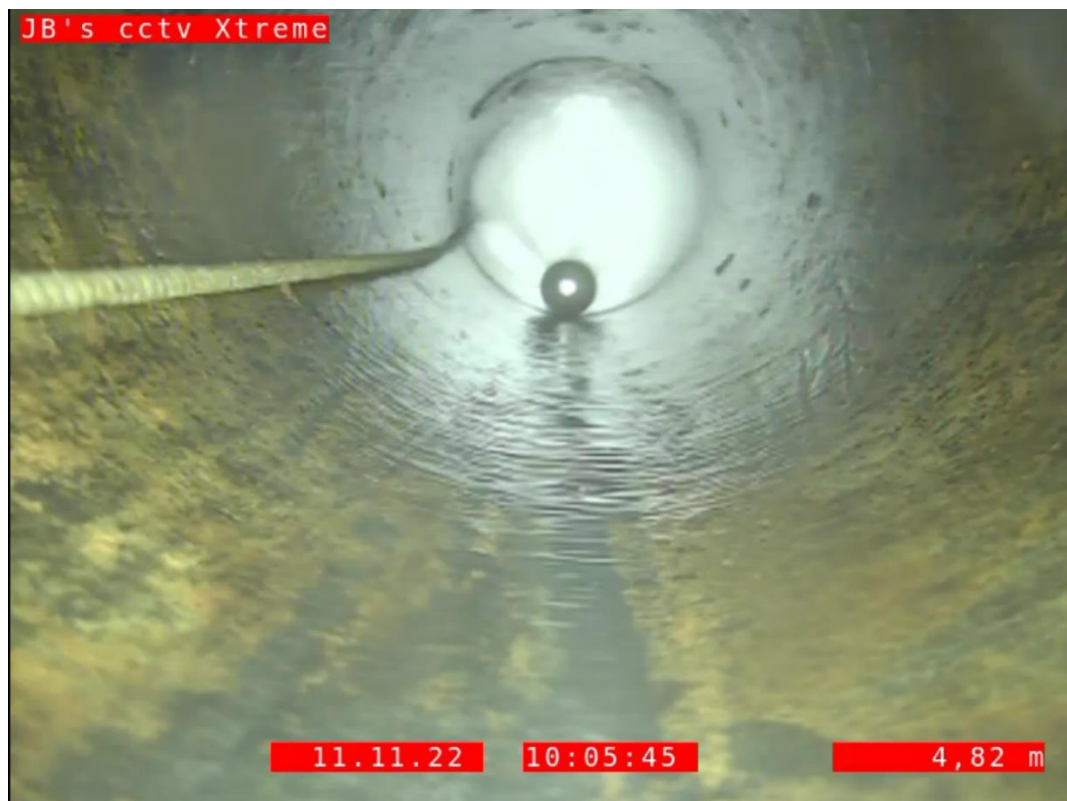
Figure 6: Internal condition of the existing cast-iron Featherston Street rising main after being flushed clean by a high-pressure jet (CH 4.82m).

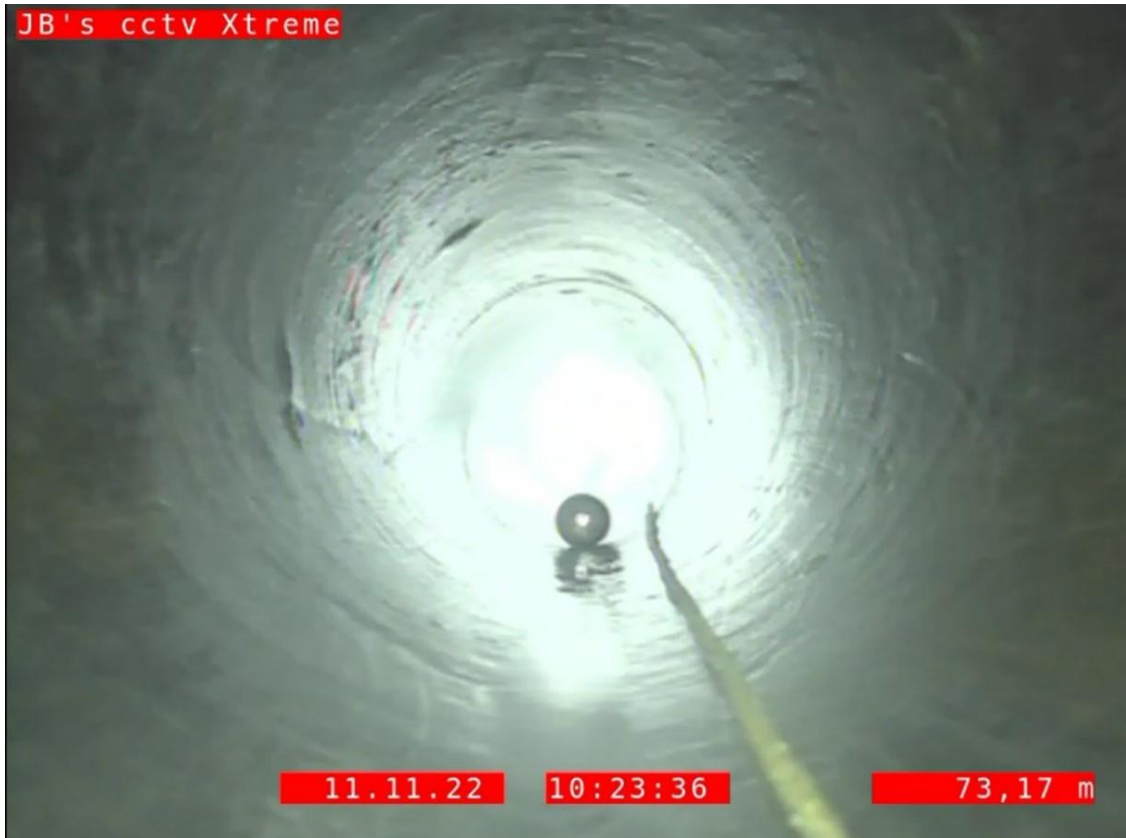
Figure 7: Internal condition of the existing cast-iron Featherston Street rising main after being flushed clean by a high-pressure jet (CH 73.17m).

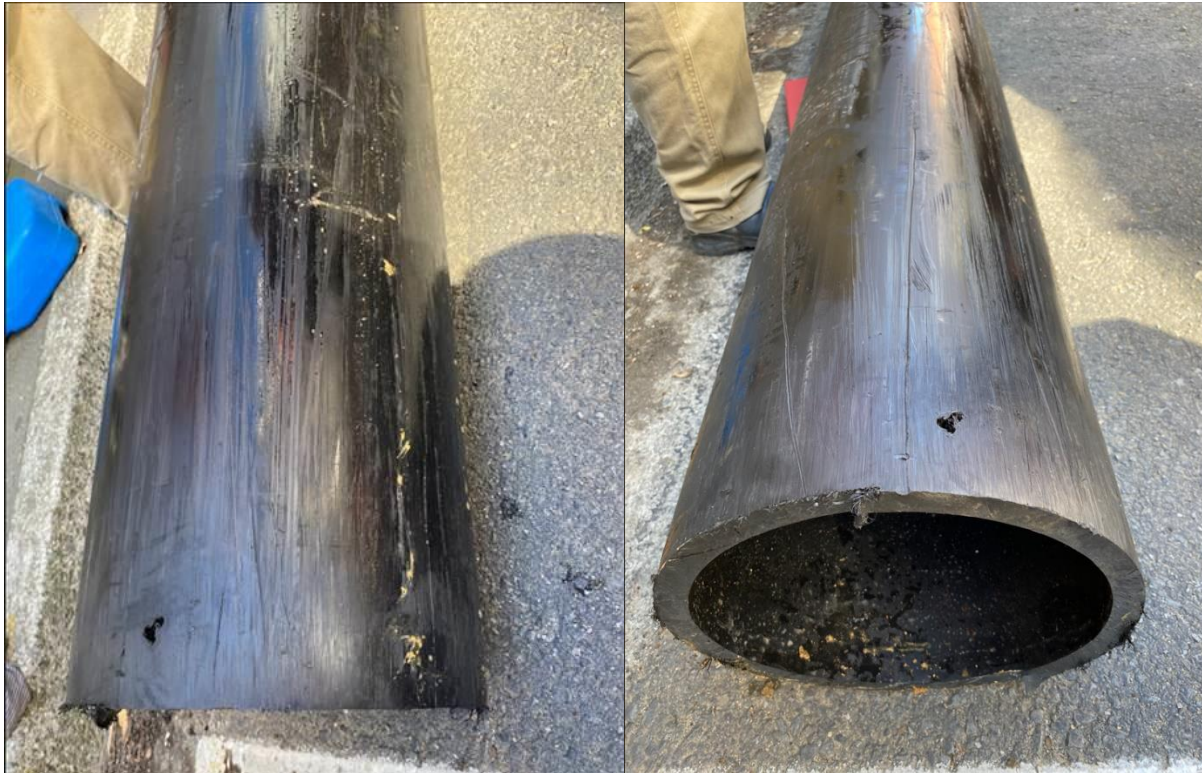
To confirm no significant defects remained in the host pipe after cleaning, G P Friel Ltd pulled a three-meter section of 315OD PE100-RC SDR17 pipe along the full slip line alignment. The walls of this test piece were inspected for gouges that exceeded the 2mm tolerance as per the Wellington Water Specification for Water Services. No measurable defects were identified, as all markings had a depth of less than 0.5mm. This indicated that the pipe's bore was free of any material that could cause notable damage to the new pipe during installation. The test piece's external condition post-slip line is presented in Figure 8.

Figure 8: External condition of the three-meter long test section post-slip line.

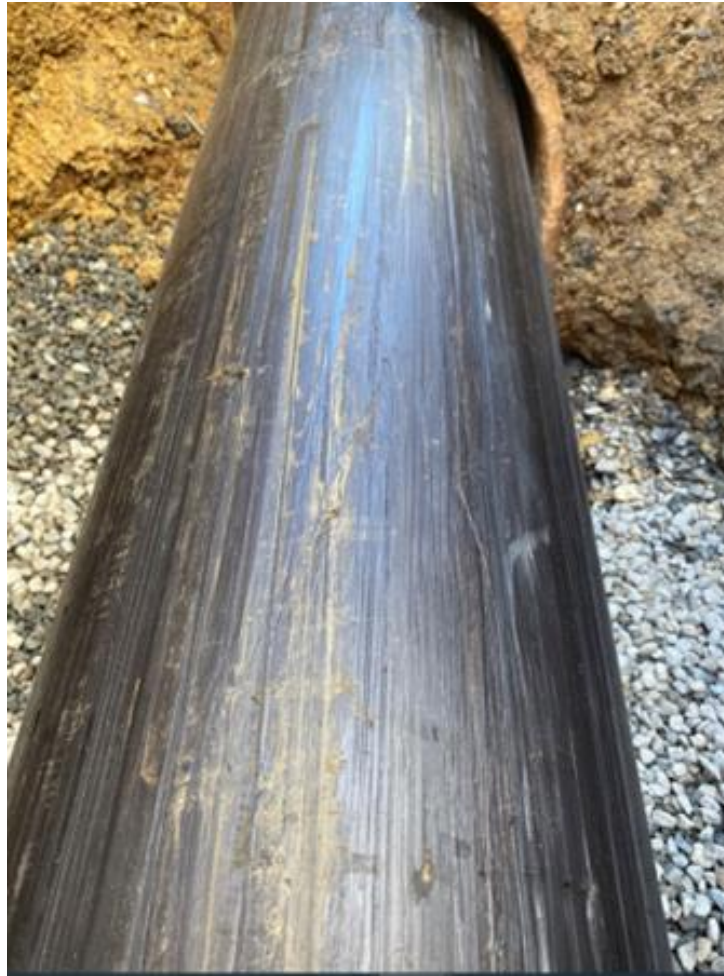
The first five meters of pipe could be accessed in the reception pit for inspection after the slip line was complete. This section was inspected as it should theoretically bear the most damage compared to the remaining 175m of pipe. This is because it is in contact with the host pipe over the full 180m alignment. A section of pipe located halfway along the alignment would only travel half the distance and hence not come in contact with all defects present in the host pipe. The new pipe's external condition post-slip line is shown in Figure 9. The post-slip line inspection found that the markings on the pipe were predominantly superficial scratches that could not be measured. No gouges that exceeded the 2mm tolerance specified were found to extend into the host pipe. Based on these findings, the new pipe was accepted for installation.

Figure 9: External condition of the new pipe post-slip lining (top of pipe).
