# Our Critical Assets are Ageing – A Story of Renewal over Replacement

Stantec New Zealand

**water**  
NEW ZEALAND  
CONFERENCE & EXPO  
17-19 OCTOBER 2023  
Tākina, Te Whanganui-a-Tara Wellington

PS8, PS9 & PS42 Rising Main Network

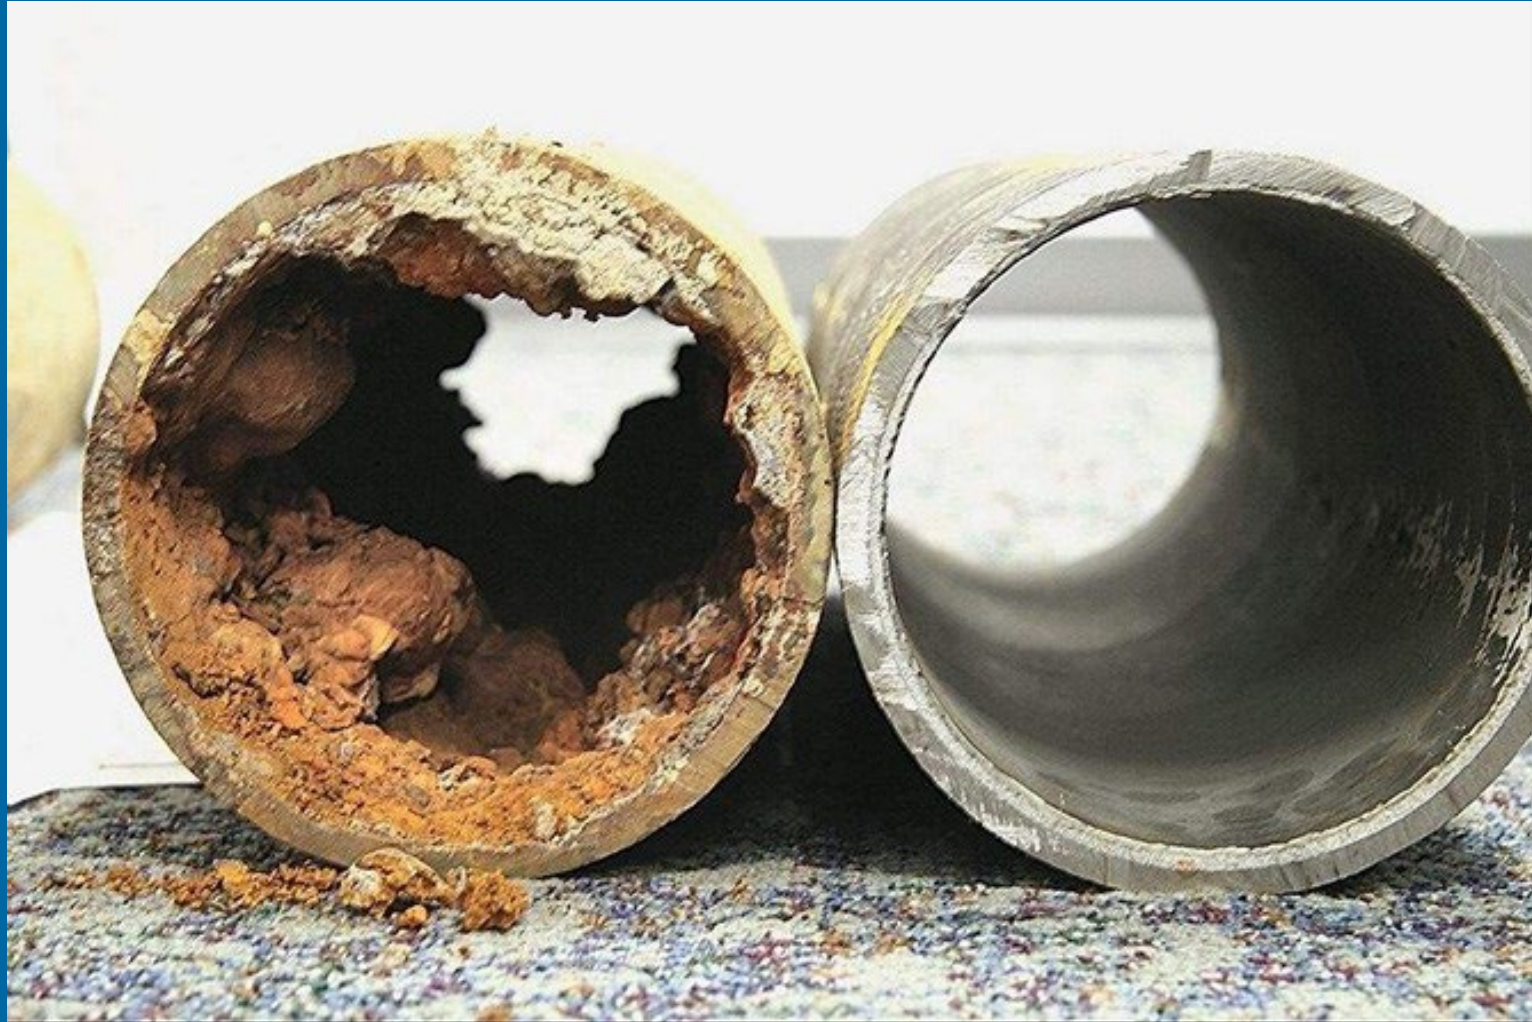
# Tuberculation

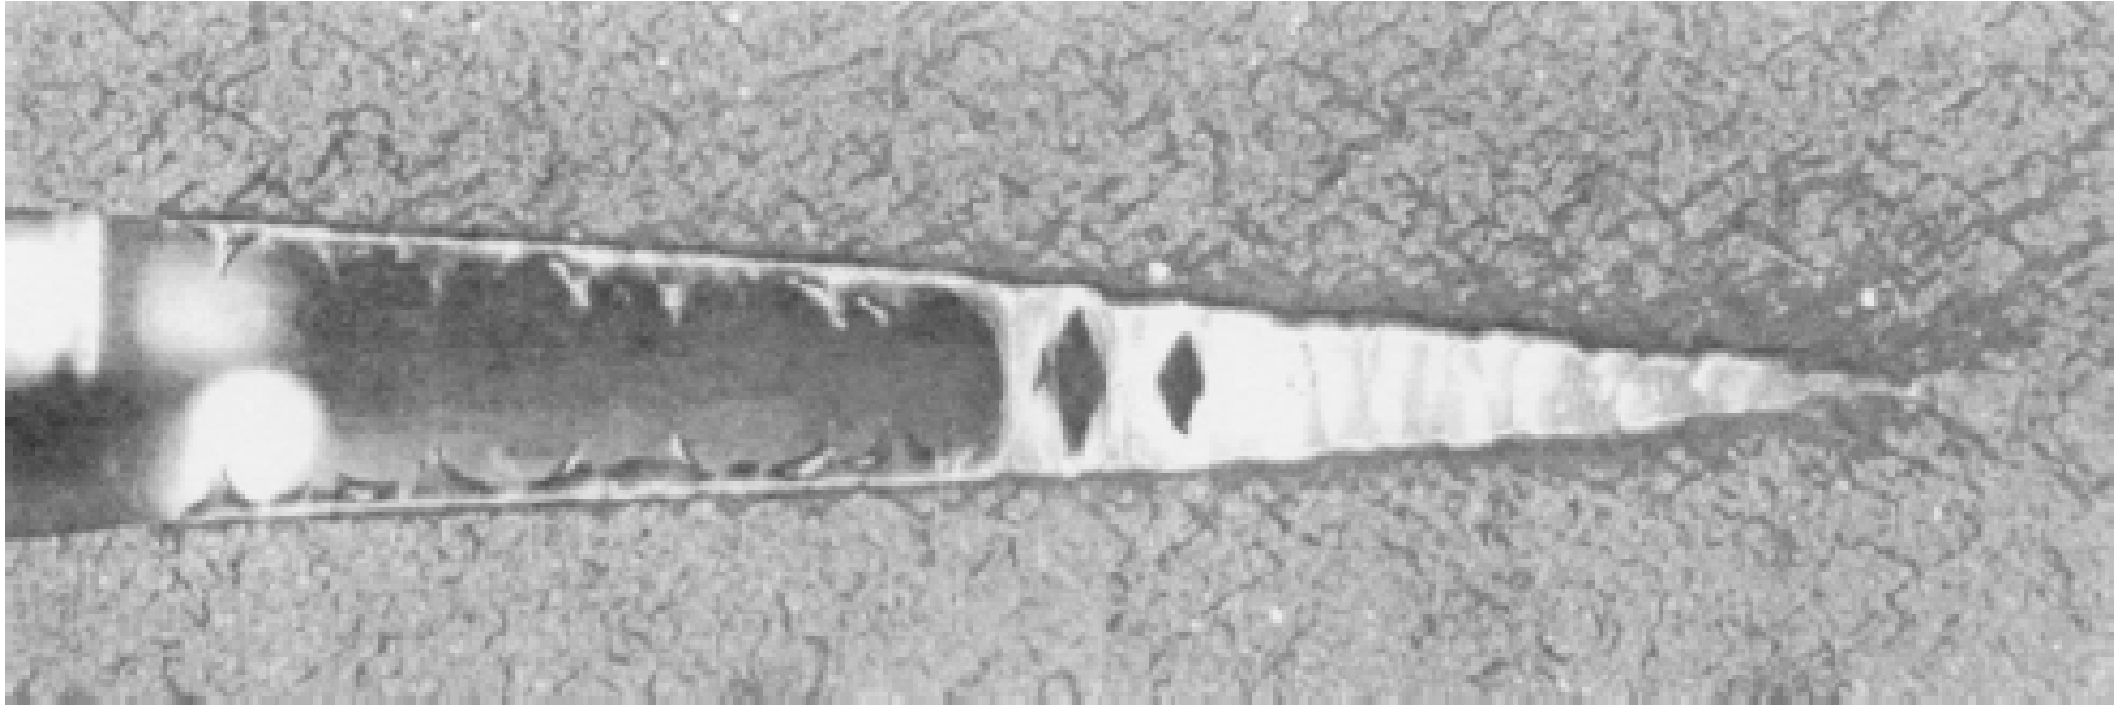
# Slow Crack Growth

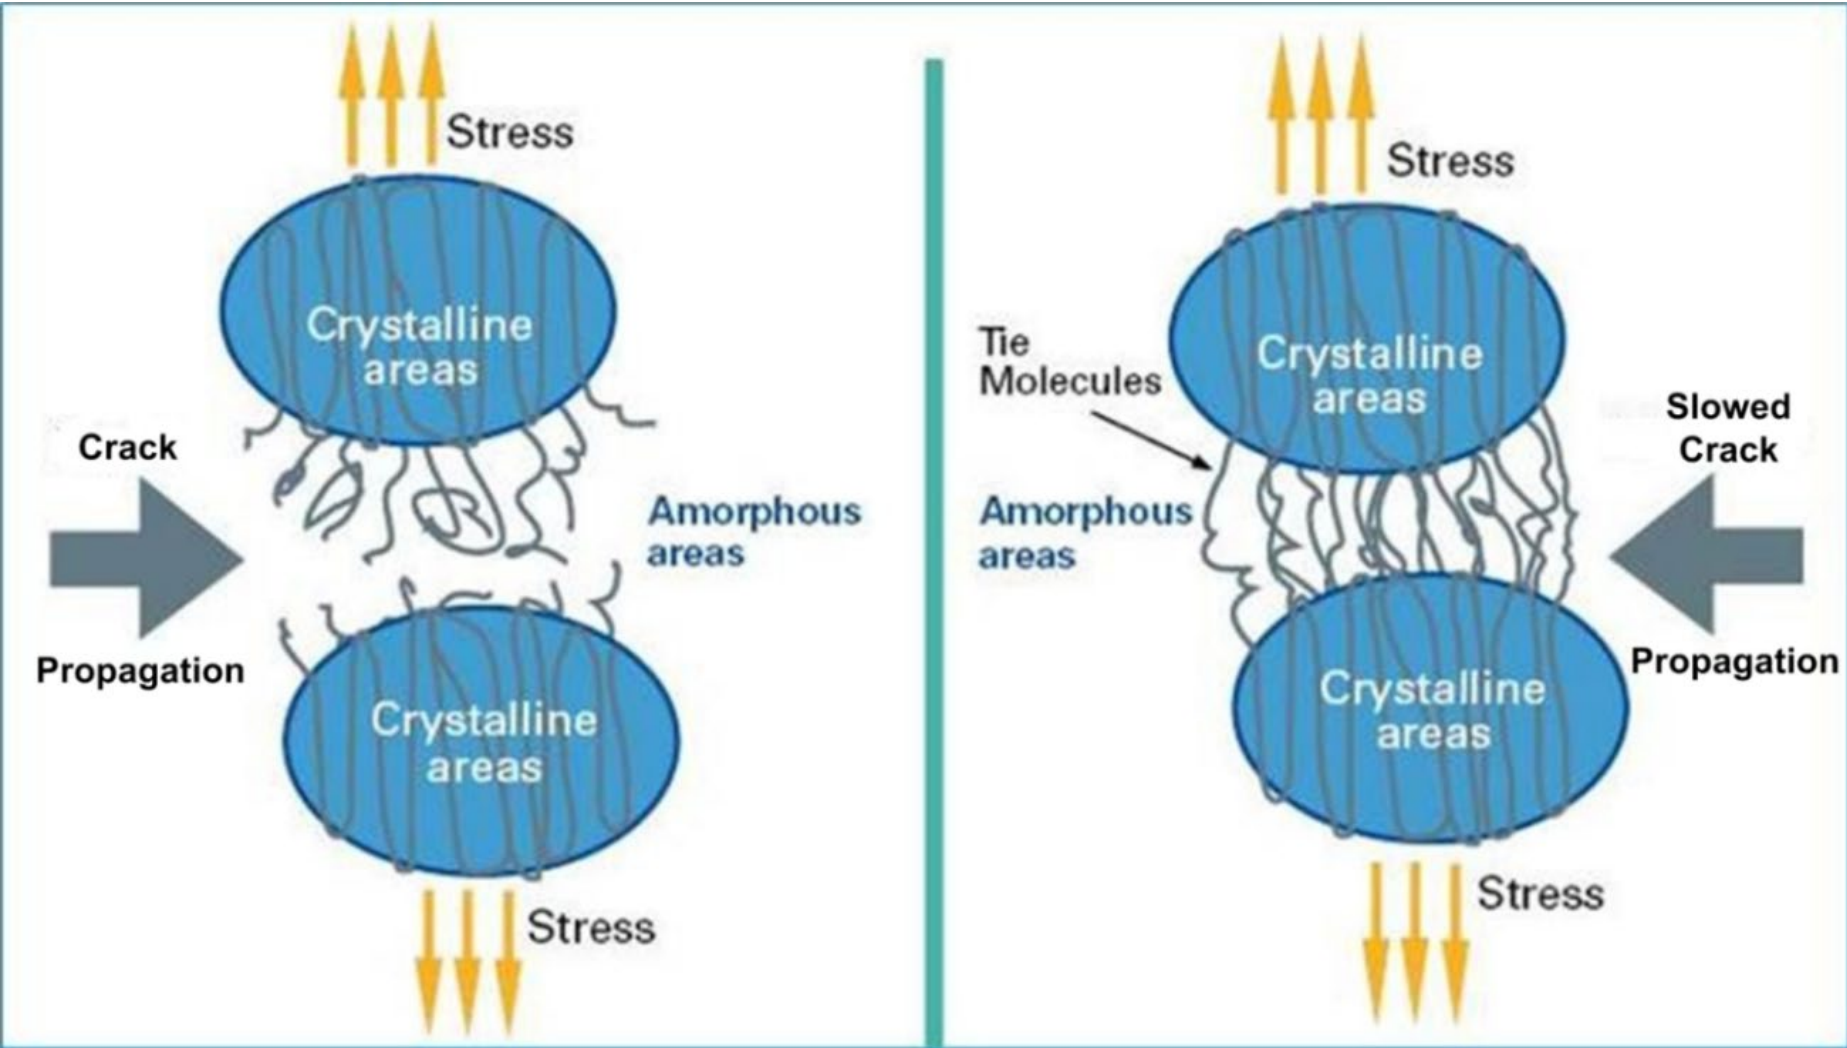
# Material Selection

# Standard PE100

# “Resistant to Crack” PE100

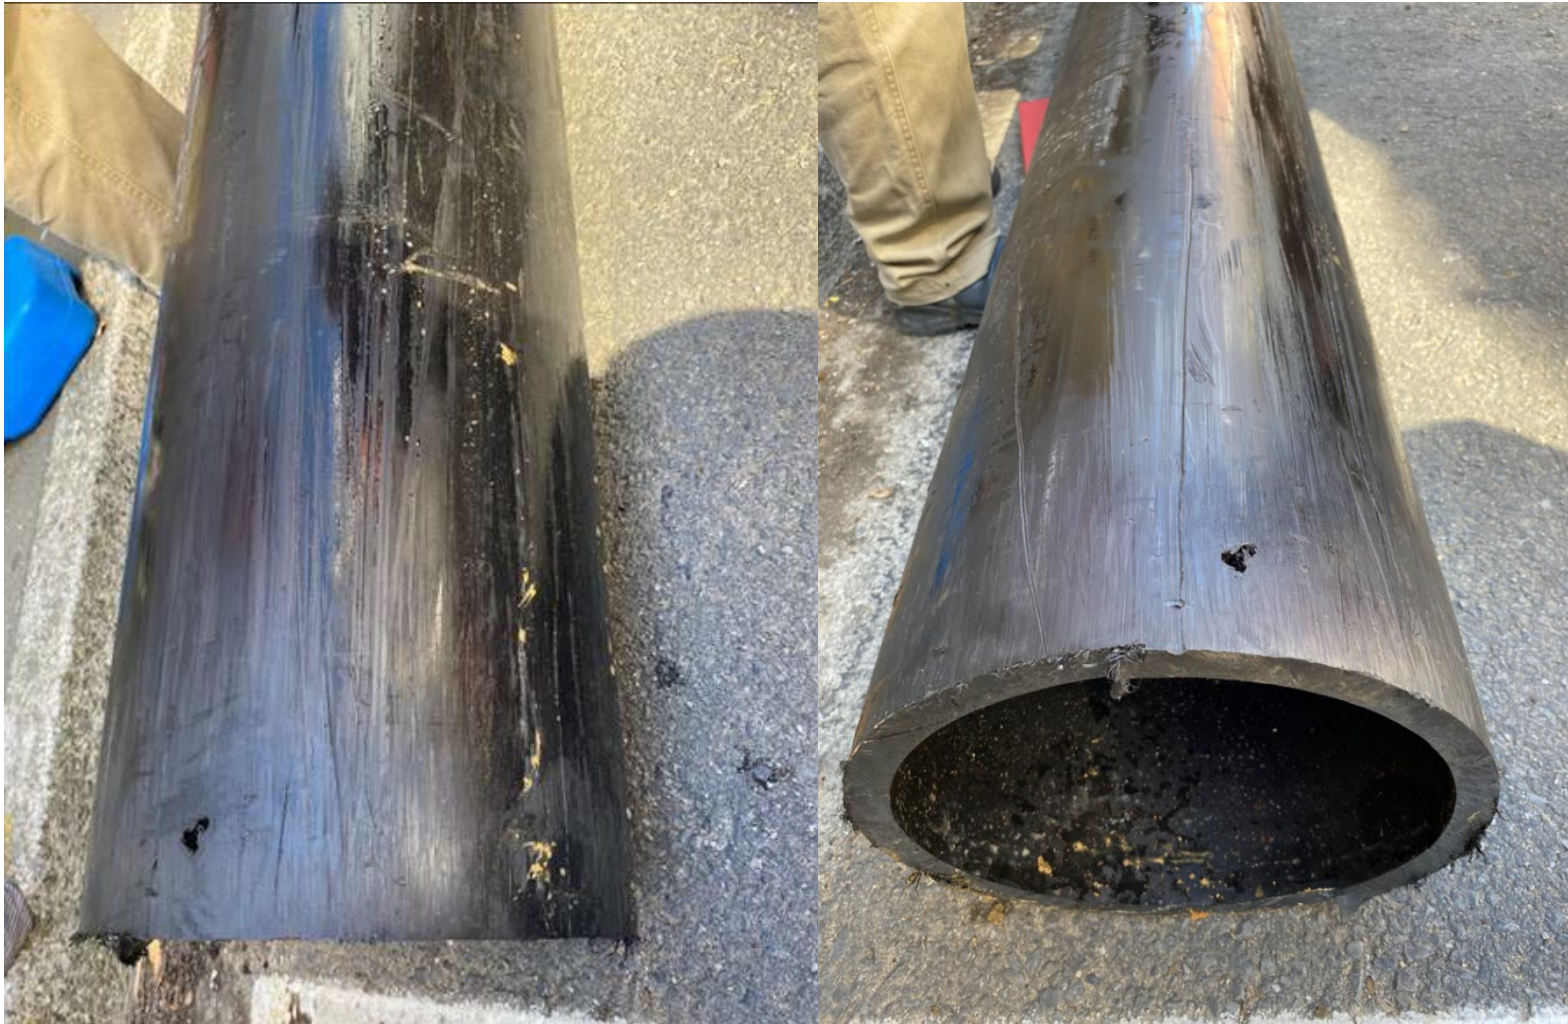
# Test Piece

- Minimal markings identified
- All scratches extended less than 0.5mm into the pipe wall

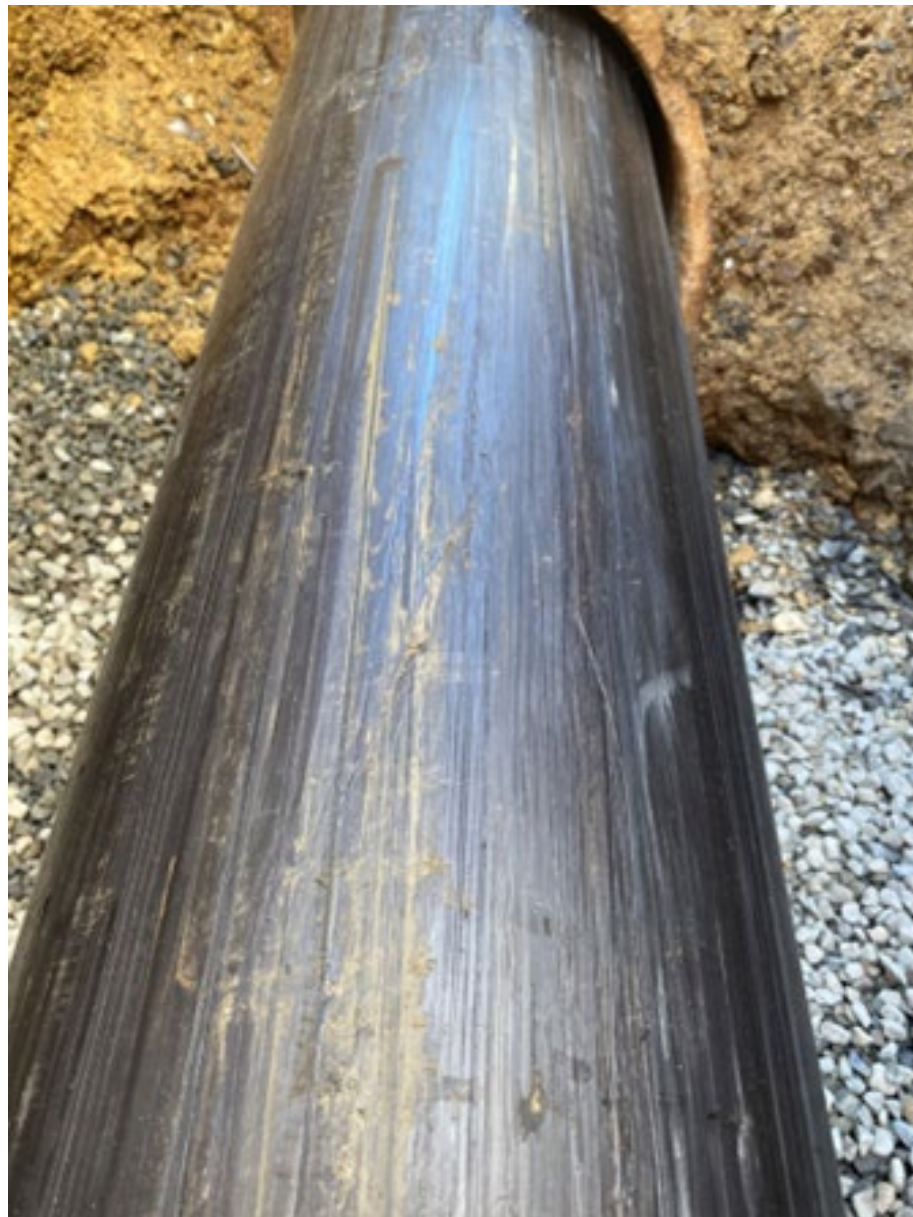
# Post Slip Line Defects Inspection

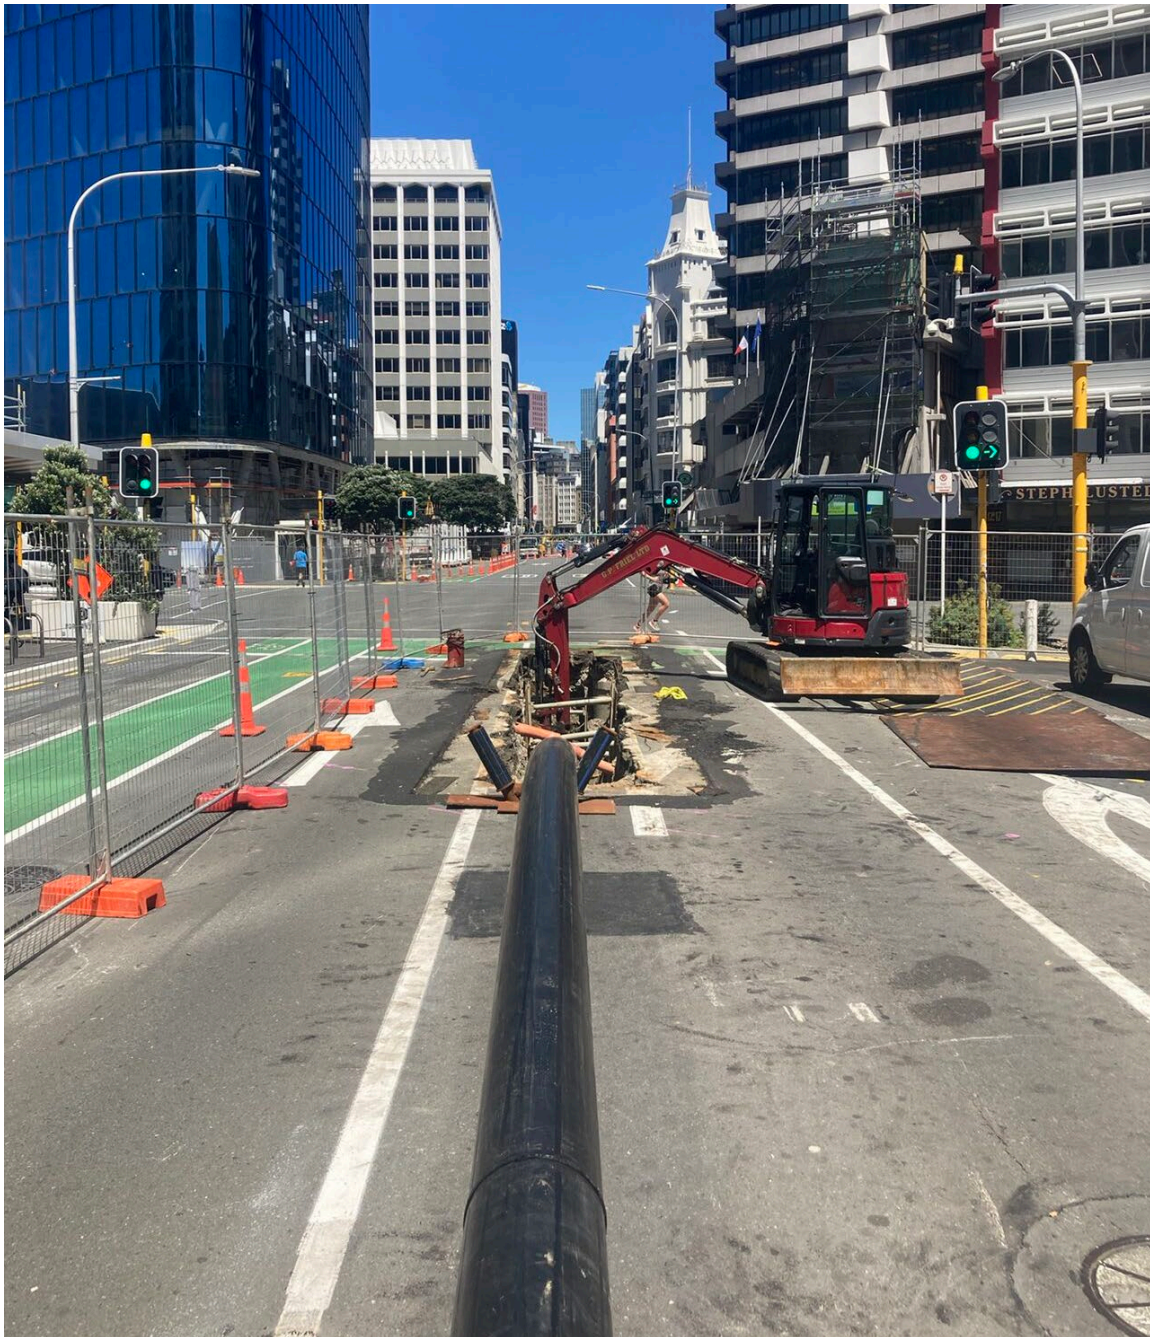
**Total estimated construction-related carbon emissions to renew 180m of rising main (tonnes CO<sub>2</sub>eq)**
