CONQUERING EXTREME TURBIDITY

Mike Charteris – Hauraki District Council

Iain Rabbitts – Harrison Grierson

Nicky Smalberger – Harrison Grierson

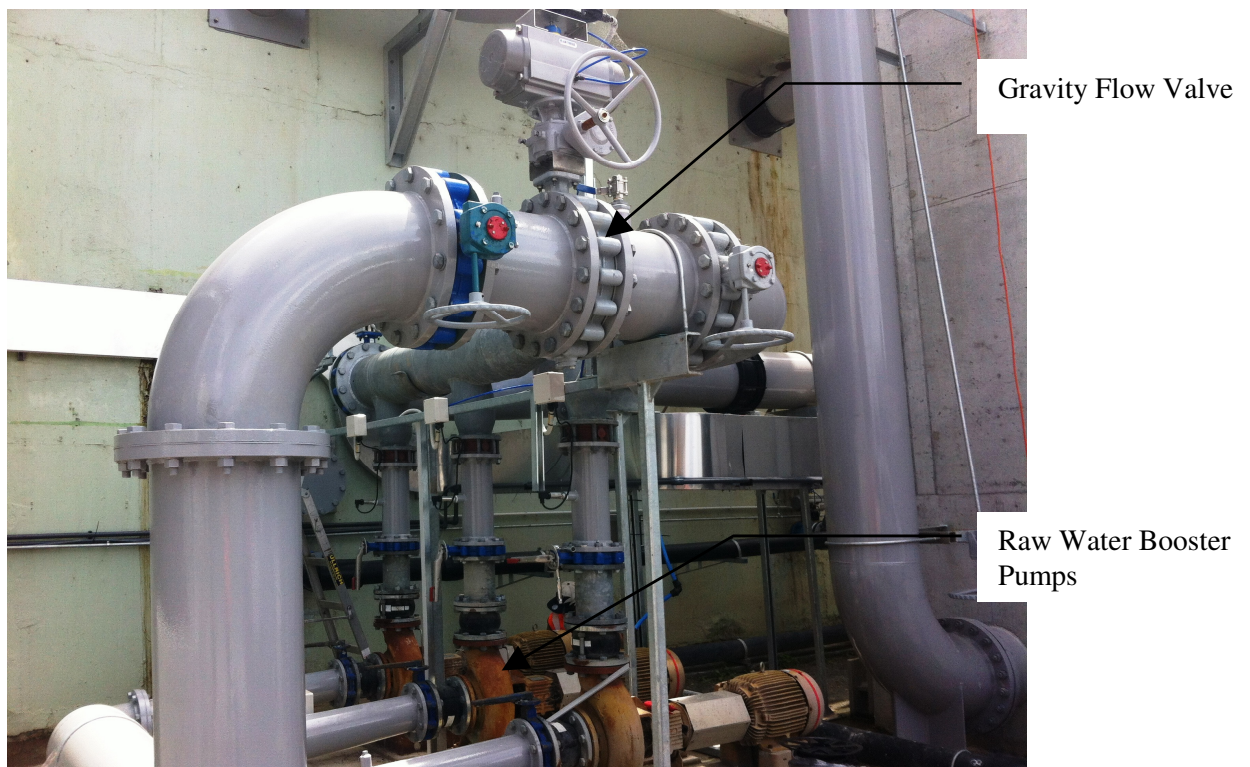
Photograph 1 – Raw Water Booster Pumps and Gravity Flow Valve

required. This required a carefully designed system that could automatically change from gravity flow to pumped flow, whilst not causing cavitation on the pumps due to a low pumping head and the re-use of the existing pumps. The reduction in pumping costs produces a saving for Haruaki District Council over the original philosophy. The photograph below shows the arrangement of three duty pumps and a bypass gravity system.

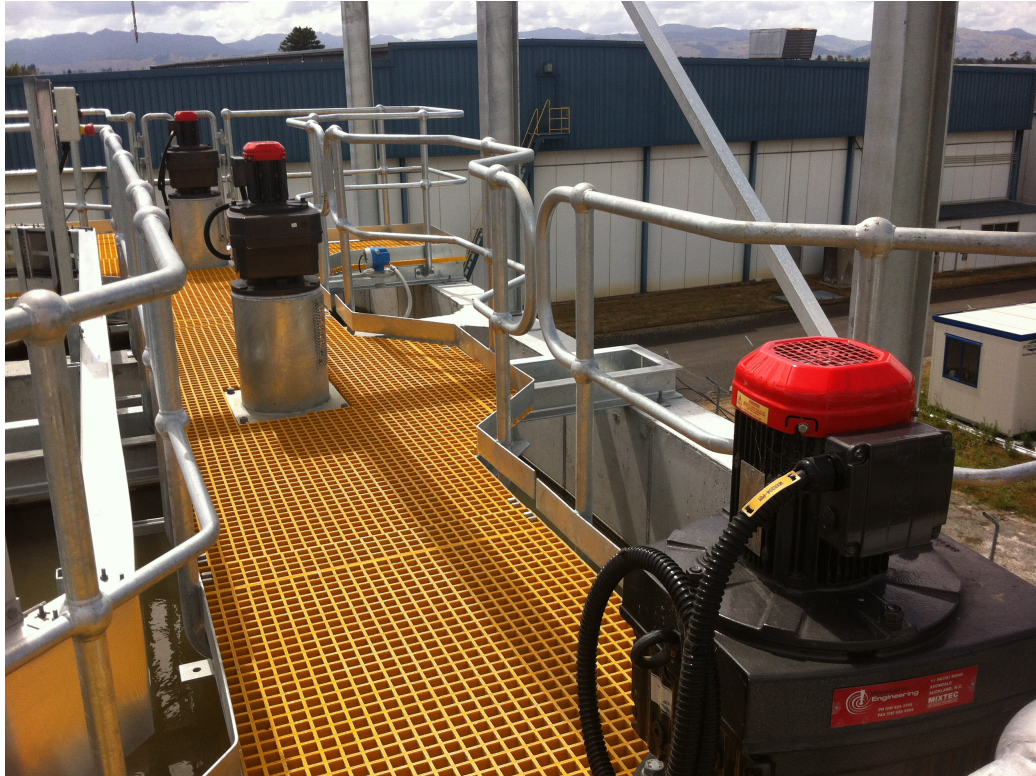
Photograph 2 – Flocculation Tank Mixers

The second difference was the flash mixing of coagulant and the separate flocculation tanks. The pre-upgrade design relied on the use of polymer to enhance flocculation for the existing blanket clarifier and was required as a principle of operation for the absorber clarifier. Given that tube settlers have no integral flocculation zone, separate flocculation is required.

Jar testing of the raw water indicated that the use of polymer had little or no effect on the size and settle-ability of the floc. Therefore by moving to tube settlers, there was the initial disadvantage of the additional flocculation towers but the advantage of potentially removing polymer from the dosing stream completely. As shown in the schematic above, the plant was designed without polymer but with the ability to add it at a later date if required. At the time of writing (August 2013), polymer has still not been used in the upgraded plant.

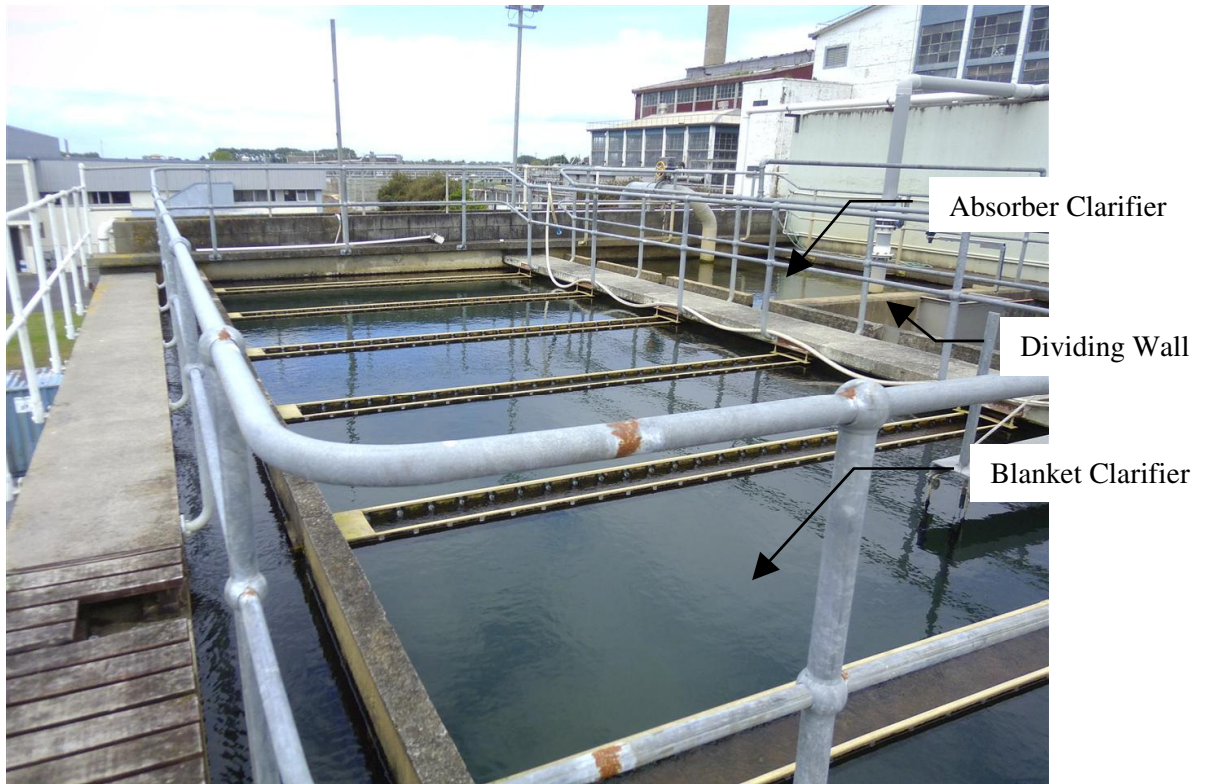
Photograph 3 – Original Clarifiers

The existing clarifiers had originally been two blanket type clarifiers approximately 11 metres long by 5.5 metres wide. In the early 1990s, one of the clarifiers had been converted into an absorber clarifier by halving the length of the clarifier – with a cast in-situ concrete wall – and installing the necessary mechanical equipment.

Whilst the original blanket clarifier performed well within its design limits, the absorber clarifier did not perform well with turbidities over 20 NTU without constant manual intervention. Both clarifiers were converted in this upgrade to horizontal flow tube settlers.

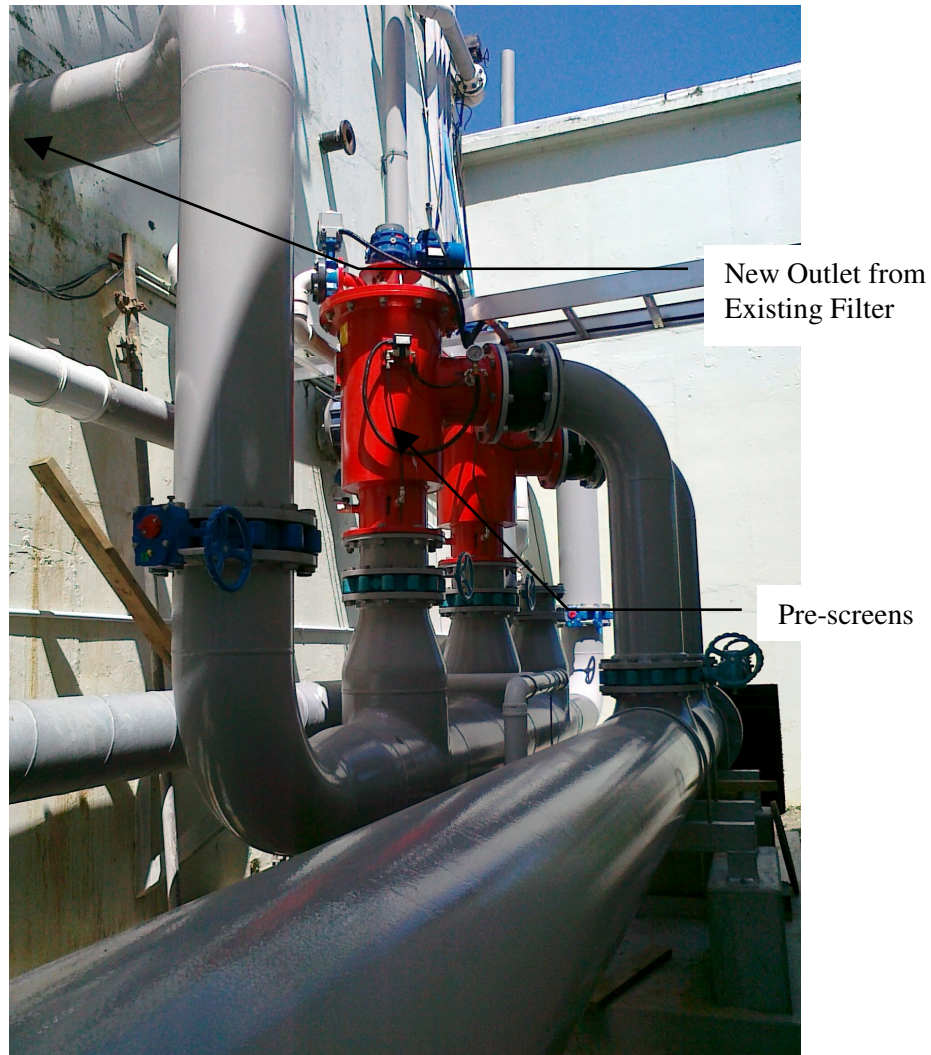
Photograph 5 – Membrane Pre-screens

The existing sand filters served as a water tank with a top water level sufficient to drive the clarified water through the pre-screens and into the membrane cells. The only modifications to the filters were removing the old media and installing a new clarified water outlet to the membrane pre-screens. The photo below shows the new outlets and the pre-screens as installed.

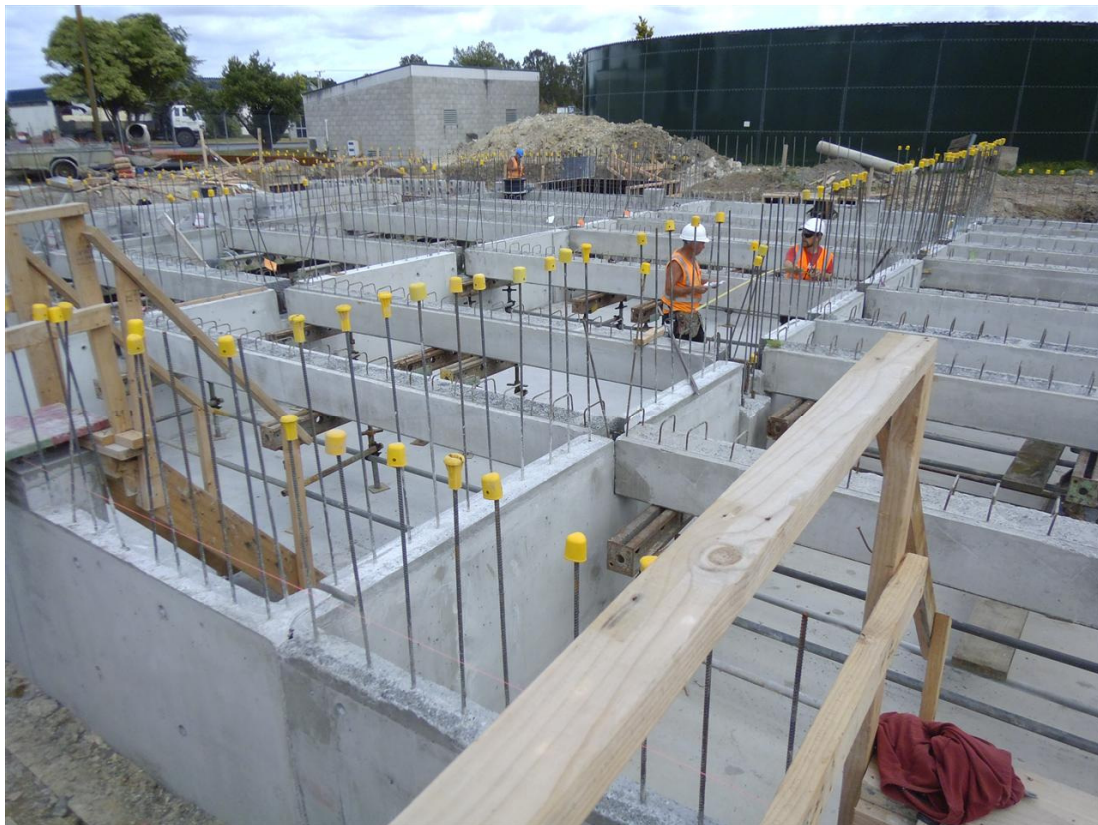
Photograph 6 – Construction of the Sludge/Backwash and CIP Tanks

A new building was constructed to house the new membrane plant and the new UV disinfection system. As discussed above, the membrane plant and building was to be built over the sludge/backwash and CIP neutralization tanks. Each of these tanks were about 70 m³ with a maximum depth of about 1.5 metres. The photo below shows the construction of these tanks. The depth of the tanks is clearly indicated by the men standing inside them.

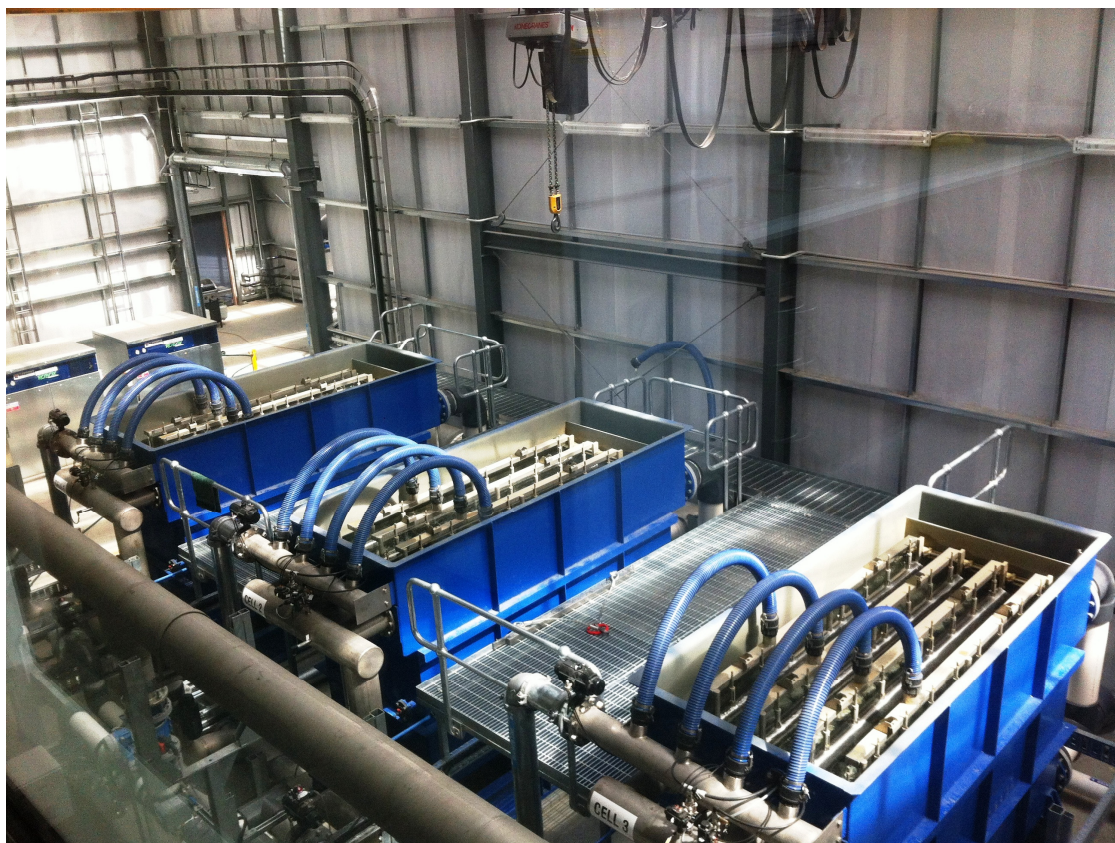
Photograph 7 – Membrane Cells

The membrane plant is a Memcor submerged membrane plant consisting of three cells, each with 144 membrane modules, and has a capacity of 12.5 Mld output. The feed for the membranes was clarified water from the converted filter tanks via the pre-screens to the membrane cells. The hydraulic head available to drive the water through the screens to the membrane cells was approximately 4.8 metres. This achieved two goals: 1) to refill

the membrane cells quickly after backwash; and 2) to provide sufficient head to drive through the pre-screens. This available head was a result of re-using the existing clarifiers and filters to feed the membrane plant installed at grade.

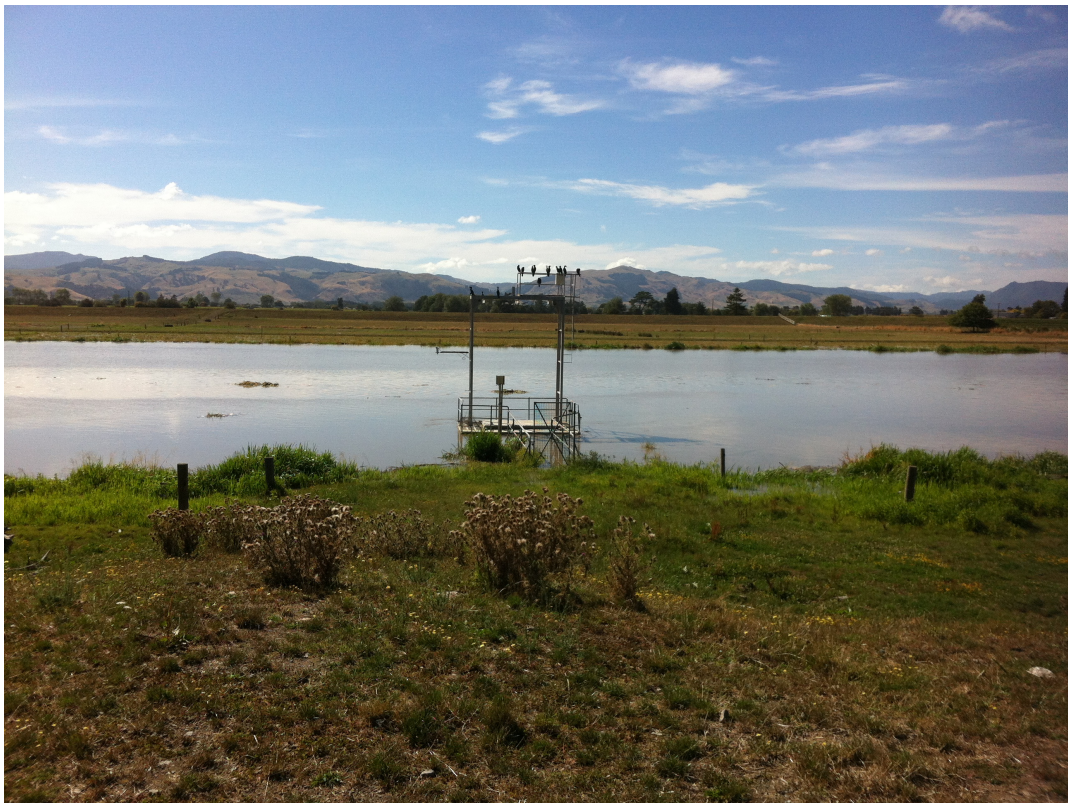
Photograph 8 – Waihou Intake February 2013

The second high turbidity event occurred from Monday 11th February to Wednesday 13th February 2013. The predicted tide height in the Firth of Thames was 3.5 metres and the Hauraki District was in the grip of the worst drought for 70 years. Very high turbidities were expected in the Waihou River. As shown in the photograph below, the high tide occurred as predicted and almost submerged the intake structure.

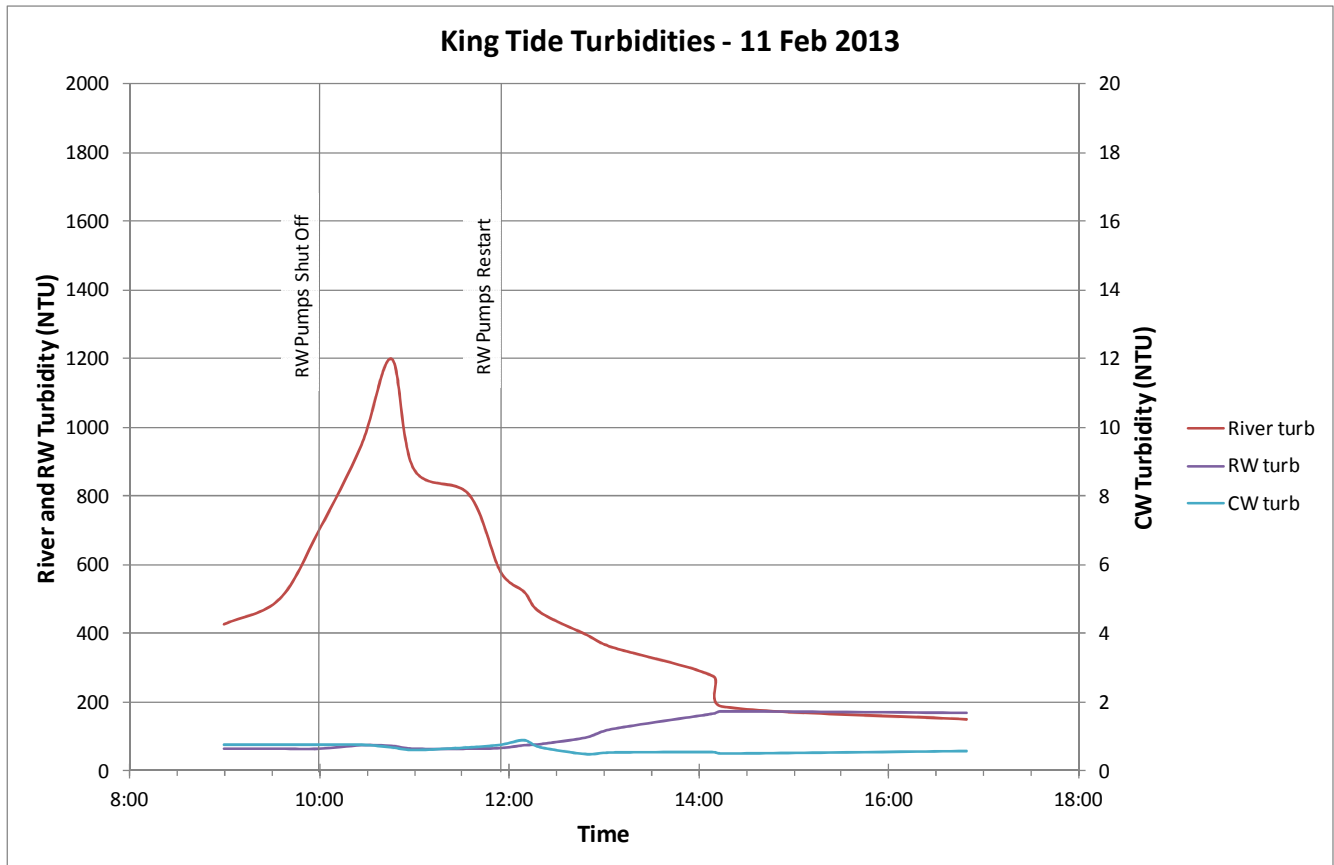
Figure 2 – King Tide Event 11th February 2013

The idea of the trial was to challenge the plant with high turbidity. The turbidity rose as expected with the peak turbidity in the river at about 11:00am being about 1200 NTU. The raw water pumps switched off at approximately 10:00 am when the river water turbidity exceeded 700 NTU. The raw water being fed from the raw water tank peaked at about 170 NTU but the trend was severely flattened out as expected by the buffering effect of the raw water tank.

The raw water pumps were restarted at approximately 11:45 am. The level in the raw water tank dropped to a minimum level of 78% from the starting point of 91%. Figure 2 below shows the turbidities into the plant and from the clarifier. What is interesting is that the clarified water turbidity does not vary over this time.

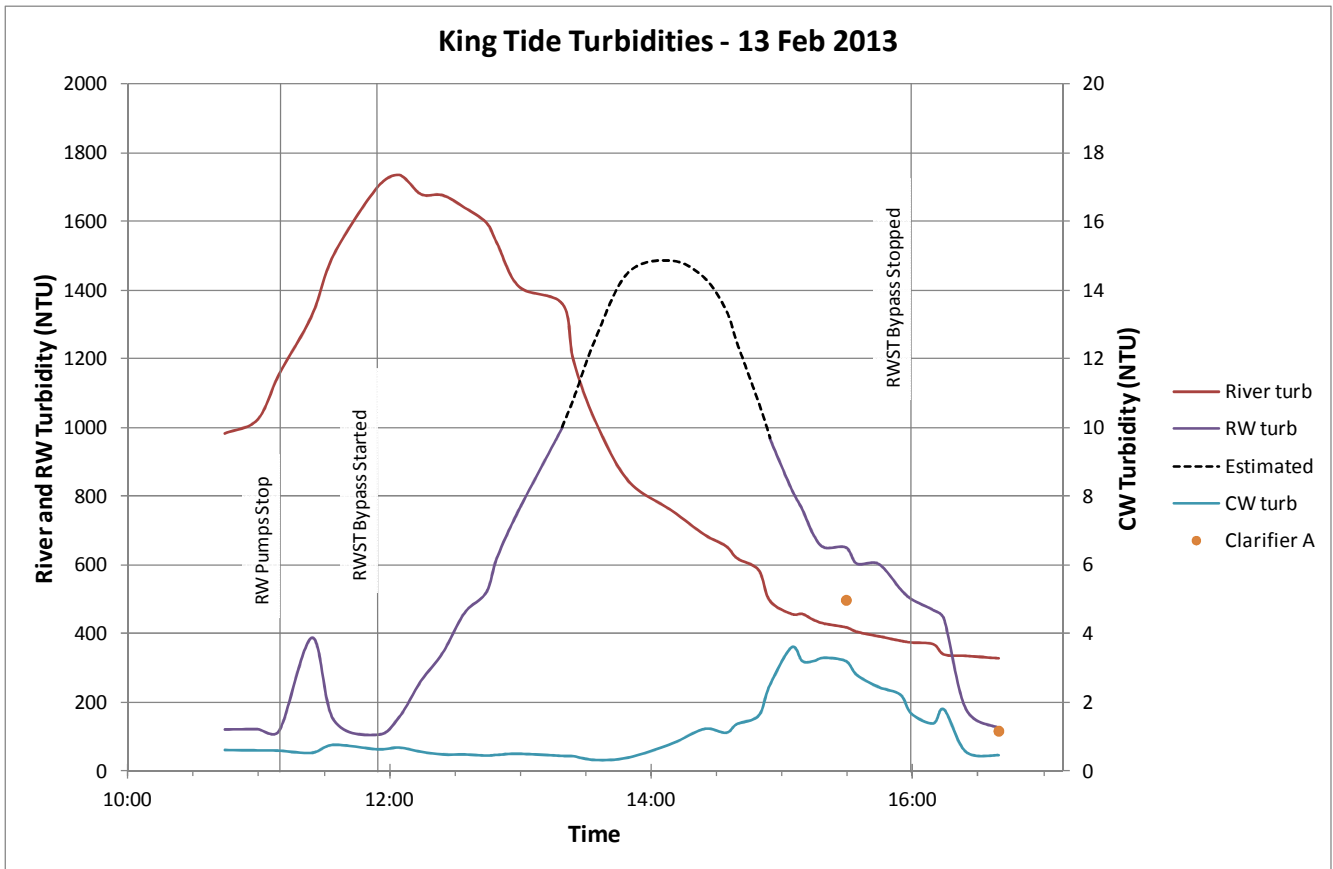
Figure 4 - King Tide Event 13th February 2013

High tide on the Wednesday was approximately 10:35 am. By the time the jar testing had been completed, the by-pass was not opened until 11:55am. The graph below shows the turbidity traces from the river, the raw water into the plant and the clarified water turbidity.

There are a number of interesting areas to address in the graph above. The first is the problem of the raw water turbidity meter at the plant having a range of 0 to 1000 NTU. The dotted line is a best guess at the turbidity that actually came into the plant, estimated at over 1400 NTU. The second issue is the delay between the turbidity reading in the river and the turbidity reading in the plant (in the order of two hours). This can partially be attributed to the transit time in the raw water pipeline which is approximately five kilometres long.

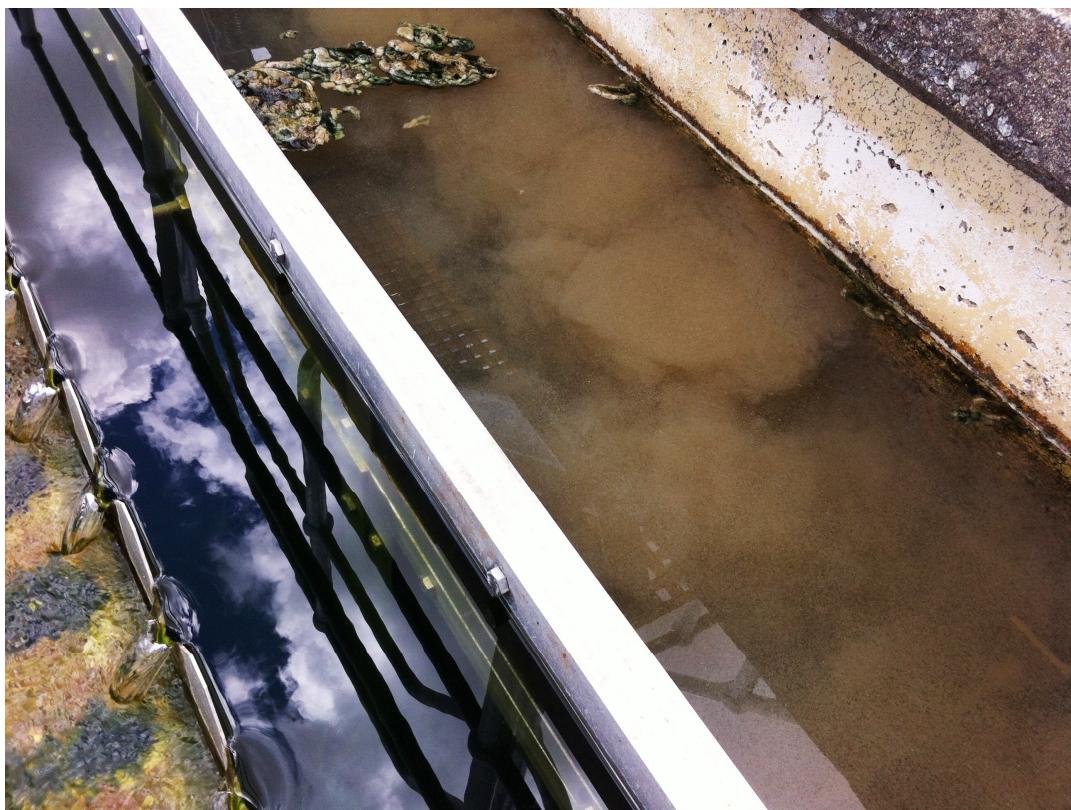
Photograph 9 – Clarifier Inlet February 2013

During this event, the turbidity into the plant exceeded the design inlet conditions of 700 NTU for approximately two hours. The clarified water turbidity was mildly affected and rose to approximately 5 NTU on one of the clarifiers. Given that what was being put into the clarifier was roughly the same as the sludge normally discharged, the ability of the clarifiers to remove the sludge was compromised. The design had been for a certain solids loading and the plant was treating roughly double that amount. Solids were building up in the clarifier despite the frequency of desludges and the duration being increased. It was of interest that at the time of the turbidity spike, sludge was seen by the commissioning engineer coming out the tubes at the far end of the clarifier, possibly indicating that the sludge scraper had been over-loaded and unable to remove the amount of sludge produced in the clarifier sufficiently quickly.
