FLOOD RESPONSE IN THE WAIMAKARIRI DISTRICT

Kate Purton (Beca) & Gerard Cleary (Waimakariri District Council)

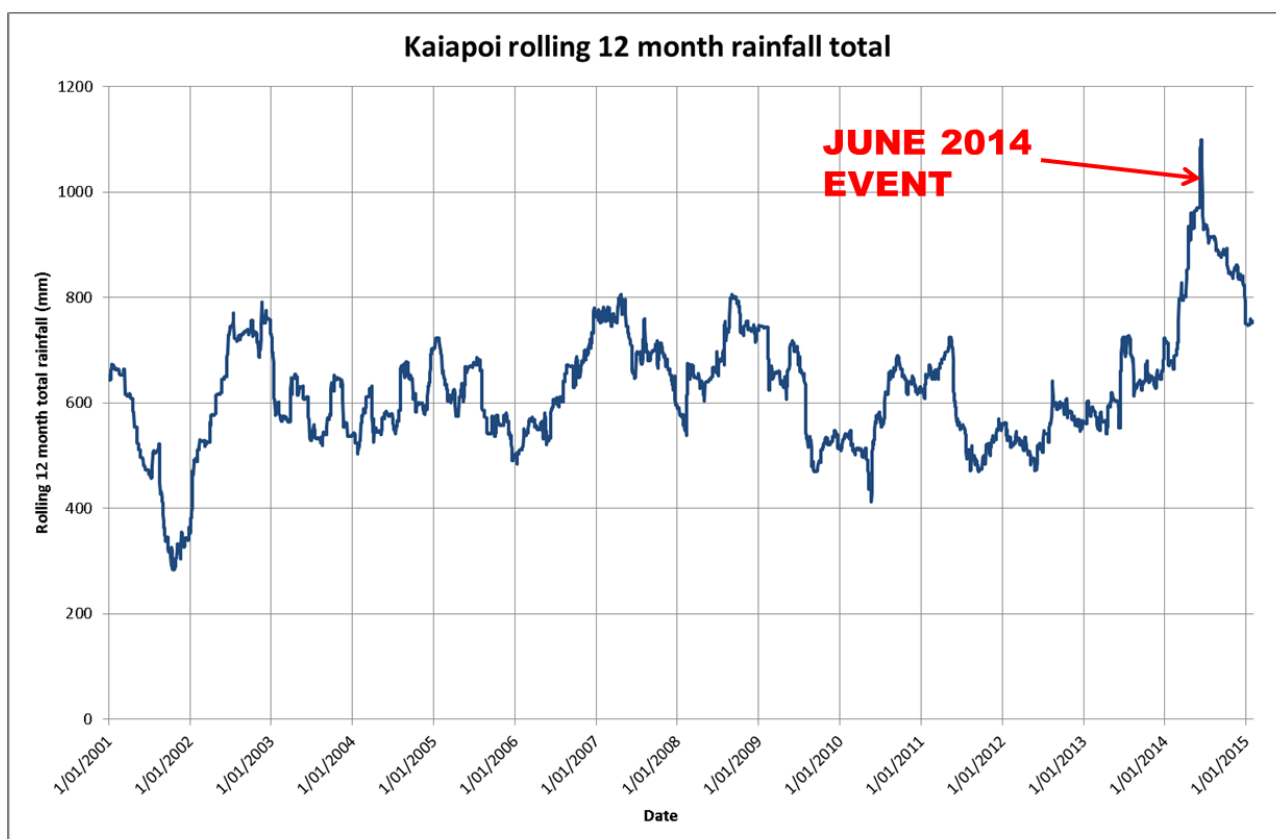
Prior to the June 2014 event, the district had experienced higher than normal total rainfall over the previous months. The average annual rainfall in the district is approximately 550mm and in the 12 months prior to June 2014 there had been 1,015mm of rainfall. The rolling 12 month rainfall total for Kaiapoi for the 13 years up to and including the June 2014 event is shown in Figure 4.

Figure 4: Kaiapoi rolling 12 month rainfall total

This high total rainfall in the months preceding the June 2014 storm meant that the ground was already saturated and groundwater levels were very high. In parts of the district, particularly Mandeville and Ohoka (approximately 9km west and 6km north-west of Kaiapoi, respectively), this high groundwater led to groundwater resurgence flows (springs or surface discharge of groundwater).

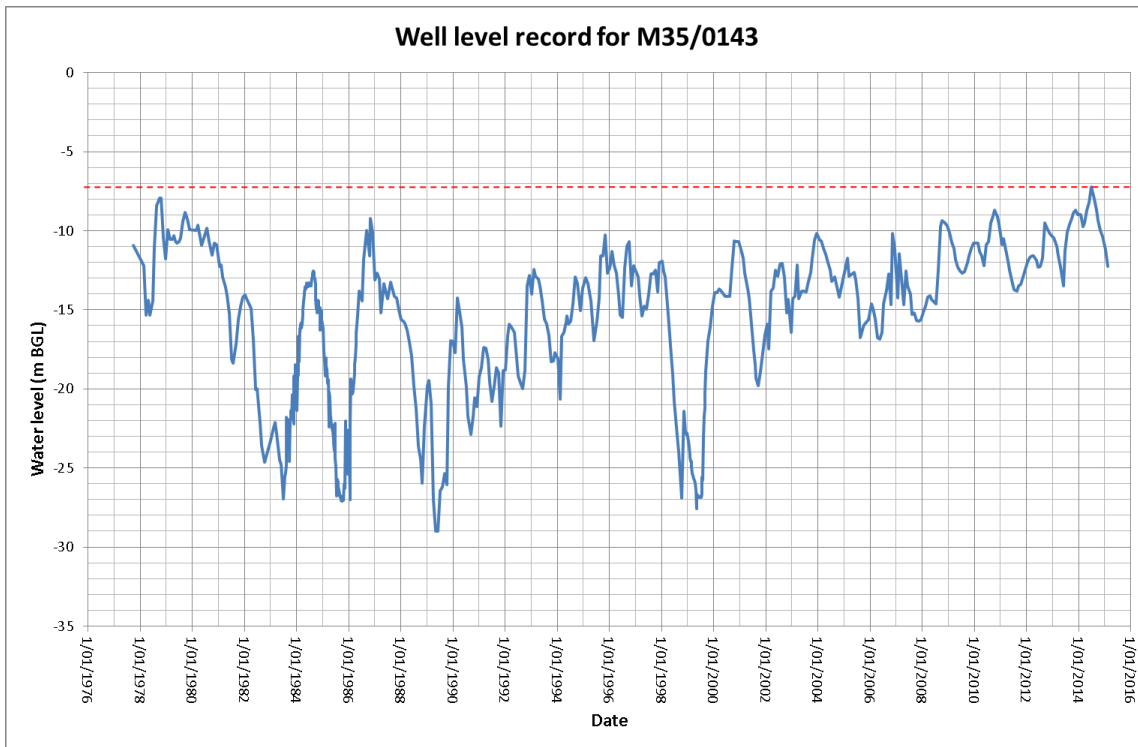
Figure 5 shows long term groundwater levels from an Environment Canterbury (ECan) shallow groundwater monitoring bore M35/0724, near the intersection of Tram Road and Chapmans Boundary Road, approximately 10km upgradient of Mandeville. It can be seen from Figure 4 that the groundwater level measured in mid-2014 was the highest on record, with the record dating back to the late 1970s. While the levels in Figure 4 are still several metres below ground level, the depth to groundwater decreases further east. When the groundwater level in well M35/0143 is at 10m below ground level, the water table in Mandeville and Ohoka is generally at or above the ground surface. During times when the water table is at these high levels, groundwater emerges, ponds and flows via

overland flow paths throughout these areas. This groundwater resurgence flow can be constant for many months.

Figure 5: Groundwater level data at well M35/0143, approximately 10km upgradient of Mandeville

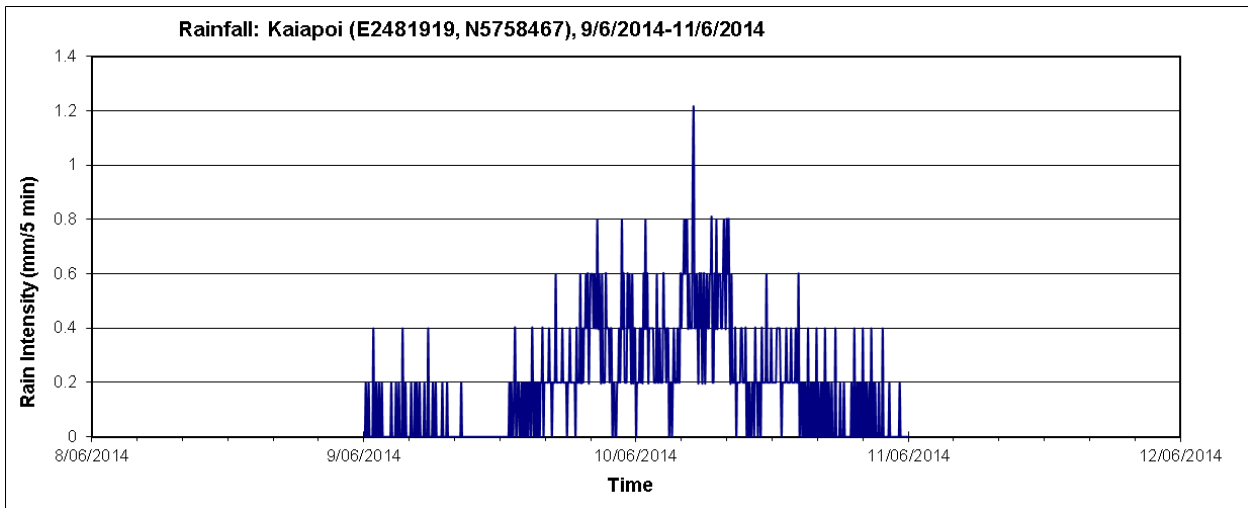
Figure 6: Kaiapoi rainfall intensity June 2014 event

From 9 until 11 June 2014 there was approximately 180mm rainfall in Rangiora and 110mm in Kaiapoi over a 72 hour period. The rainfall is understood to have been higher in the rural area further west.

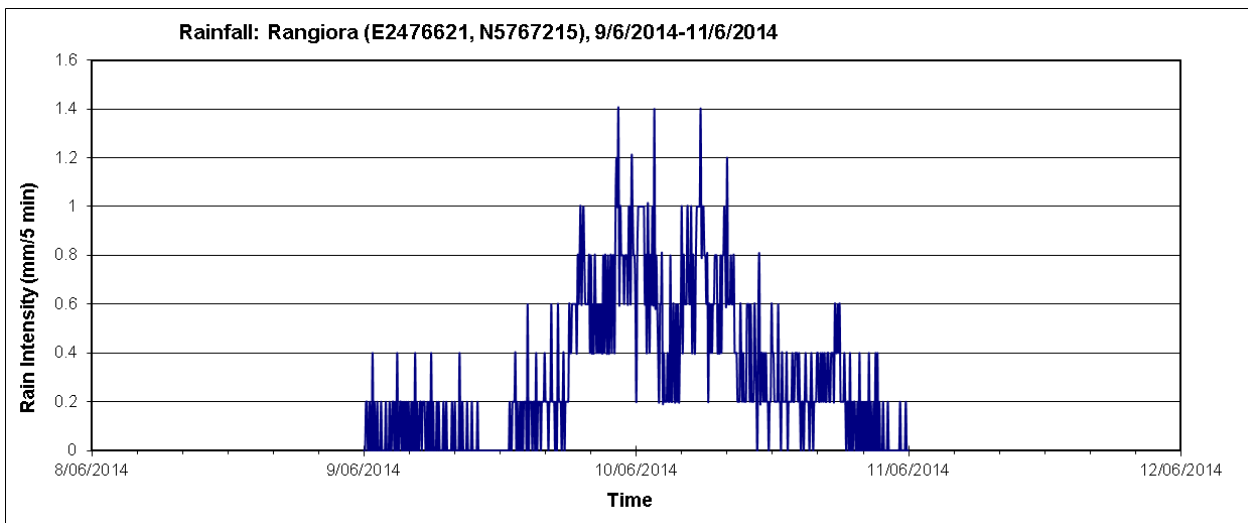
Figure 7: Rangiora rainfall intensity June 2014 event

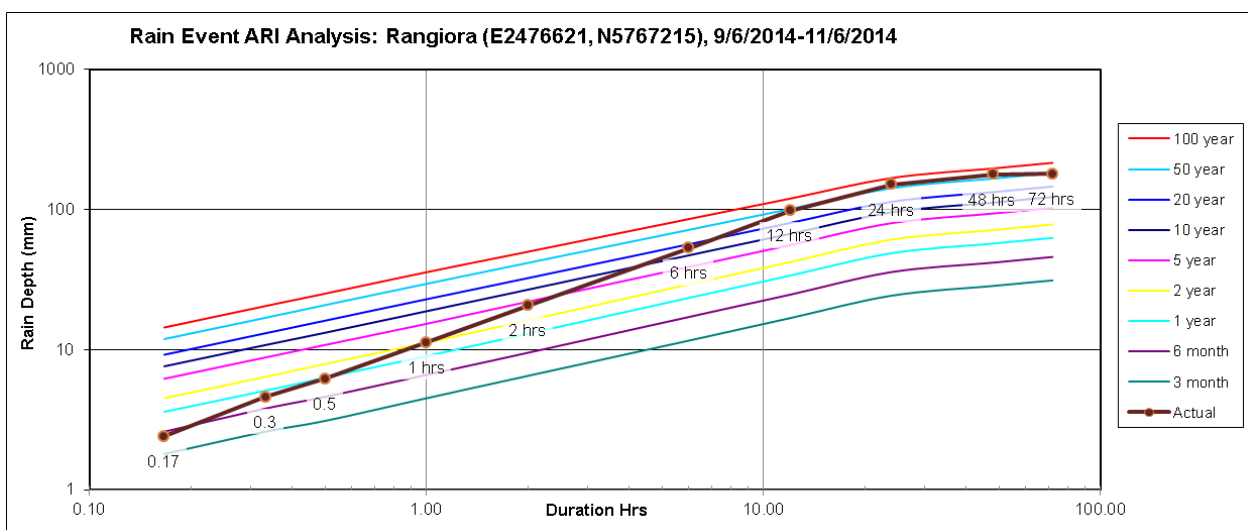
The return period of this rainfall event has been assessed (by WDC staff) as approximately a 66 year return period for Rangiora and approximately a 12 year return period for Kaiapoi, over a 48 hour duration. The rainfall intensity for Kaiapoi and Rangiora over the event and shown in Figures 6 and 7, and the return period analysis for Rangiora is shown in Figure 8.

Figure 8: Rangiora June 2014 Event Return Period Analysis

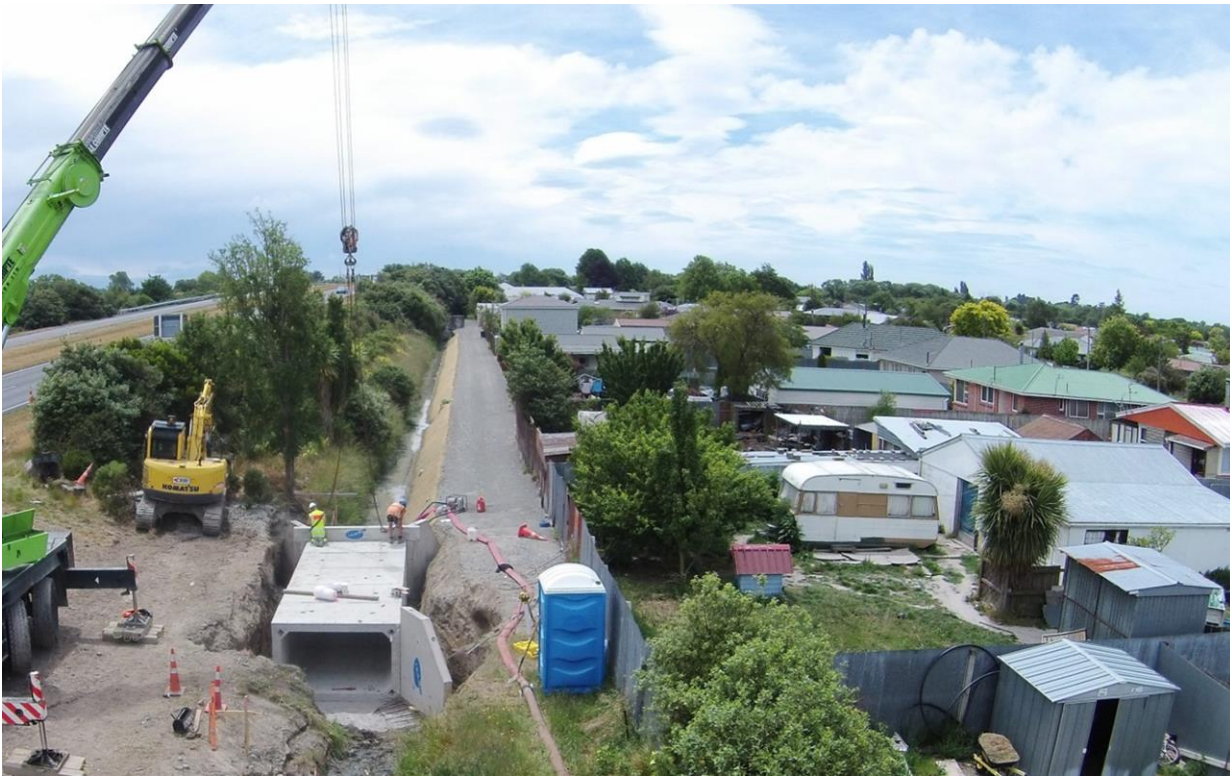
A photograph of the Parnhams Drain works, showing the new box culvert (under construction) and drain widening (complete downstream of the culvert) is included in Photograph 1. The Northern Motorway can be seen at the left hand side of the photograph and the new drain access road on the right. The pump station is at the far end of the drain in the distance.

Photograph 1: Parnhams Drain upgrade works, Kaiapoi, December 2015

The Parnhams Drain and pump station upgrade work involved widening the existing drain, upgrading an existing culvert and modifications to the pump station controls to increase the system capacity from approximately $1\text{m}^3/\text{s}$ to $2\text{m}^3/\text{s}$. In conjunction with this work, the pump station maintenance access was improved, with a new unsealed access road and a turning area constructed, to improve safety for staff. The Parnhams Drain pump station work also includes concrete repairs at the pump station, pipe joint sealing and flap gate maintenance.

The works carried out in Parnhams Drain and pump station are a good example of getting the best “bang for your buck” getting a massive capacity improvement for a relatively low cost. The capacity of a system that would cost many millions of dollars to replace had its capacity doubled for a few hundred thousand dollars.
