# Vancouver Green Infrastructure Performance Monitoring Report 2021-2023

City of Vancouver, Engineering Department, Green Infrastructure Implementation Branch

Published: January 2024

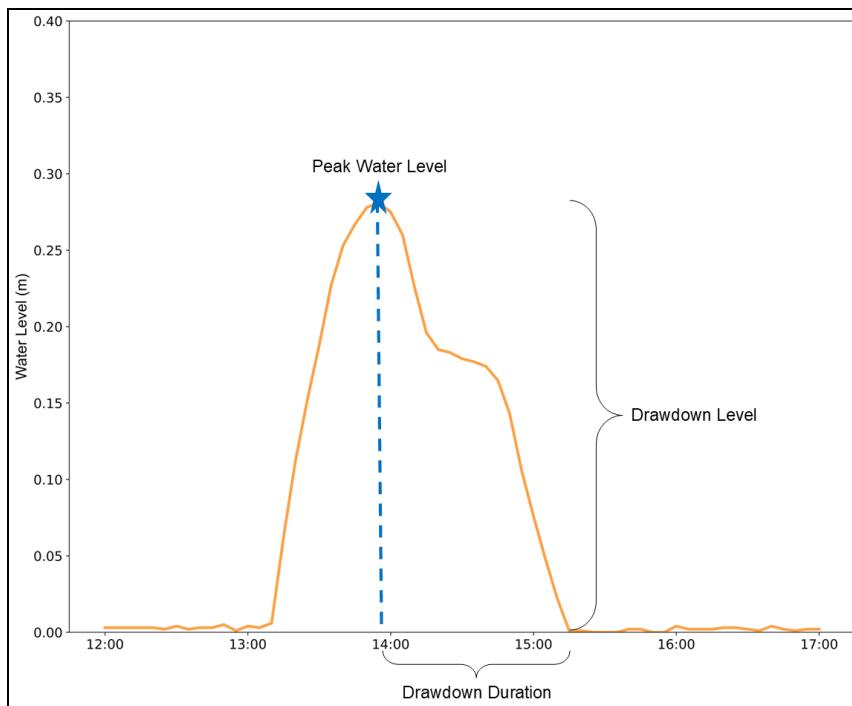
Each individual storm event and water level change was analyzed to determine the drawdown rate and drawdown duration. Drawdown duration is the time between peak water level and the return to the pre-event water level (Figure 7). Drawdown rate is defined as the rate at which water exits the bioretention system during and following a rainfall event, and is calculated by dividing the drawdown level (from peak water level to water level before rainfall) by the drawdown duration. Drawdown rate is compared to the design infiltration rate. The design infiltration rate was determined by infiltration rate testing of native soils beneath the GRI system prior to construction and installation, and is a conservative estimate of the real drawdown rate.

Figure 7 Example of water level response to show calculation of drawdown duration and drawdown rate.

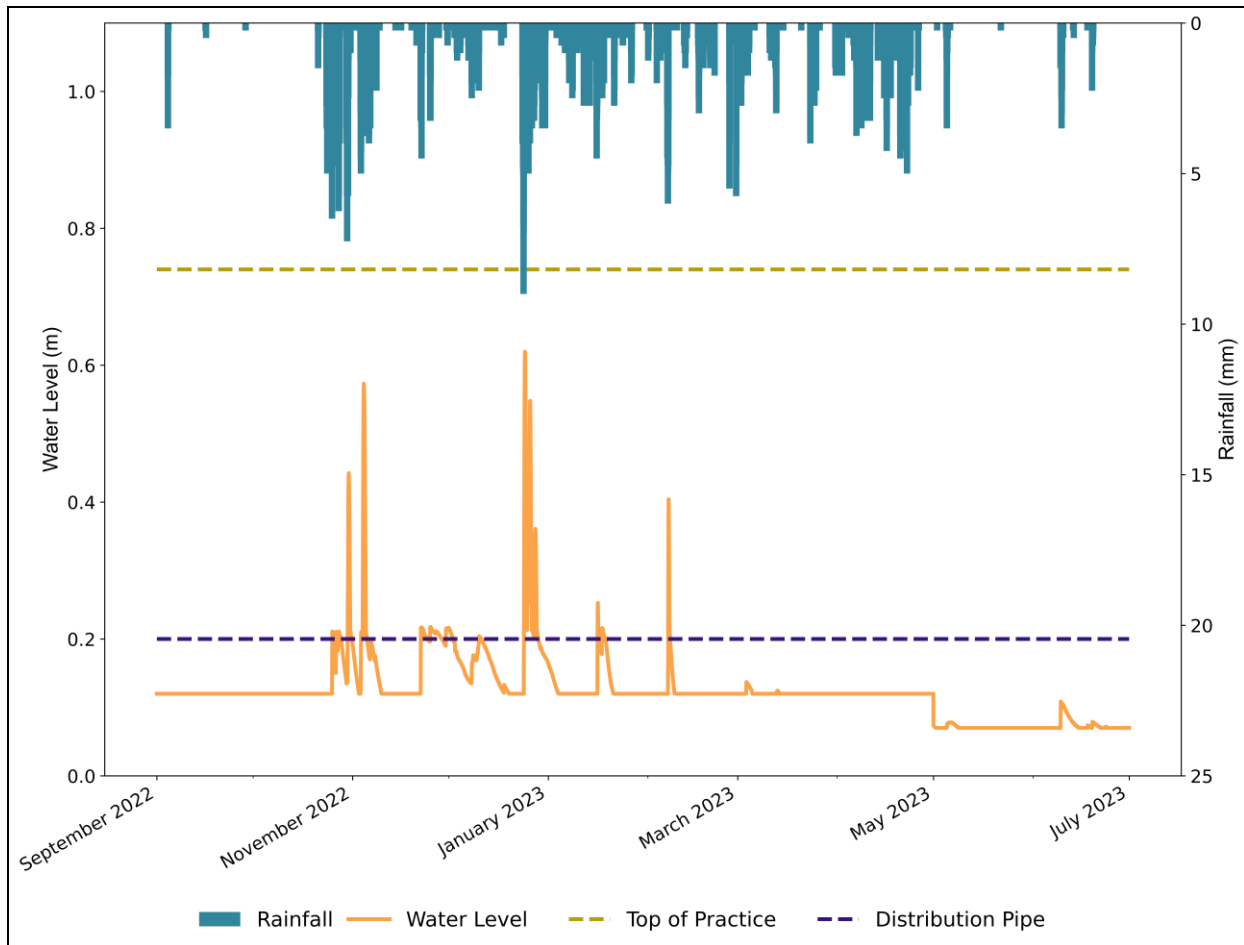
Water level monitoring using Novion loggers has occurred from September 2022 to present (see Figure 19). The results from Harriet Laneway show that there is quick drawdown whenever the driving head is high, and that there is a long tail and slower drawdown whenever the driving head is low (0.2 m or lower). This system did not see response to storm events that are smaller than 24 mm, likely as those were fully infiltrated before reaching the monitoring well. This is a fully infiltrating system, and the only overflow is via surface flow to the next downstream catchbasin. Storm events, drawdown durations and drawdown rate summary is found in Table 9.

Figure 19 Hourly water level response at Harriet Laneway and hourly rainfall response at Trout Lake rain gauge

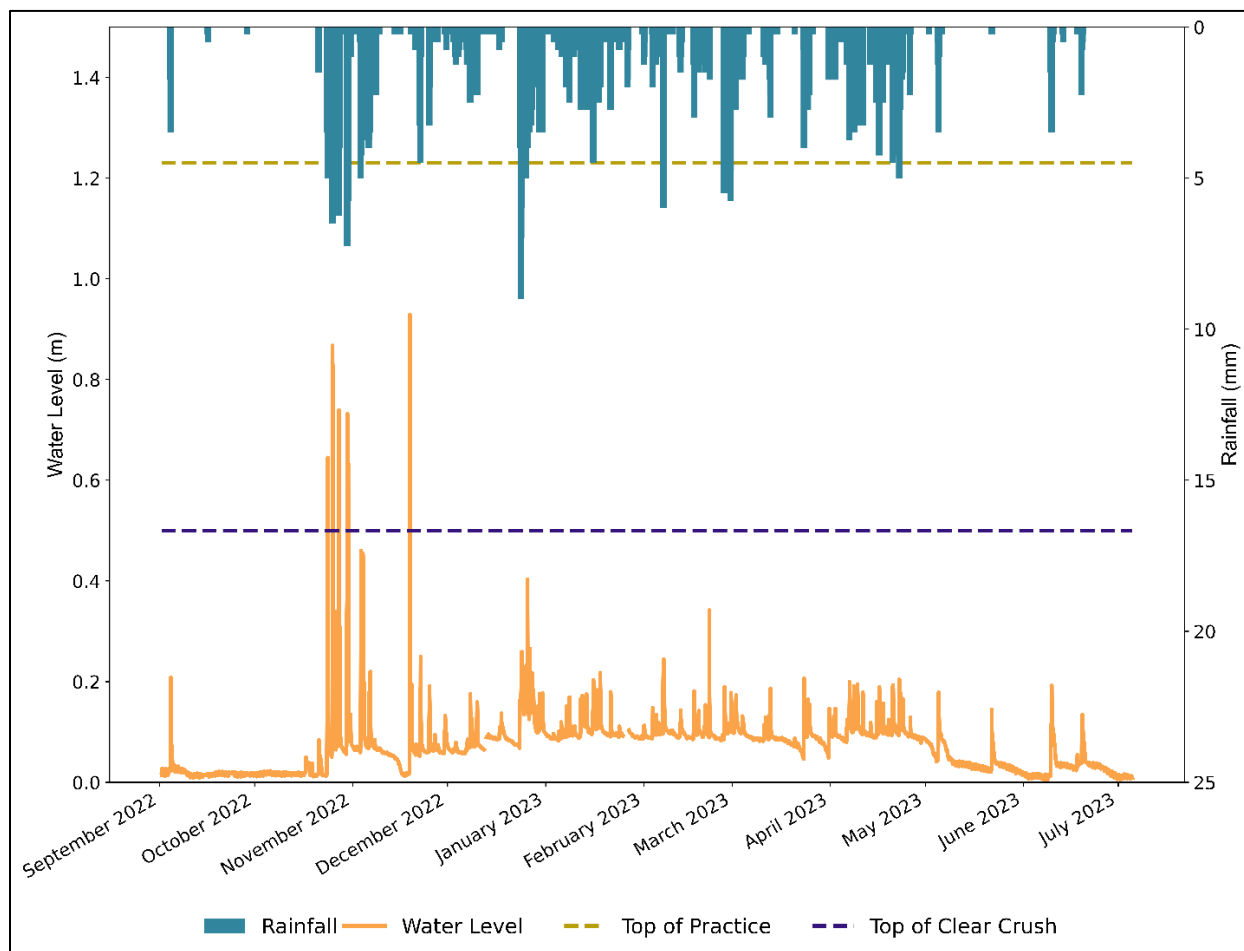
The North well experienced the most water level response in the heavy rainfall winter season as shown in Figure 20. This well experiences quick drawdown durations and drawdown rates well above the design infiltration rate. Storm events, and water level responses are shown in Table 10.

Figure 20 Hourly water level response at Woodland Dr. and 2<sup>nd</sup> Ave. North bioretention and hourly rainfall response at Trout Lake rain gauge

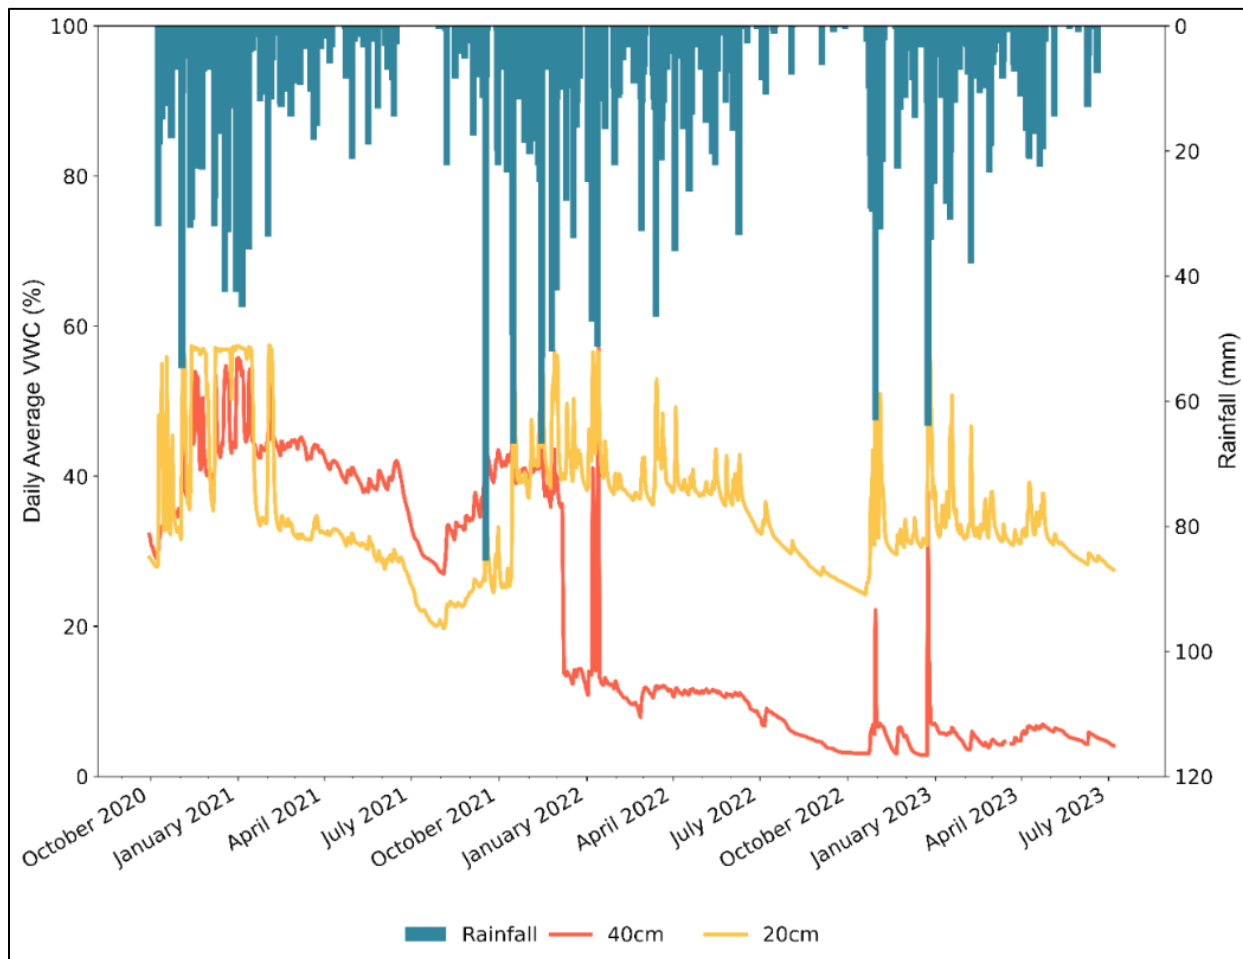
Soil moisture monitoring at this site has been very variable throughout the monitoring period. The 20-cm sensor has been very reactive to rainfall events, especially during the wet weather seasons, but drops over the dry seasons. Overall, the 20-cm soil VWC ranges from 20%-60% over the course of the monitoring period. The 40-cm sensor displays a large drop in December 2021, and remains below 20% VWC after that time, except for large rain events where it peaks sharply. This large decrease in VWC in December occurs only over a span of 10 minutes, leading us to believe that something may have happened to the sensor tip or the surrounding area leading to this change, and may not be representative of the soil moisture at this location. The 40-cm soil VWC ranges from 3-63% (see Figure 24).

Figure 24 Daily average volumetric water content at 20-cm and 40-cm depth at Expo Blvd and Smithe St. and daily rainfall from Creekside rain gauge

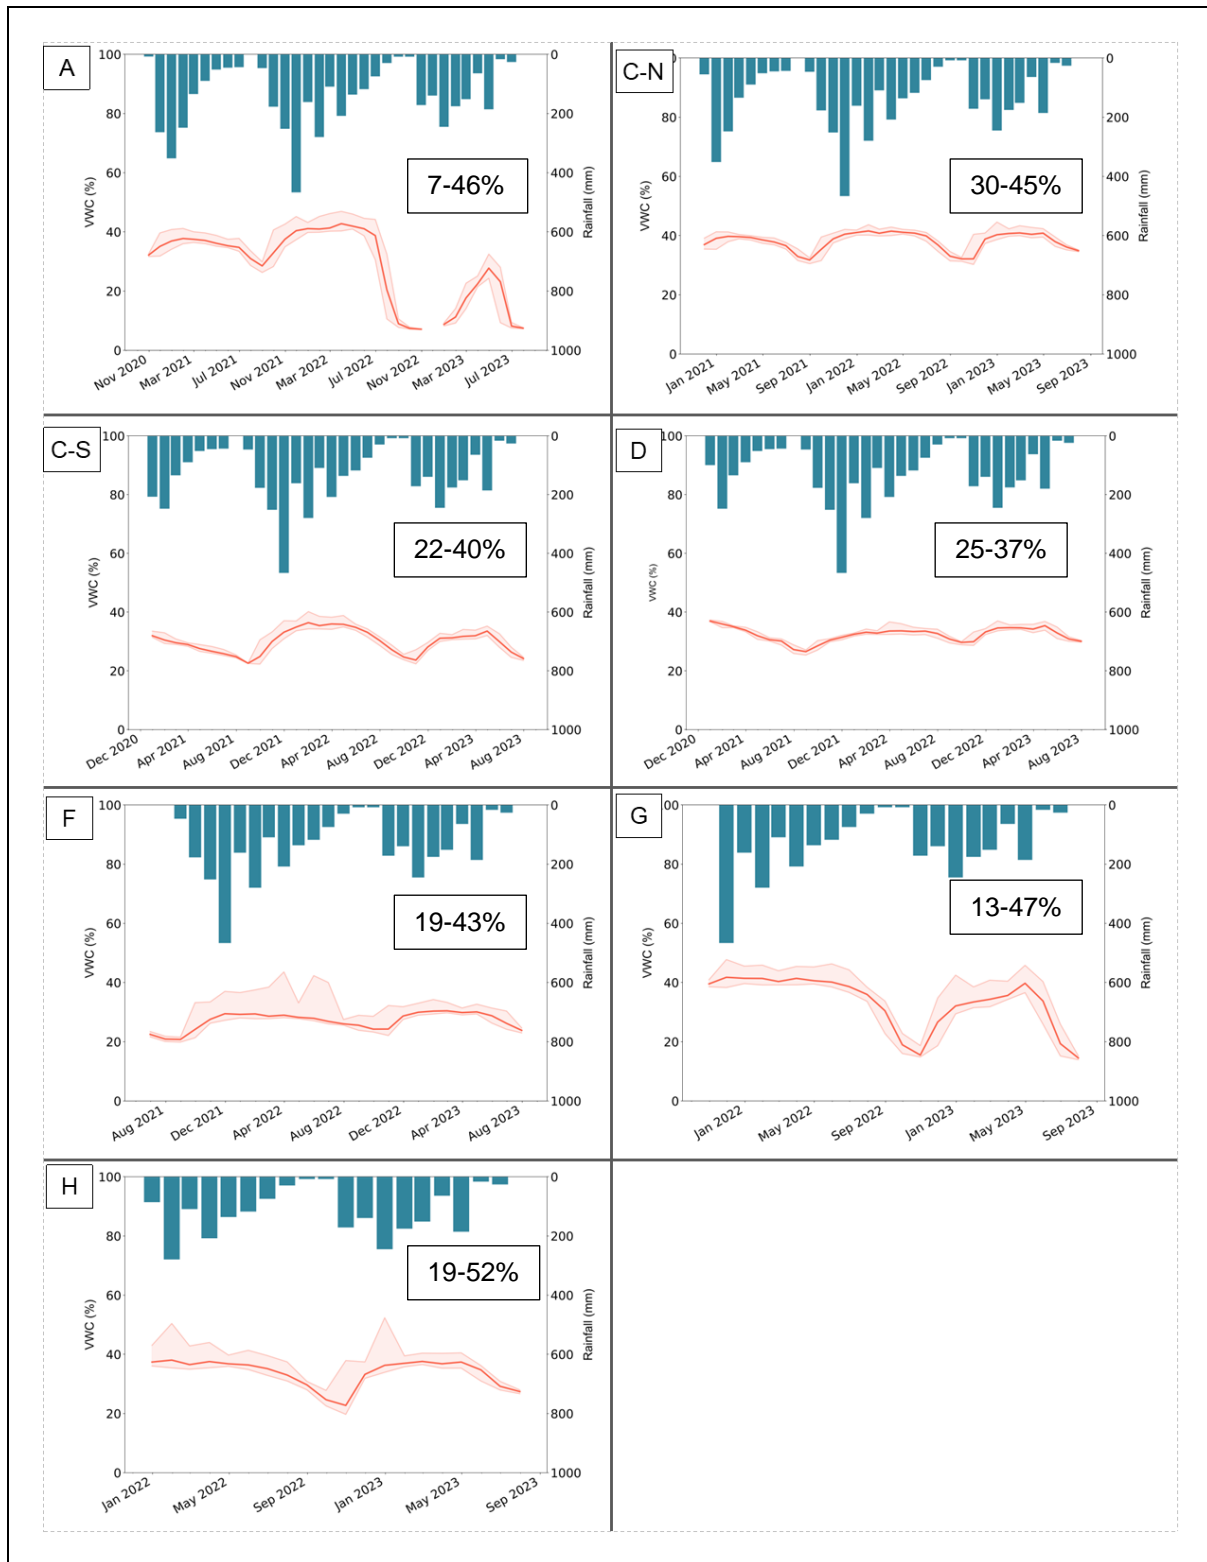
All sites had free draining soils, except for Block H which had a tank product with wicking tiles, called permavoid, beneath the soil, which allows plants to access the water in the tank via wicking. Block H soil moisture was always above 20%, but then so were other free-draining blocks in structural soil, such as Blocks C, D and F. Block A demonstrates the greatest variation of all the blocks, with the VWC dropping during the summer months when there is less rainfall. We are unsure what characteristics lead to Block A having more moisture loss in the summer than the other blocks. The rest of the blocks remain above the 10% minimum. Monthly maximum, monthly minimum and monthly mean VWC can be seen in Figure 25 for all blocks over the course of their respective monitoring periods.

Figure 25 Monthly maximum, monthly minimum, and monthly mean volumetric water content of Richards St. project, with full ranges shown in text, for A) Block A, C-N) Block C North, C-S) Block C-South, D) Block D, F) Block F, G) Block G, H) Block H and rainfall from Creekside rain gauge

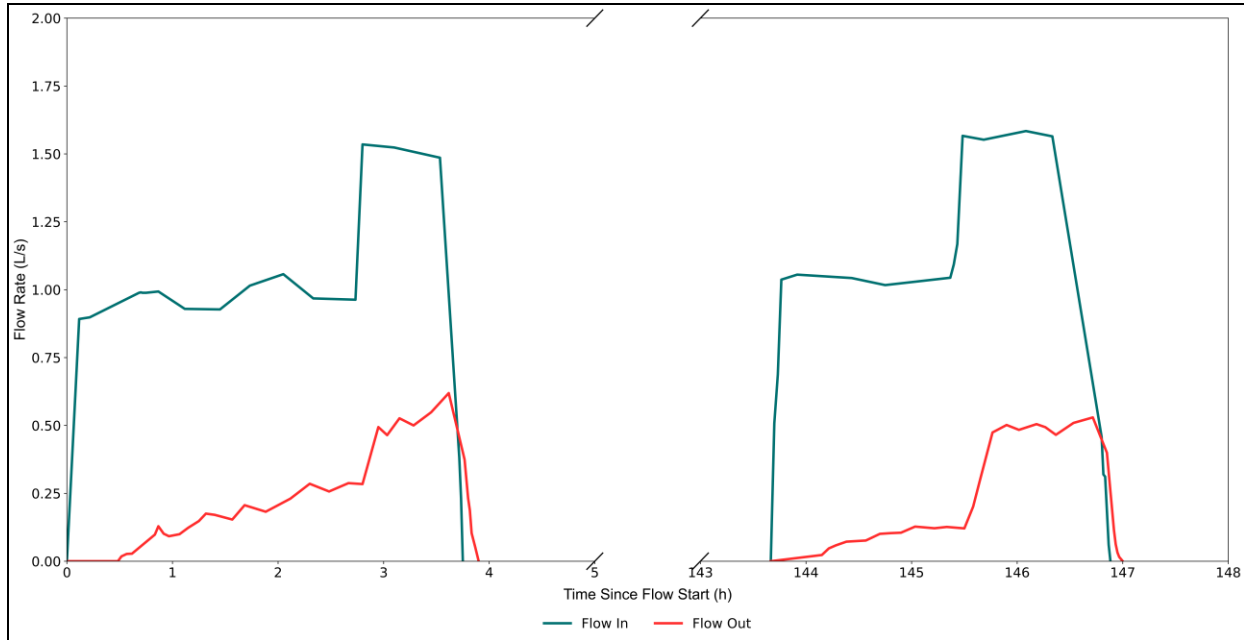
underdrain outlet for this test. A total of 3,366 L were estimated to flow out of the underdrain outlet, meaning that 76% of water was retained in the bioretention system.

Figure 26 Hydrograph at the inlet and outlet of Pine St. and 8<sup>th</sup> Ave. synthetic run-off test, July 2022

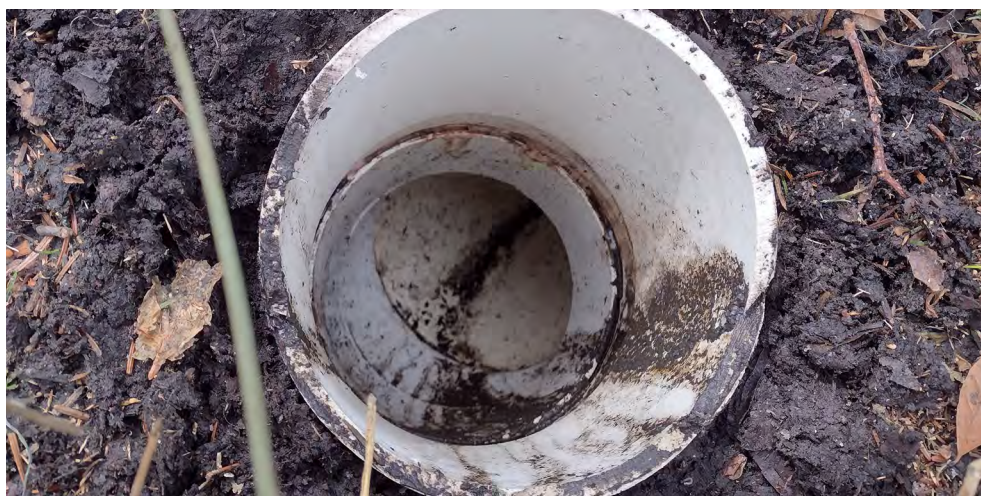
Condition score: 1

Example of a monitoring well with minimal sediment and no damage.

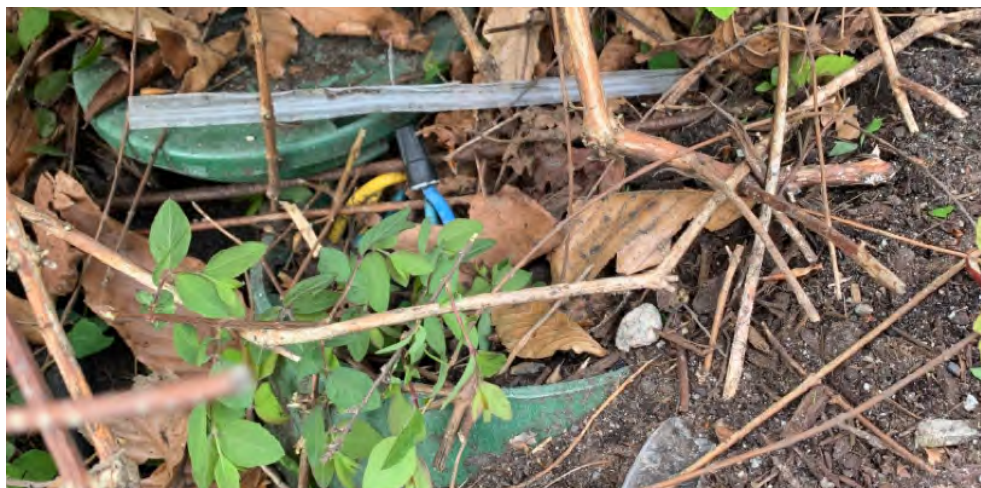
Example of a monitoring well extensive build up of debris and is non-functional.

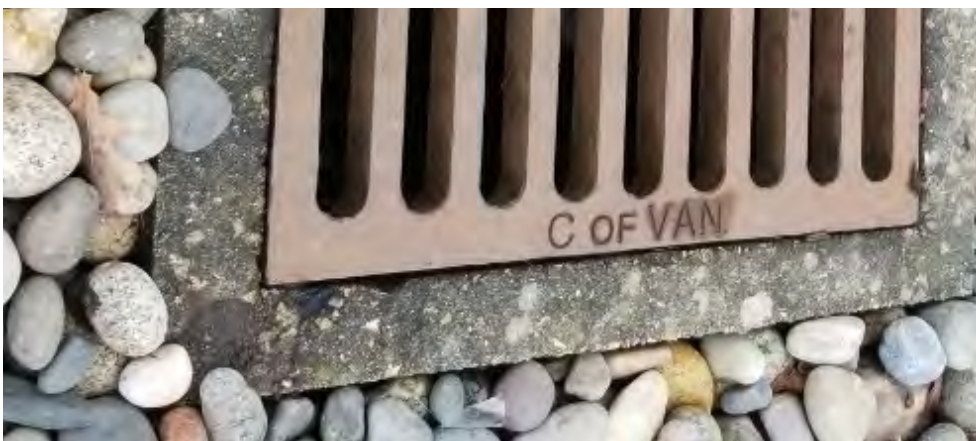
CB with minimal spalling on exterior  
Condition score: 2

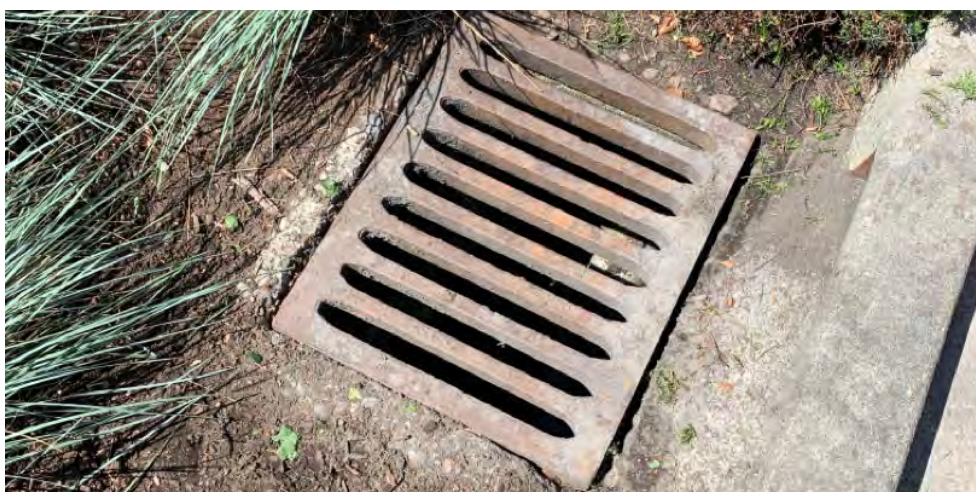
Moderate damage to concrete around CB, could be sign of water leakage.  
Condition score: 3

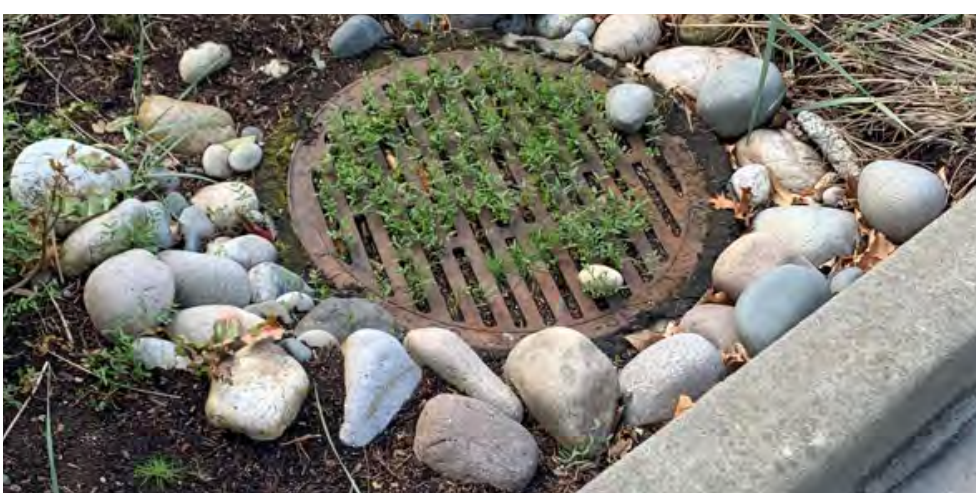
CB is filled with debris and non-functional. Could cause backups that create community risk.  
Condition score: 5
