RESTORATION AND BETTERMENT OF A UNIQUE CHRISTCHURCH WATERWAY CATCHMENT POST-EARTHQUAKE

Byron Munro and Richard Brunton (Pattle Delamore Partners Ltd)

Wairarapa and Wai-iti streams – conceptual design for post-earthquake remediation

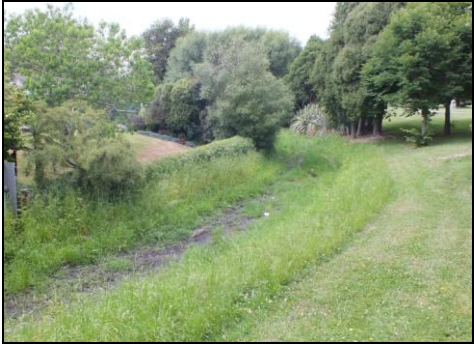
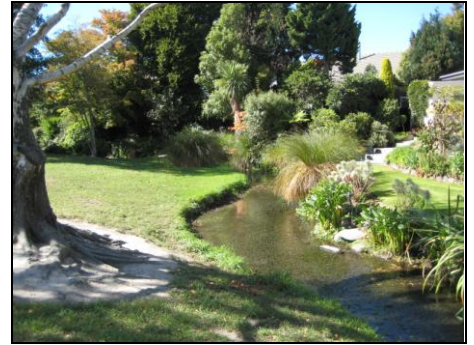
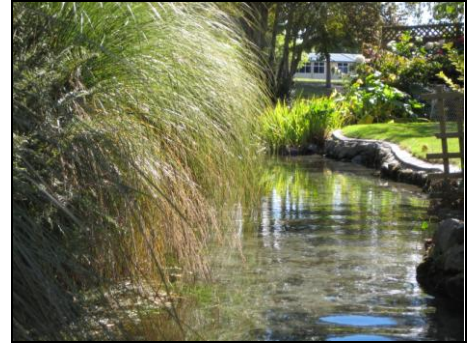
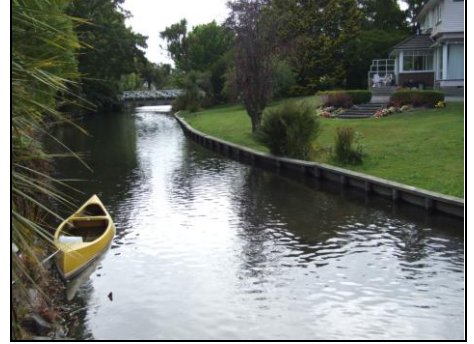
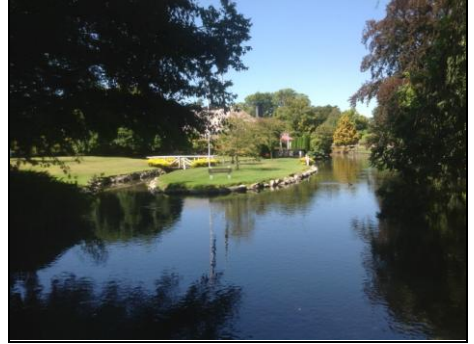
Table 1: Description of the Stream Sections for the Wairarapa and Wai-iti stream project

Section ID	Section Description	Example Photo
1	Tributary of Wairarapa Stream, large extent of ephemeral channel. Bounded by private property.

2	Upper reaches are ephemeral, flows begin as the stream passes through Jellie Park. The stream also passes through Cobham School, otherwise it is bounded by private property

3	Meandering stream bounded by private property, small reach passes through Waiwetu Reserve. Area of highest ecological value.

4	Stream starts to widen, accumulation of silts on stream bed is noticeable. Bounded by private property. Greater private recreational use (boating)

5	Wide, shallow reach of river, heavily silted. Area of road reserve along Wairarapa Terrace, and significant open space in Mona Vale.

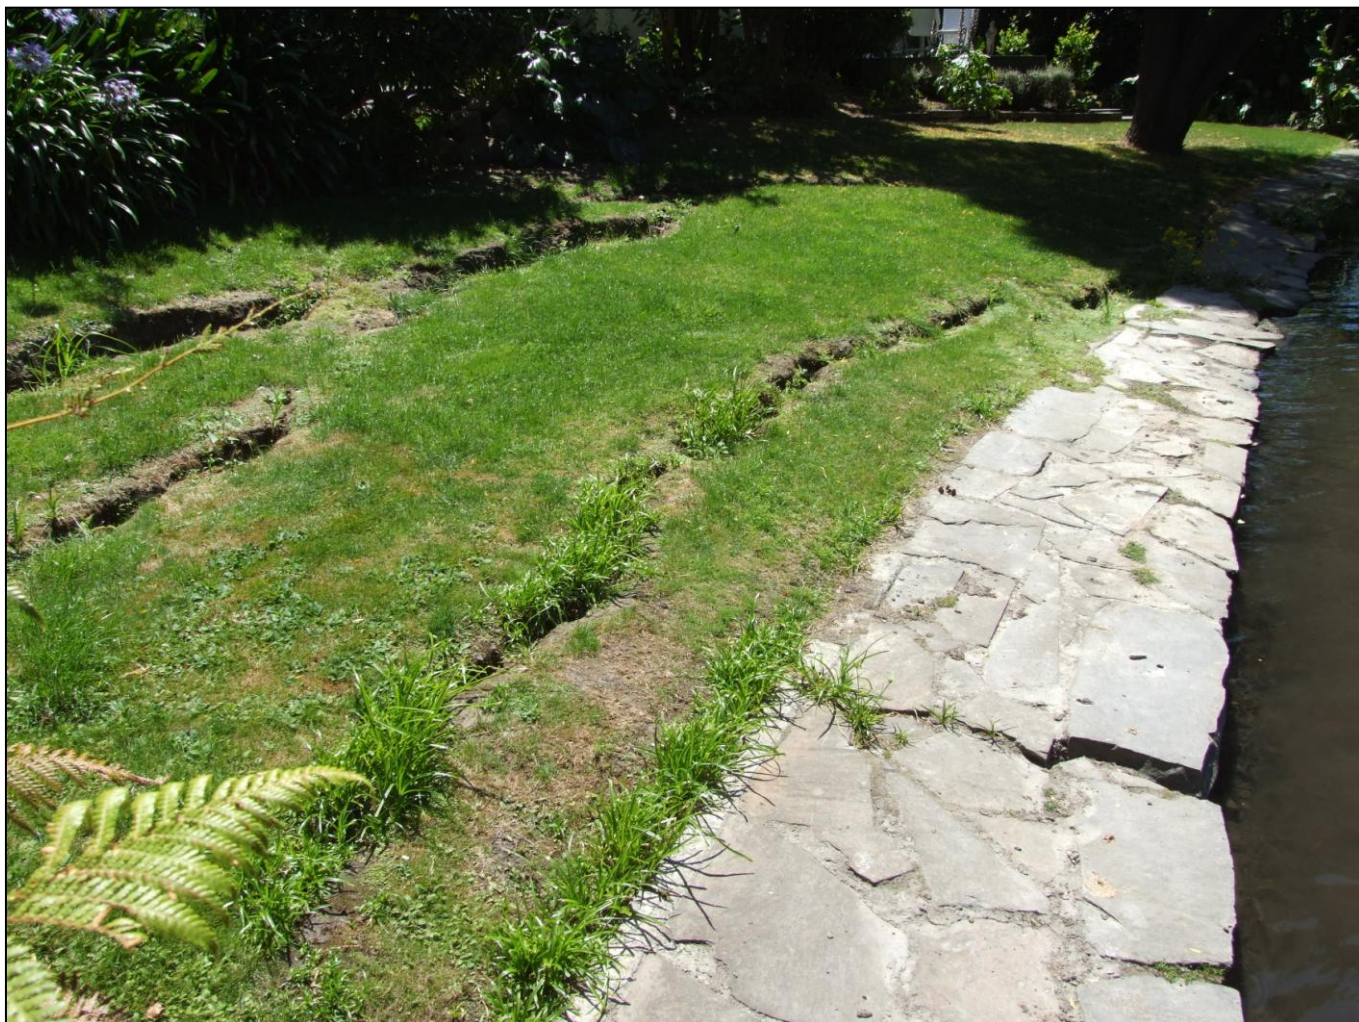
Figure 3: Earthquake related stream bank damage – Lateral Spread

Obvious earthquake effects were seen, but appear to have been mostly at a site-specific scale and have had little effect on the wider landscape, cultural, recreational and heritage values of the Wairarapa and Wai-iti streams. The typical observed earthquake effects were stream bank damage, such as shown in Figure 3. The current state of these four values identified in this assessment, should therefore be used as a baseline to either be retained or improved on when carrying out remediation works. None were triggers of necessary remedial work in themselves.

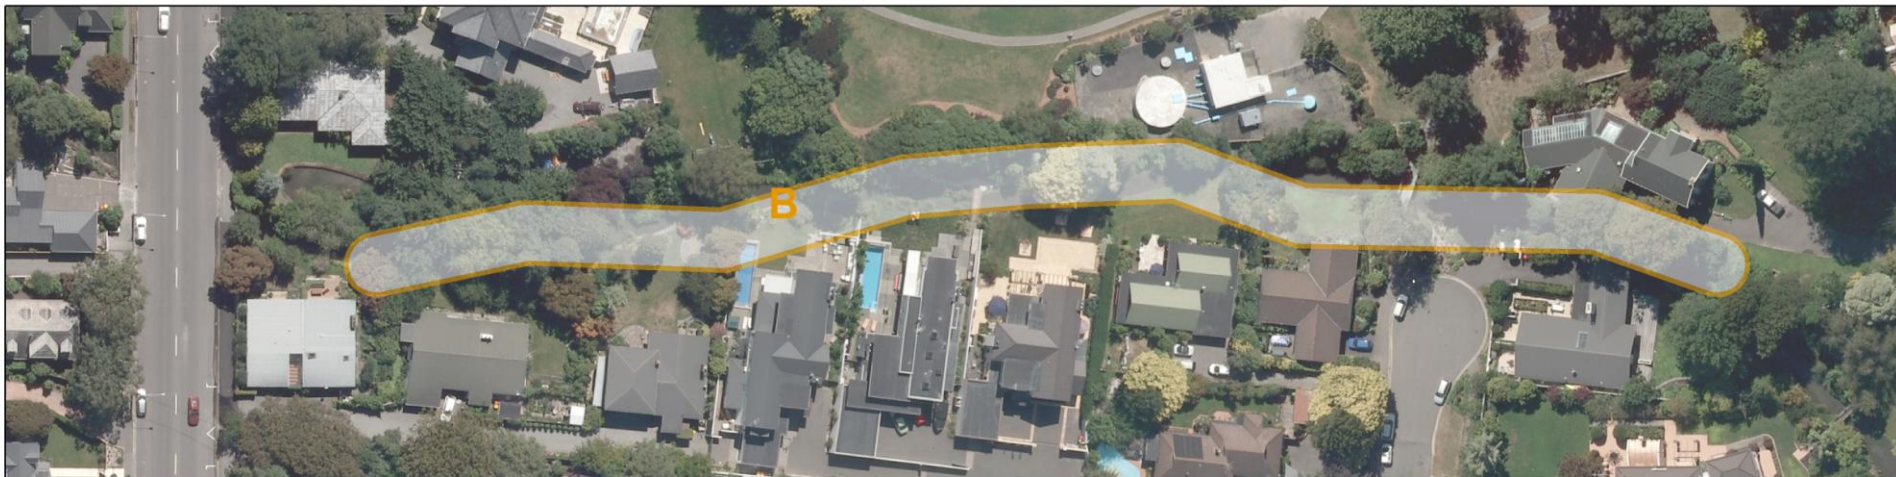
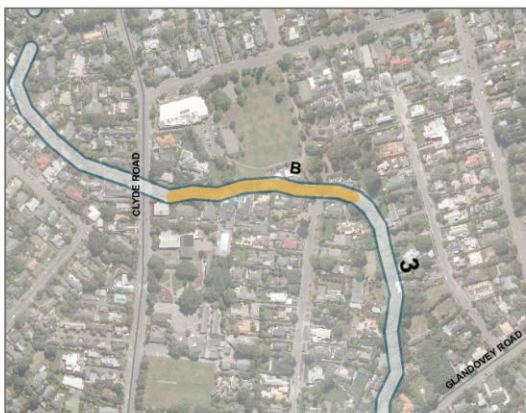
Figure 4: Example of Post-earthquake remediation

Design Considerations:

- Bed excavation to increase flow capacity
- Improve trout spawning habitat, create riffle-run sequence
- High ecological values
- Access constraints upstream
- Maintain good bank stability
- Good canopy cover, moderate downstream
- Moderate house setback, poor downstream

Representative upstream profile (B1)

Representative downstream profile (B2)

Option 1 (Bank Treatment #8)

Option 2 (Bank Treatment #3)

Option 2 (Bank Treatment #7)

Remediation Reach B

A key design factor, for restoring ecological and cultural values, is to create a low flow habitat suitable for fish and invertebrates. Generally this can be done by narrowing the low flow channel to increase water depth and velocity. Any narrowing of the low flow channel must not affect stream capacity in higher flows. Where narrowing of a low flow channel is carried out, additional capacity should be added above the low flow channel. This can be done by creating a terraced cross section, with a narrow lower terrace and a wider upper terrace. It is recommended that, where capacity is to be maintained, the cross sectional area of the channel should be increased by between 10 – 20% of the existing cross sectional area. This increase is to take into account changes in stream roughness and wetted perimeter. An example of the post-earthquake cross-section compared to the recommended cross-section is shown in Figure 4.

The preferred bank treatment options were identified for each stream section where raising the bank height is identified as remediation option. The preferred option for each reach is identified as Option 1 in the conceptual designs, a suitable alternative option (Option 2) was also provided, for use in situations where Option 1 does not provide for specific needs or land owner preferences. An example of the preferred bank treatment options for a stream section can be seen in Figure 4.
