# HARNESSING THE POWER OF NATURE FOR STORMWATER ENGINEERING

*Sarah Dudson, Andrew Broughton and Liam Foster, Opus International Consultants*

This paper looks at two bank stabilisation projects and a treatment wetland project to demonstrate the benefits and challenges of integrating nature into engineered stormwater solutions.

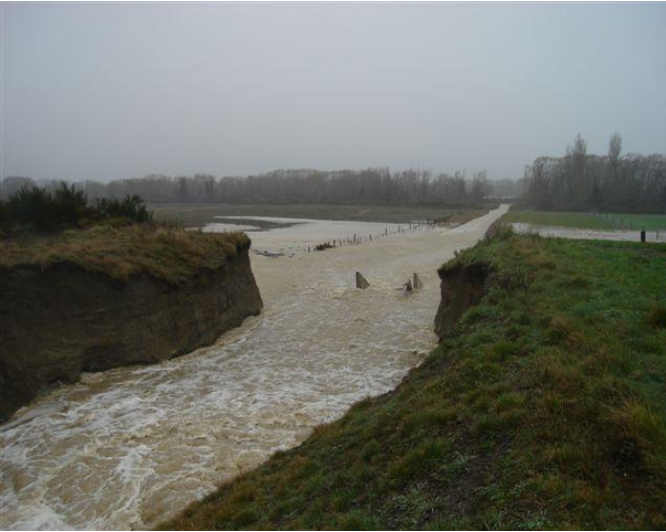
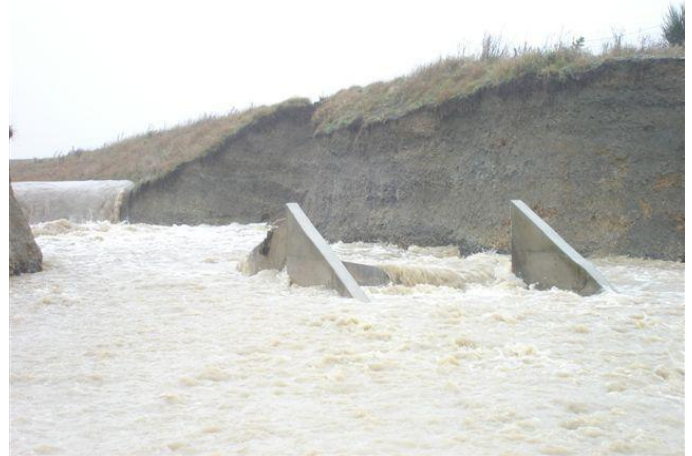
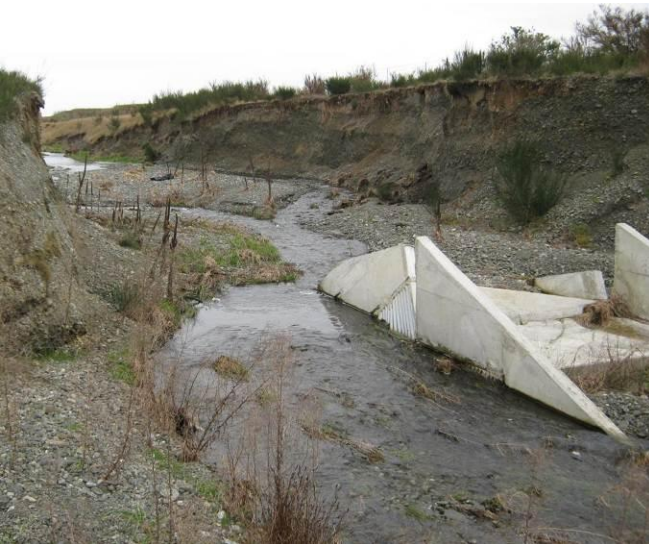
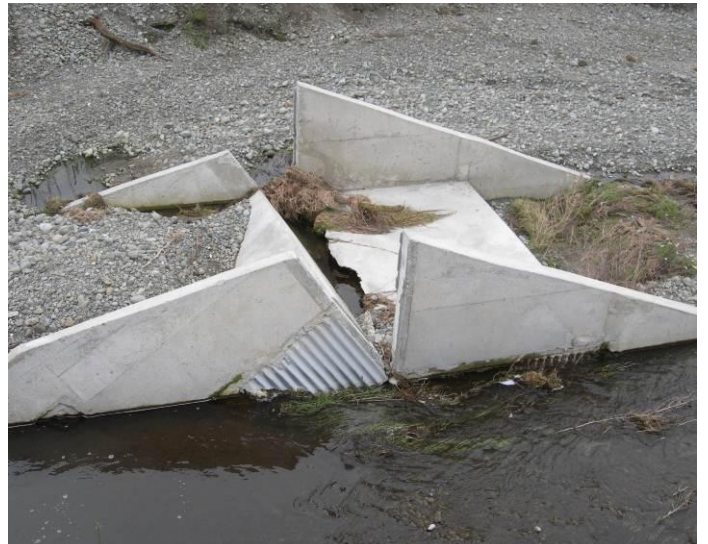
*Photographs 1, 2: Wheatstone Drain in flood after the failure*

*Photographs 3, 4: The aftermath of the failure*

A storm event causing high flows in the Wheatstone Drain resulted in the dramatic failure of the concrete drop structure. The flood flows revealed the power of water in the following chain of events:

1. Flood water overtopped the drop structure's wing wall; as a result
2. The terrace was seriously eroded and undermined the rigid drop structure;
3. The undermined concrete drop structure collapsed;
4. The collapsed drop structure allowed the erosion to track back along the grass line channel for over 100 m;
5. Eroded sediment was deposited downstream; resulting in
6. The banks of the drain downstream of the terrace were overtopped and flooded farmland.

- Steep sides had formed where the drop structure had been washed out;
- These steep unstable banks were prone to ongoing collapse and erosion during high flow conditions;
- The banks were receding placing the neighbouring fencing and other farm infrastructure at risk;
- The regraded channel was receding upstream, increasing the area requiring remedial work;
- The material that had been washed out with the drop structure had been deposited in the drain downstream, raising the bed level such that it was now higher than adjacent farmland in places and increasing the frequency and risk of flooding that land;

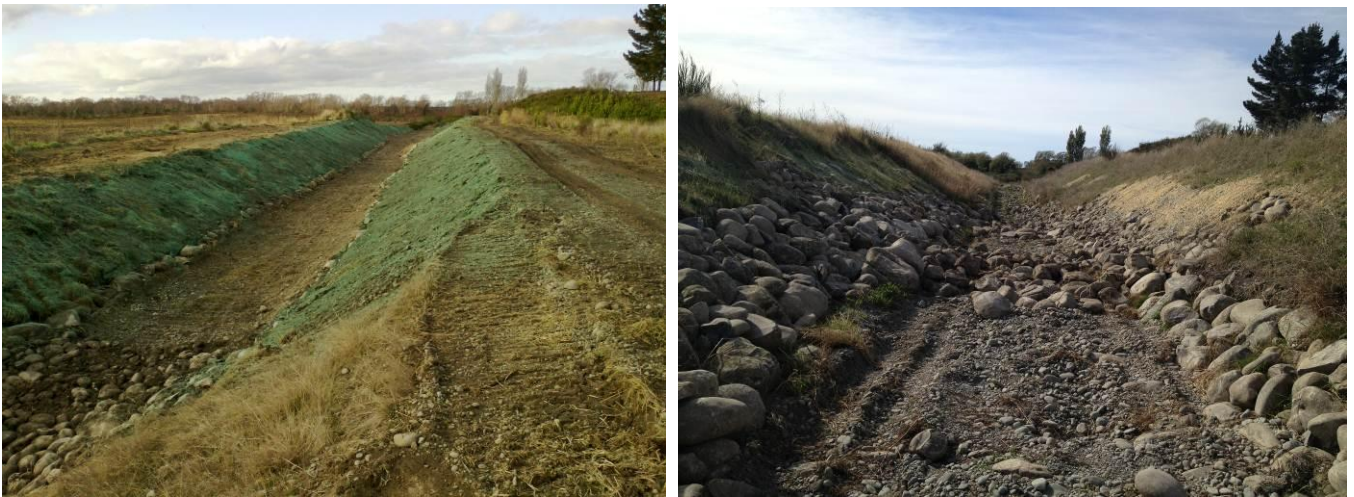
*Photographs 5, 6: Completed Wheatstone Drain bank stabilisation works before and after installation of rock sills*

Key features of the alternative solution included:

1. Grading back the steep banks to a stable slope.
2. Installation of an initial shallow synthetic root structure in the form of erosion protection matting over the lower half of the bank to provide immediate erosion protection and help to support initial vegetation growth.

3. Installing a boulder foundation at the toe of the embankment embedded in the channel bed and extending up the side of the embankments to provide protection from meandering low flows undermining the embankment. These boulders also helped to anchor the erosion protection matting in place along the toe. The boulders were sized to withstand the peak flow velocity in the drain.

4. Rock sills across the channel were installed at regular intervals along the steepest section of the drain, which is the most active and experiences the highest flow velocities. Large boulders set into the bed and extending up the sides were used to form the sills. These served to stabilise sections of the channel upstream and provide cut-offs should any streambed erosion form. The rock sills were reinforced on the sides of the banks with plantings of deeper rooted native plants. The rock sills allow the bed material freedom to move between sills whilst

5. Planting the banks for the drain. As the grass and plantings establish, their root systems hold the soil together, helping to maintain bank stability and minimise surface erosion. Hydroseeding was used initially as the mulch provides immediate protection from surface erosion while the grass establishes.

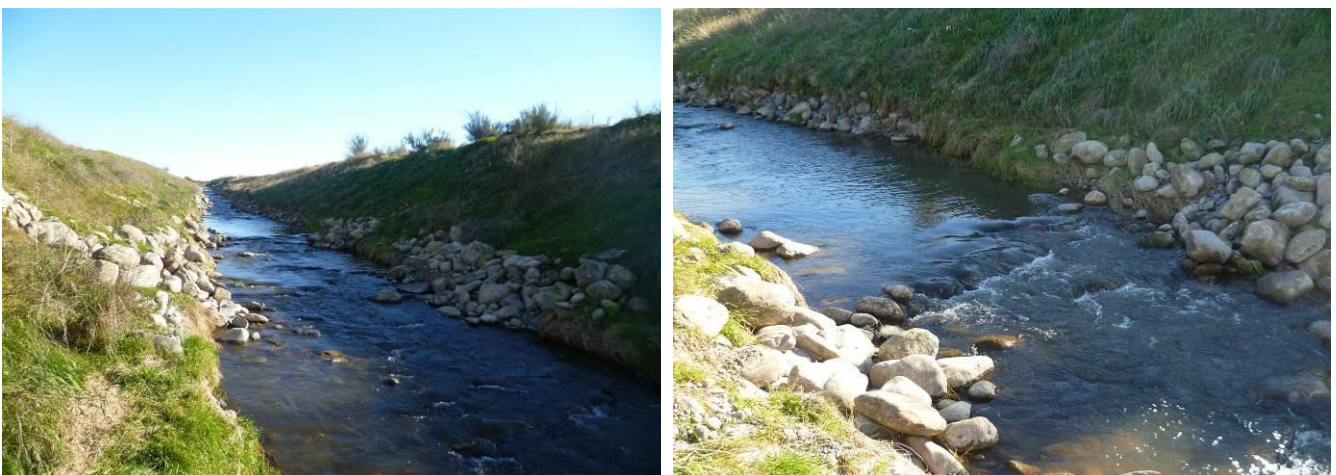
*Photographs 7, 8: Testing the Solution – The completed Wheatstone Drain works following a significant flood event.*

The bank stabilisation works were finished just in time and were tested under high flow conditions only weeks after completion. The benefits of a design that integrated engineering with nature were immediately apparent. The rock sills did not stop movement of the bed material but had restricted this movement between sills. The result being the creation of a series of pools and riffles - nature's own energy dissipation system. The rock toe, erosion protection matting and planting had also done its job to protect against surface erosion.

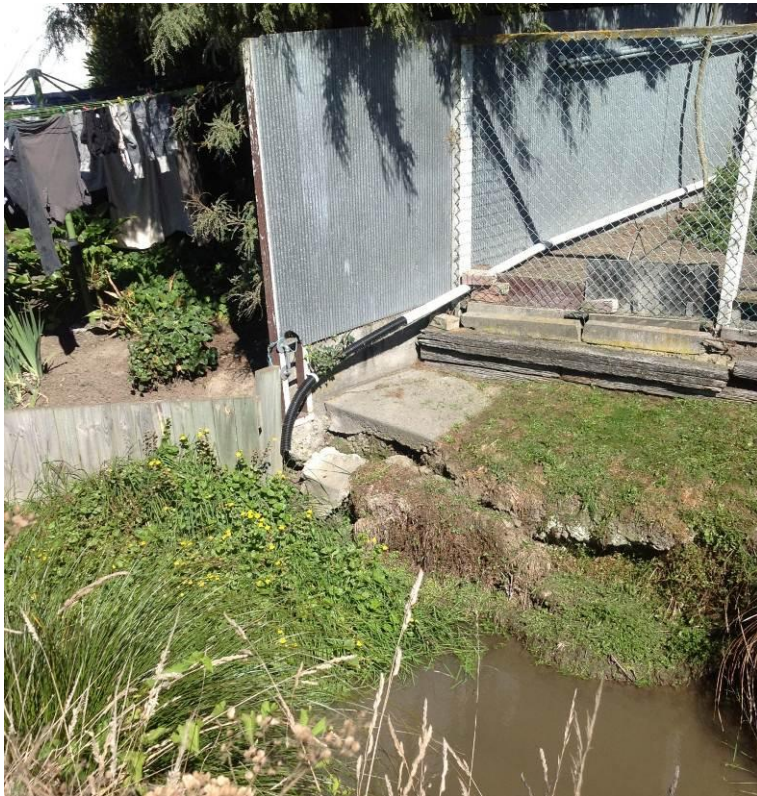
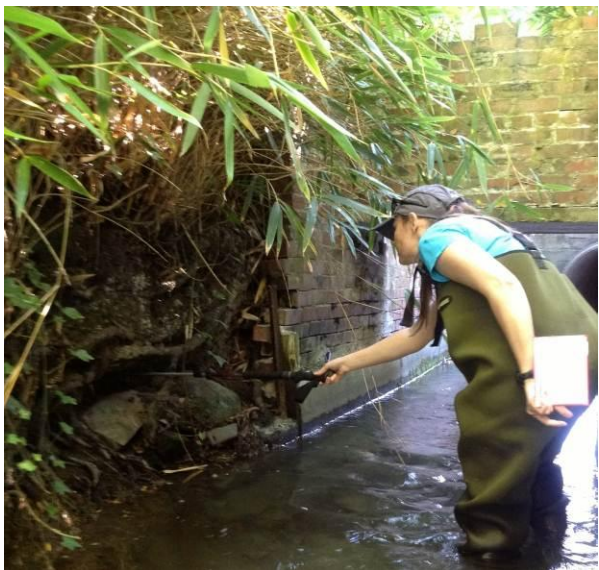
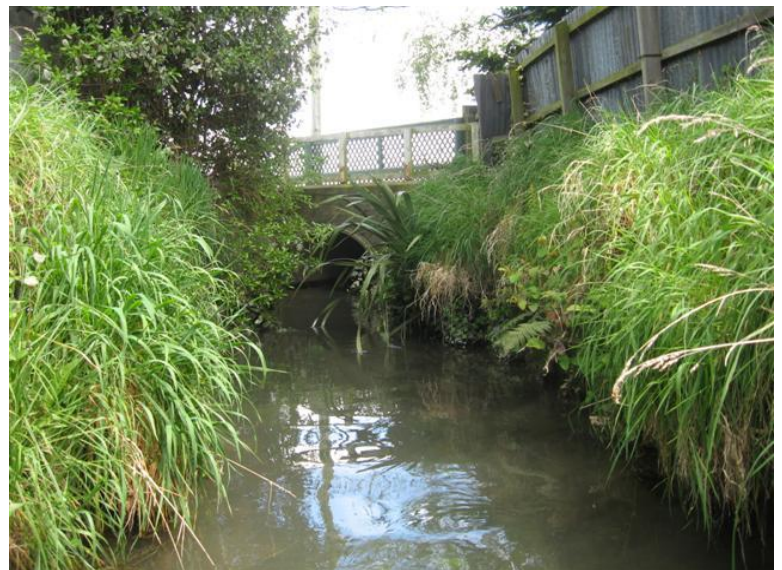
*Photograph 9-12: Pictures of undercutting and bank collapse along Mill Creek*

Another challenge we were faced with was that the extent of the problem was not always apparent during the initial site inspection. In many cases what appeared ok from the surface was severely undercut and falling apart beneath the surface. And this was generally not discovered until the contractor was onsite carrying out the initial site clearance enabling works.

The following photographs highlight some of the bank stability problems and some of the constraints we had to work within.

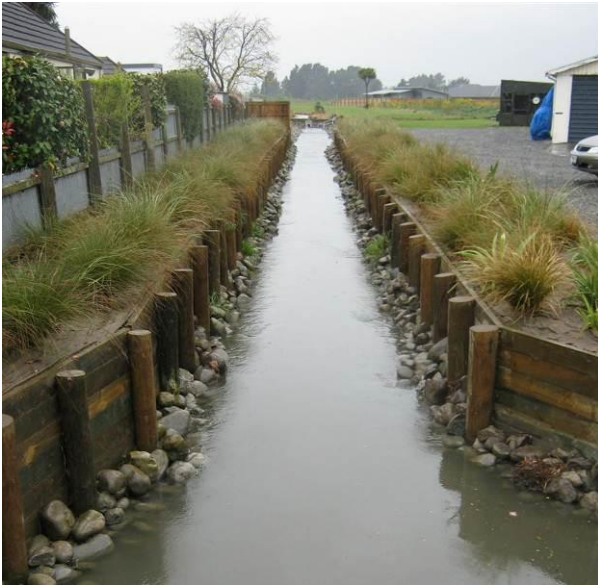
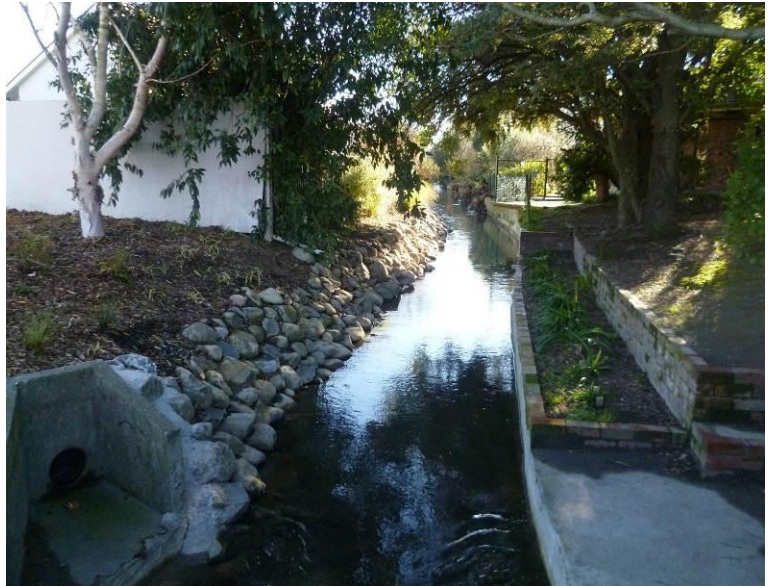
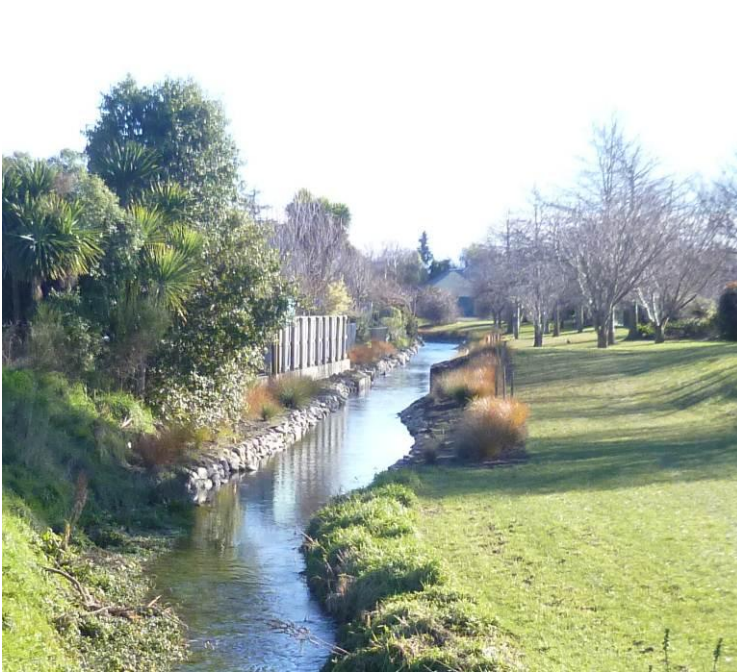
*Photographs 13-16: Completed bank stabilisation works*

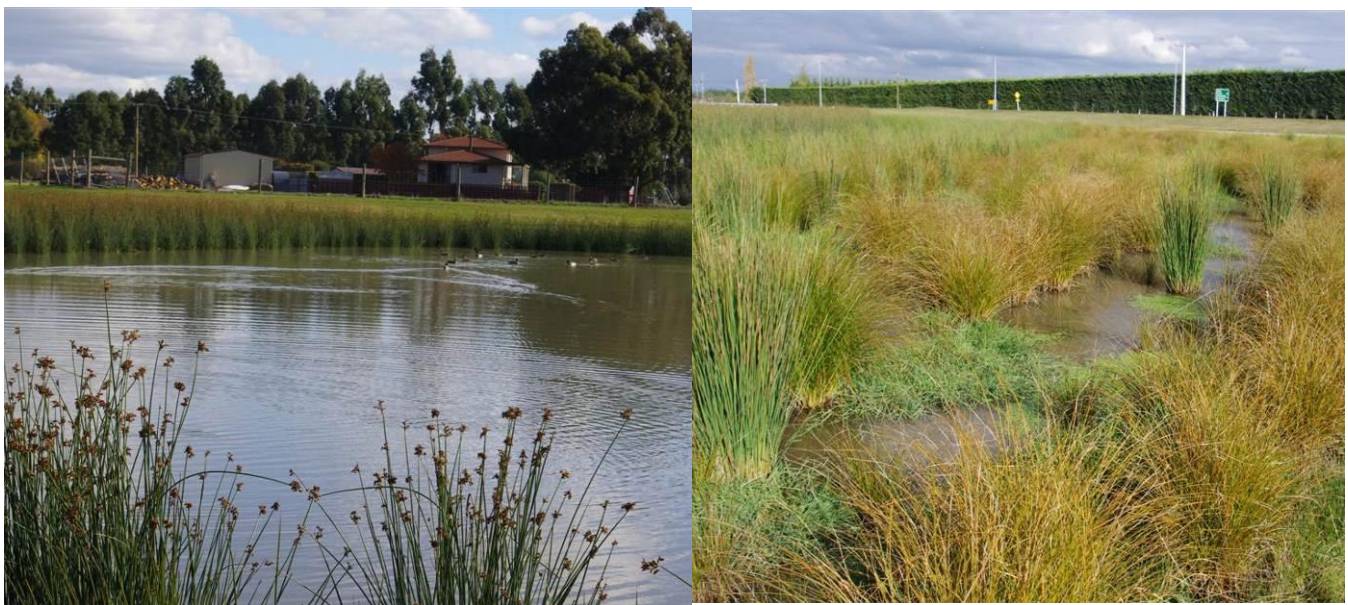
*Photographs 17-18: Completed "Pond C" wetland*

Stormwater runoff from each industrial site is discharged into an open drain that carries the flow to a sediment forebay and then into the wetland. The wetland plants are carefully chosen for their ability to uptake metals and nutrients and to filter sediments. The wetland is made up of a series of deep pools and shallow planted margins arranged in such a way as to increase the flow path of through the wetland to maximise treatment potential and settlement of suspended solids. A spring flow along the open drain ensures a permanent flow through the wetland and prevents stagnant water.

- An access track around the perimeter which will allow plant to access the site for maintenance, even during wet periods;
- Deep pools are used to prevent the weed growth from clogging and spreading everywhere;
- Slopes are such that areas which need to be kept mowed are easy to mow;
- A gravel layer was installed above the clay liner to provide a footing for any plant that might need access in the future. The gravel layer also serves to protect the clay liner and let anyone know when they are getting near the clay lining so excavation can stop before the clay liner is damaged.
