OVERLAND FLOW-FLOOD PREDICTION AND VALIDATION FROM A 100 YEAR EVENT

Barry Carter, Nick Brown, Carl Hewison, John Tate, and Frank Tian – Auckland Council, New Zealand

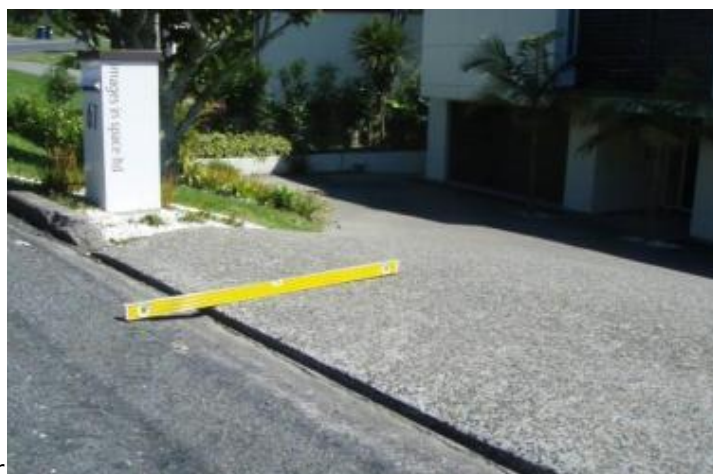
Photograph 1: Driveway crossing with inadequate roll over

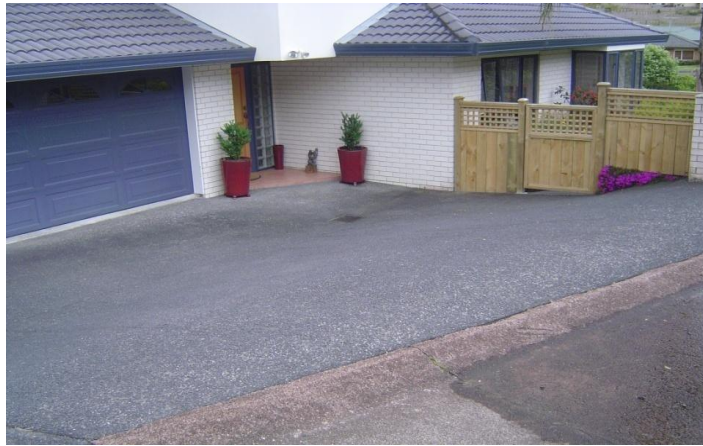
Photograph 2: Water channelled to garage and entrance-reliance on small catchpit

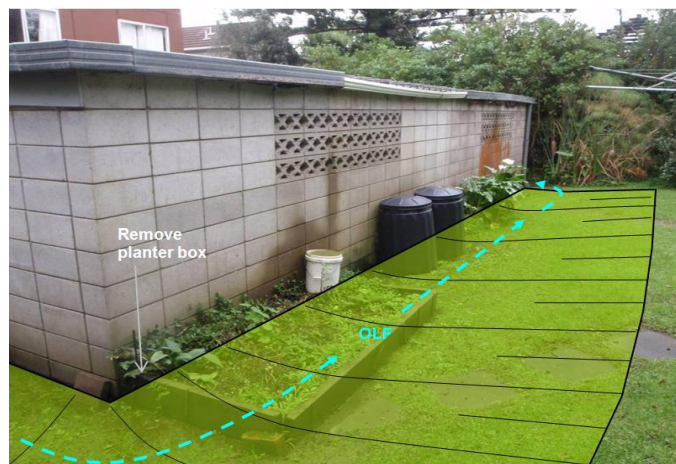
Photograph 4: Landscape and contour land to form overland flow path

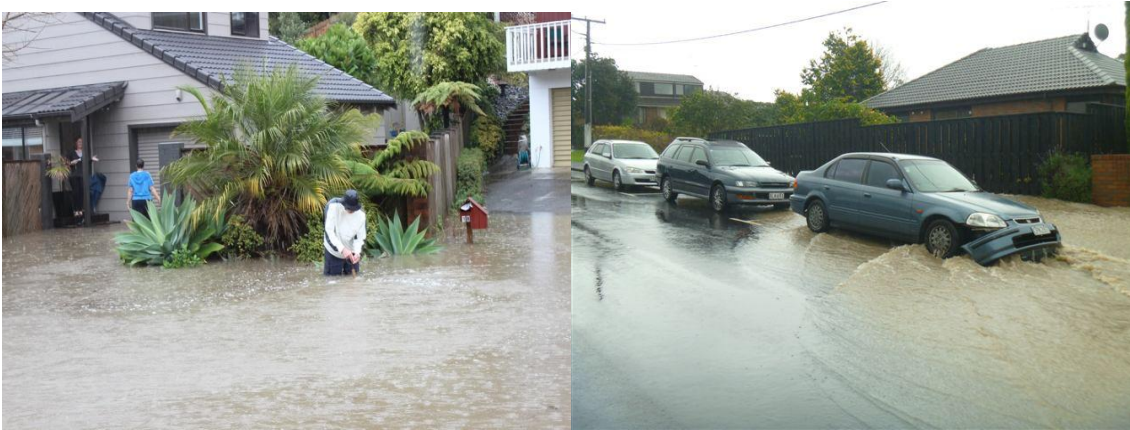
Photograph 5 and 6: Overland flows from intense short duration storm

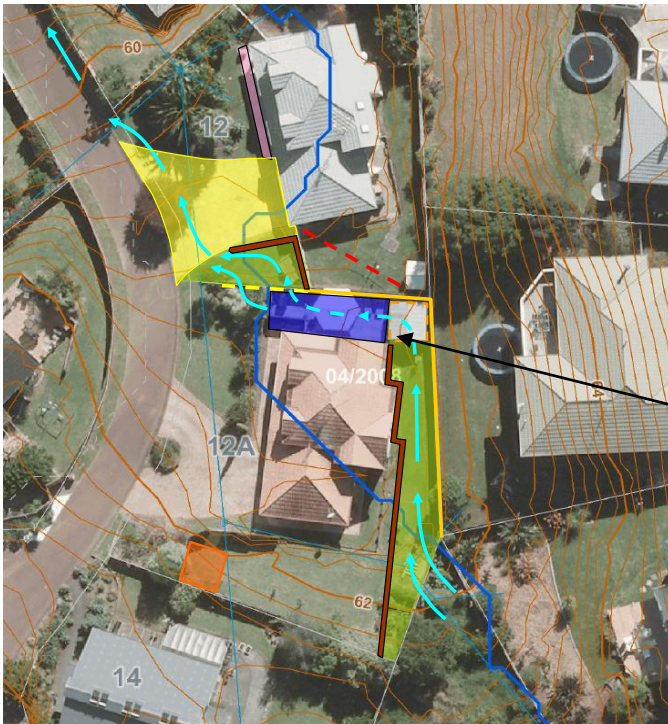
This amount is typical for the works proposed for over 200 properties where mitigation works have been identified and scoped. The following Figure 5 shows the type of mitigation works constructed and photos taken during the storm event.

Figure 5: Example of overland flow mitigation work.

Formed overland flow path in the yellow and blue area

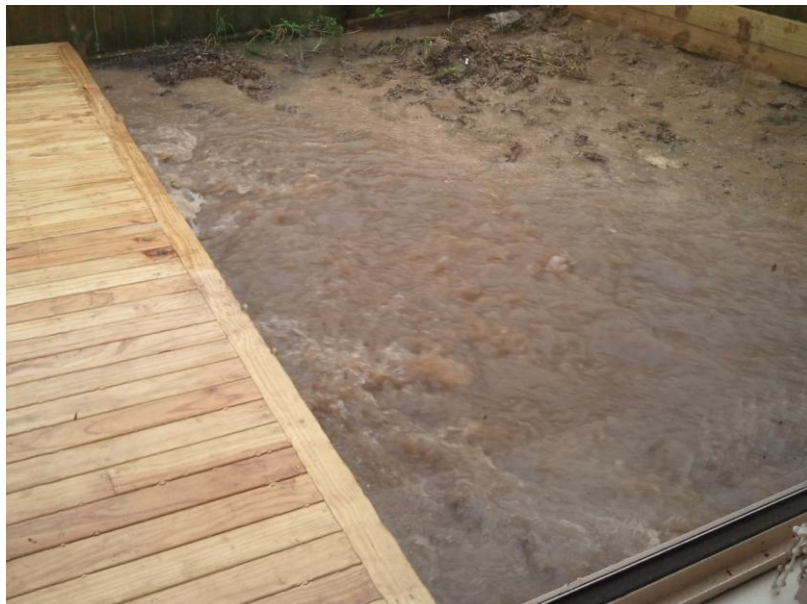
Deck can be seen in photograph 7 below

Photograph 7: Overland flows safely conveyed through property where mitigation works were in progress
