RAINGARDEN MAINTENANCE: A GOOD DESIGN STRATEGY

3 CASE STUDY – COMMERCIAL RAINGARDEN RENEWAL

Please Note: The project will be referred to as "Site Alpha", at the client's request for the site to remain anonymous

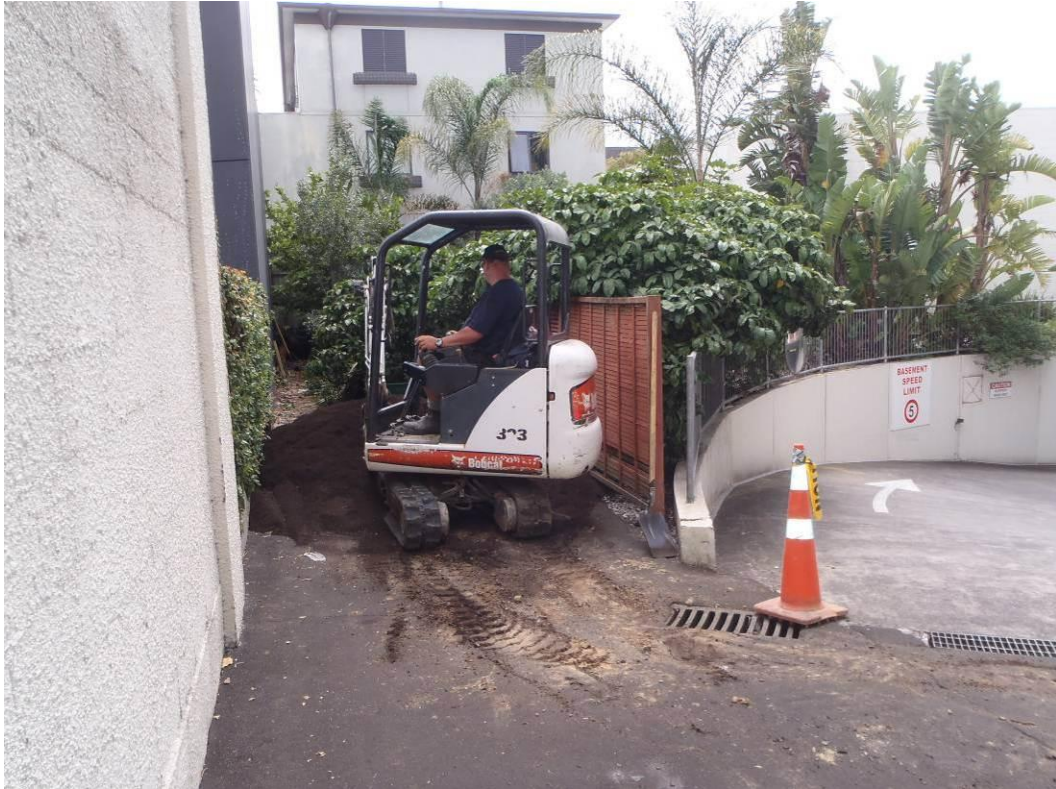
The raingarden is situated within the landscaping at the rear corner of the site with maintenance access only via through a small overgrown alleyway off the rear driveway, (see Photograph 1)

Photograph 1: Maintenance access to raingarden is restricted

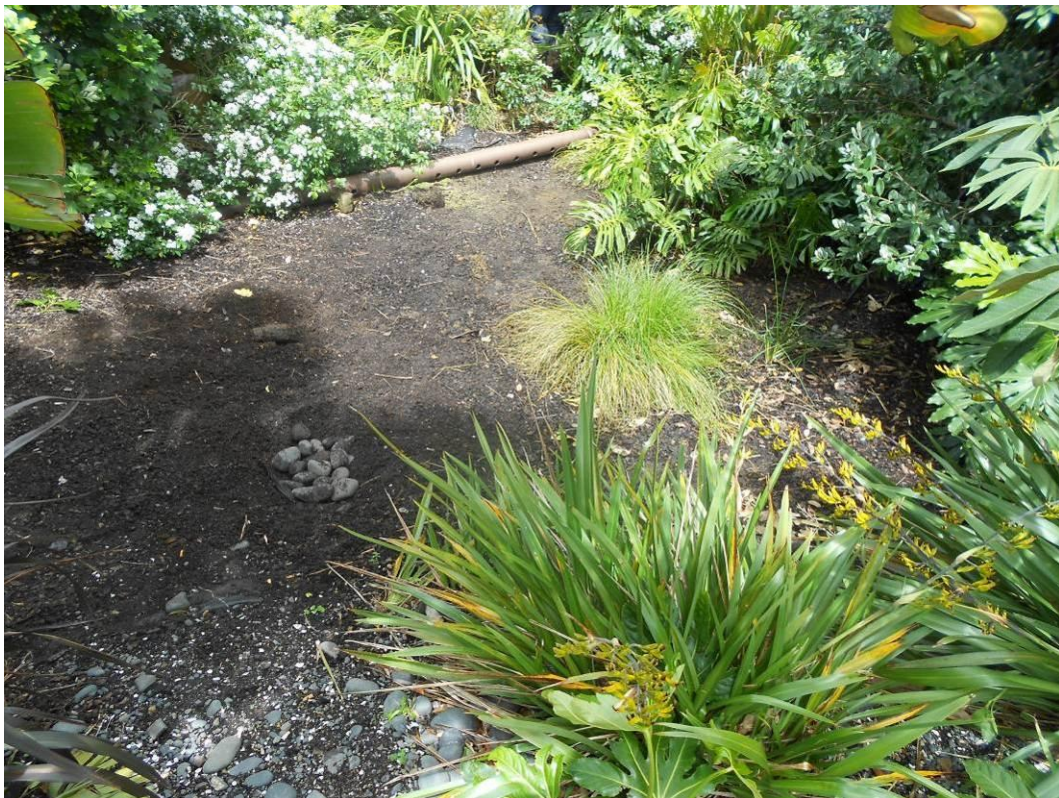
The raingarden is bordered by sloping banks on 3 sides and a level spreader on the 4th side. A medium sized Pohutakawa tree sits on one bank with several other smaller shrubs surrounding the other sides (see Photograph 2).

Photograph 2: Raingarden prior to maintenance

- The overflow cesspit was found, buried under approx. 50mm of soil and covered by a piece of weed mat.
 - The location is shown in *Photograph 2* marked by a pile of rocks.

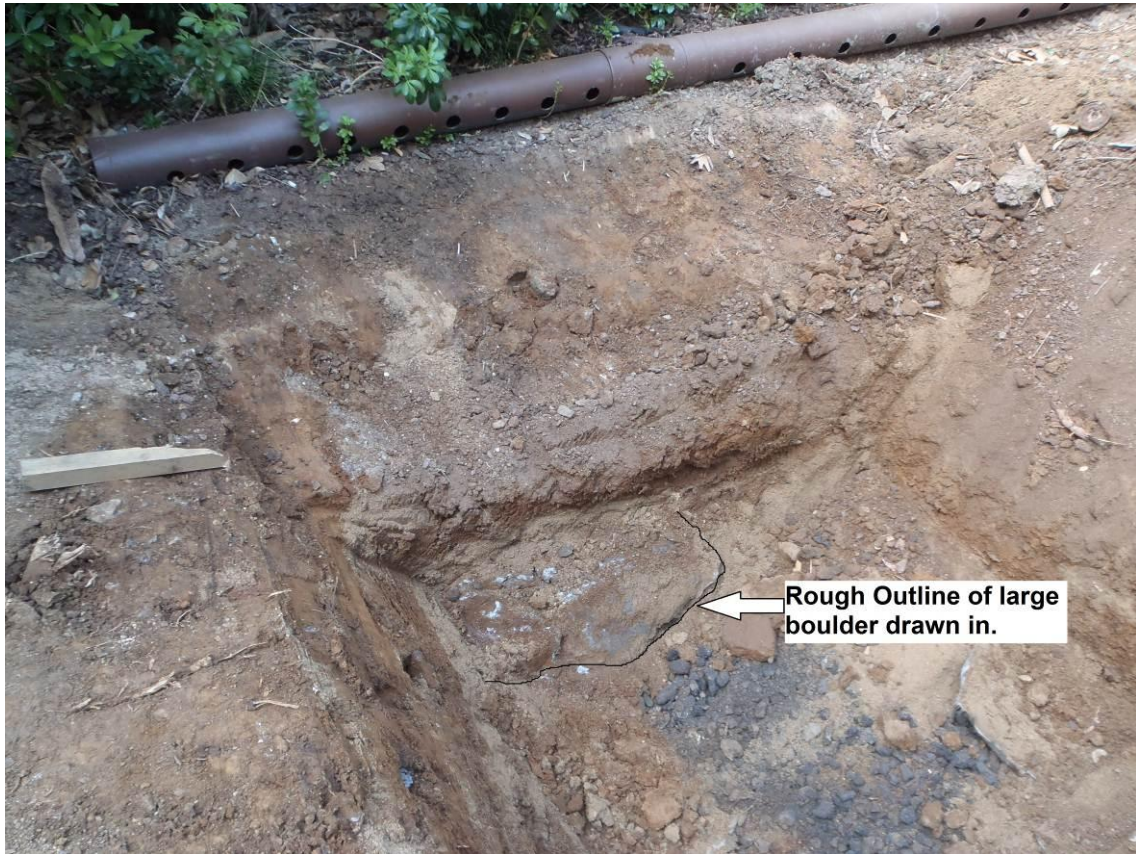
Photograph 3: Large boulder in original media bed

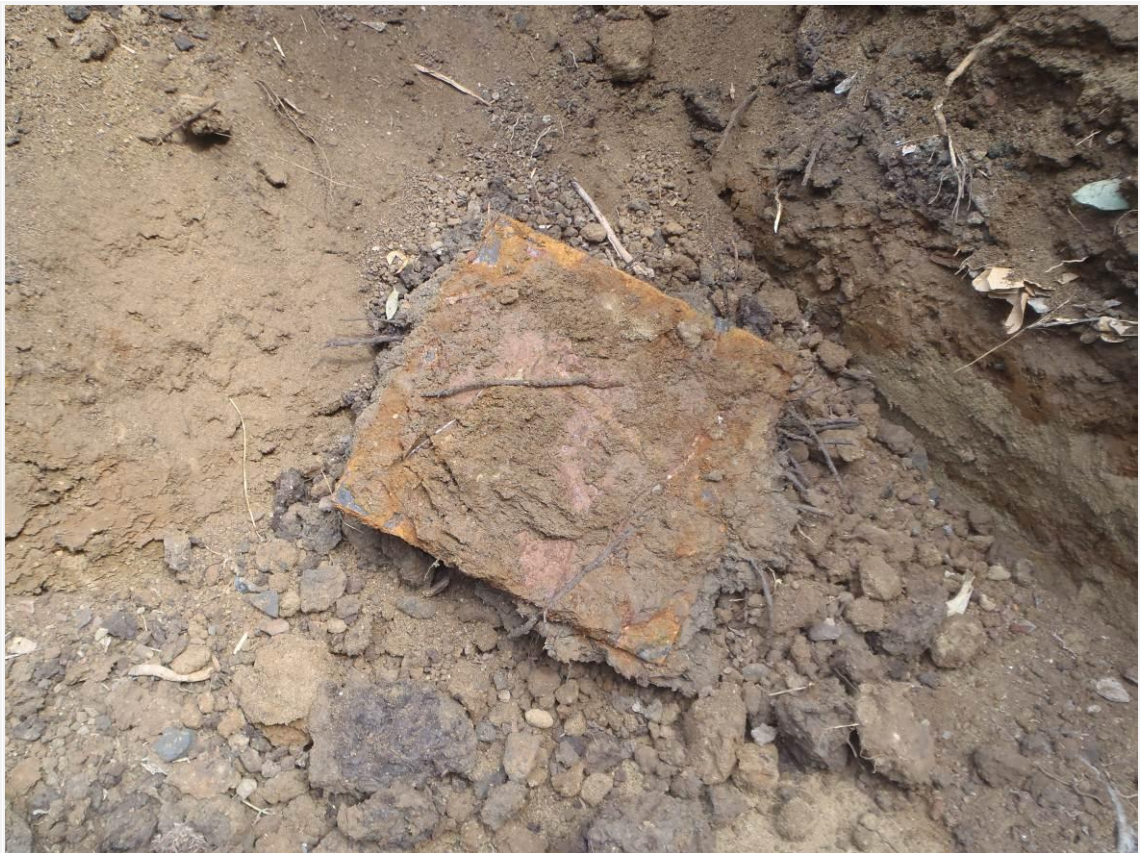
Photograph 5: Appears to be a BBQ hot plate in the original media bed

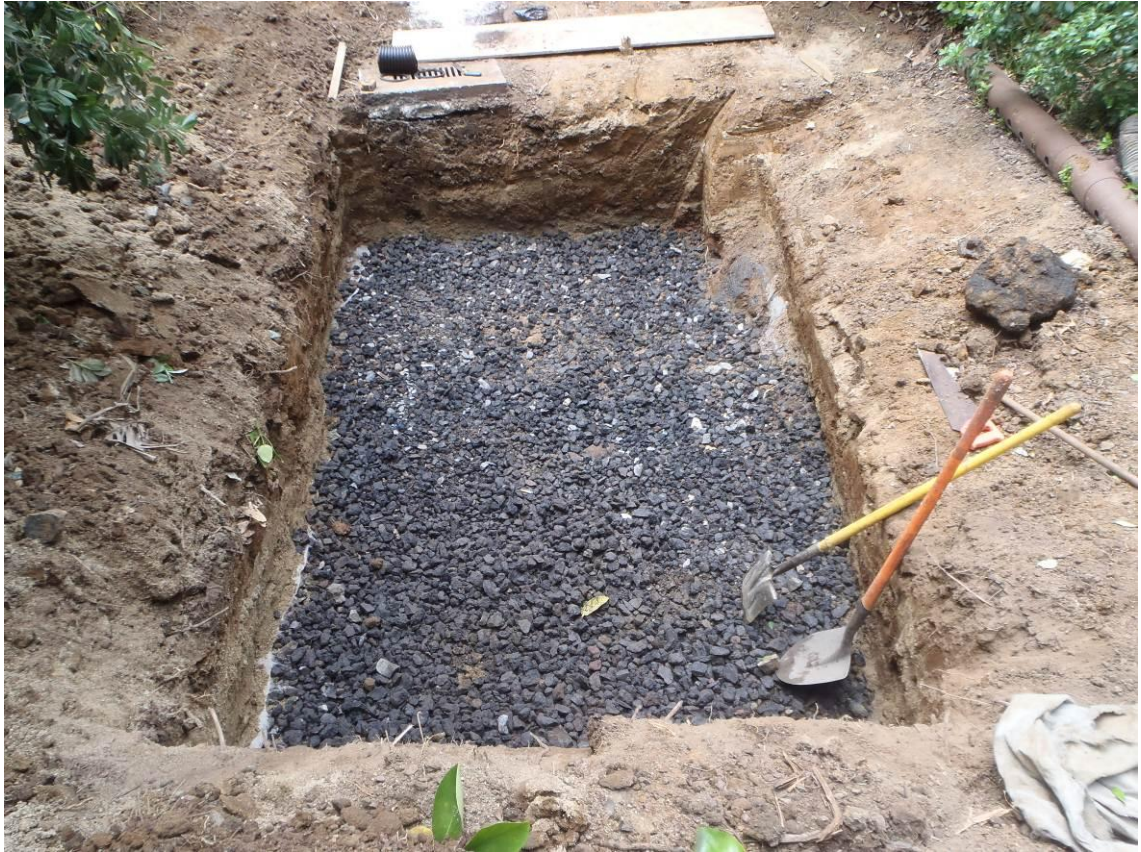
Photograph 6: Scoria Bed

- The original scoria bed was uncovered and replaced, and a new section of drainage installed to the soakhole (see Photograph 6)

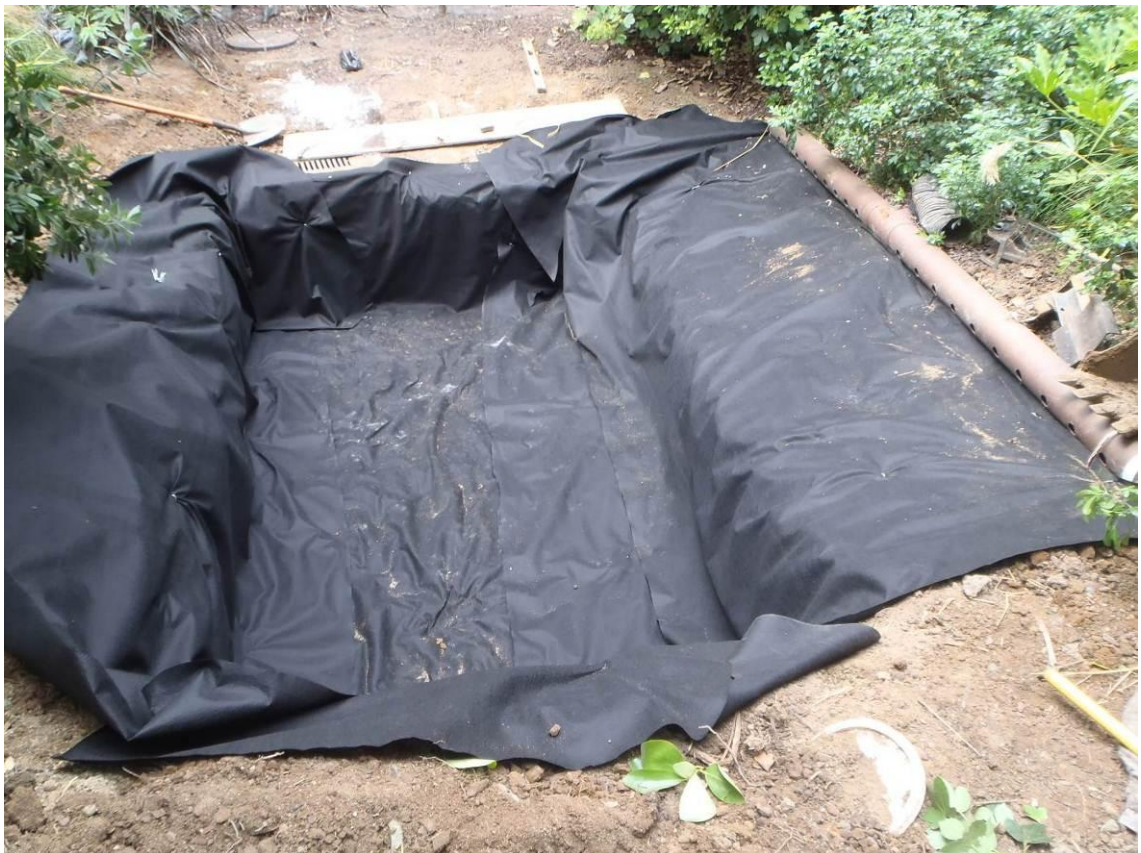
Photograph 7: Geocloth Install

- The entry slope, scoria bed and walls were covered with Geocloth, then filled with Living Earth soil media (Living Earth, 2012)(see Photographs 7 & 8)
- Carex Virgata and Oi Oi plants were selected for their suitability to the conditions and raingarden size. Large scoria rocks were installed both to demarcate the raingarden boundaries and to prevent any mulch on the surrounding areas from being washed into the filtration area (see Photograph 9)

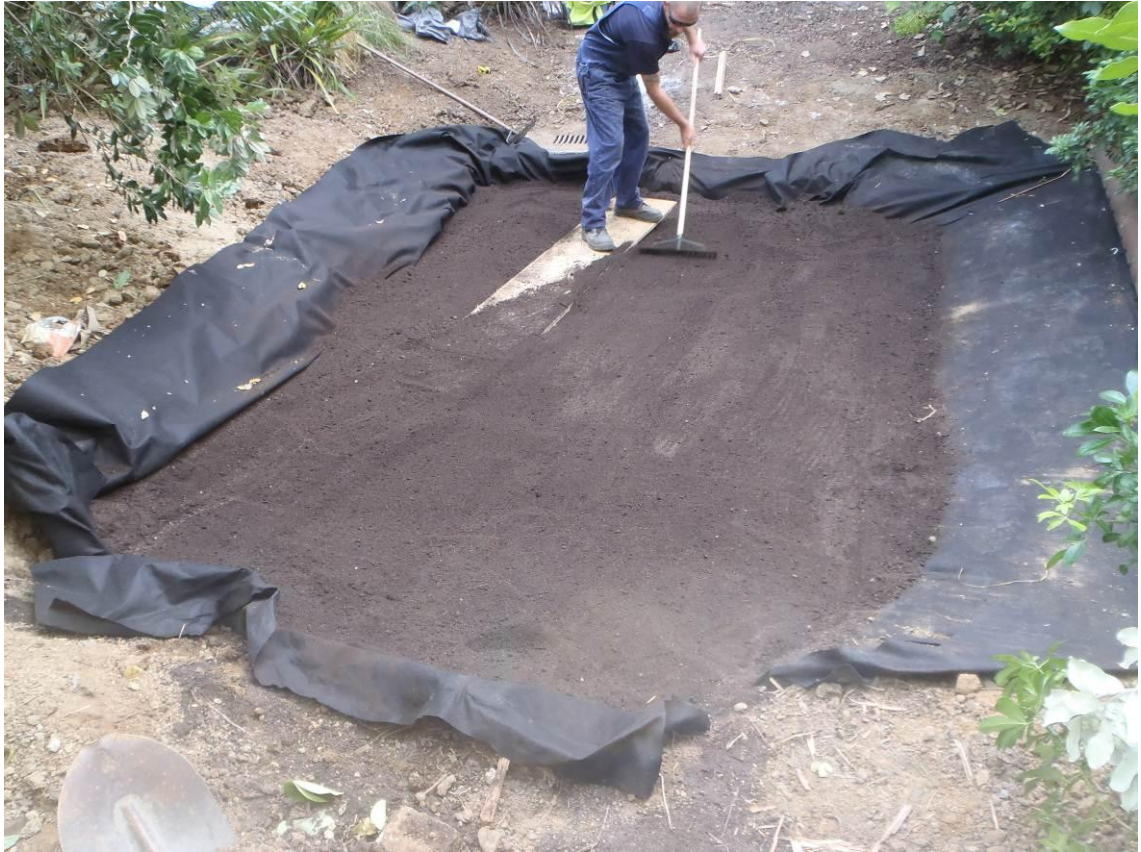
Photograph 8: Soil Media Install

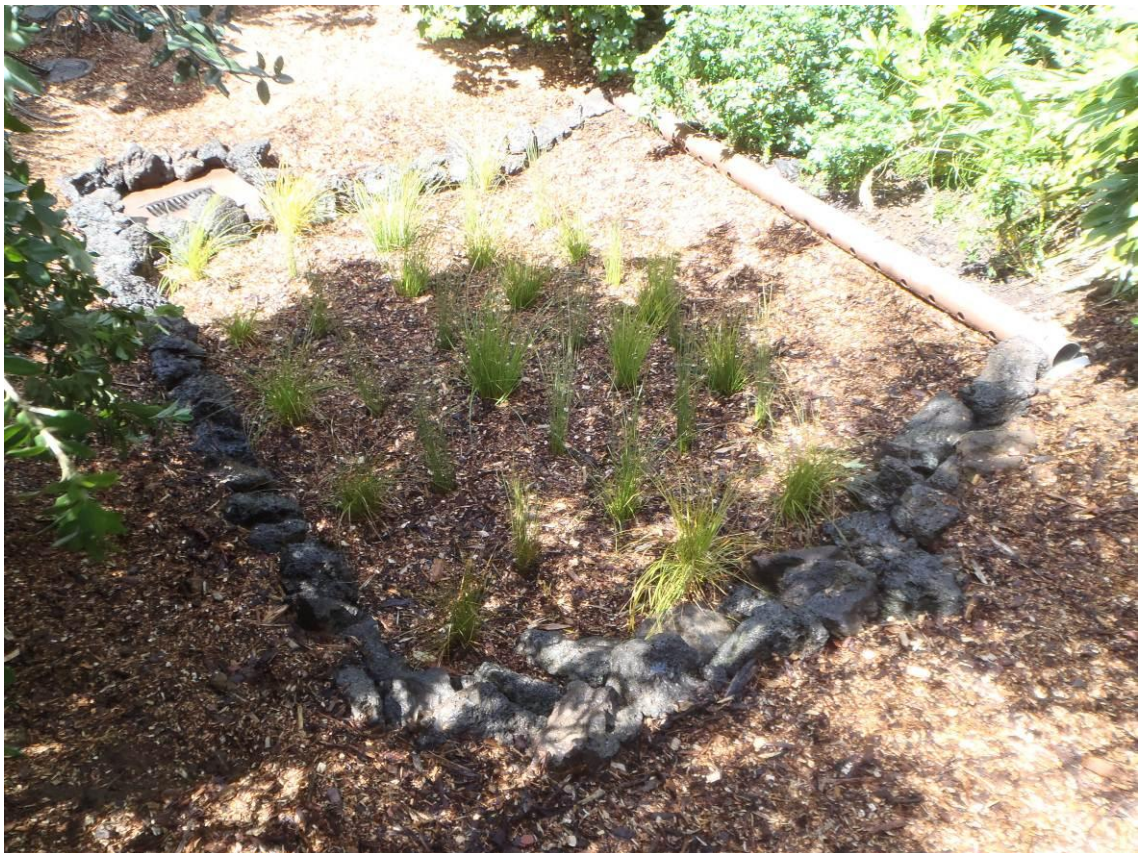
Photograph 9: Finished Rain Garden
