ACHIEVING THE POTENTIAL OF STORMWATER PONDS BY IMPROVING THEIR OPERATION AND MAINTENANCE

Mohammed Sahim Razak, Mark Thomson, and Frank Tian – Auckland Council, New Zealand

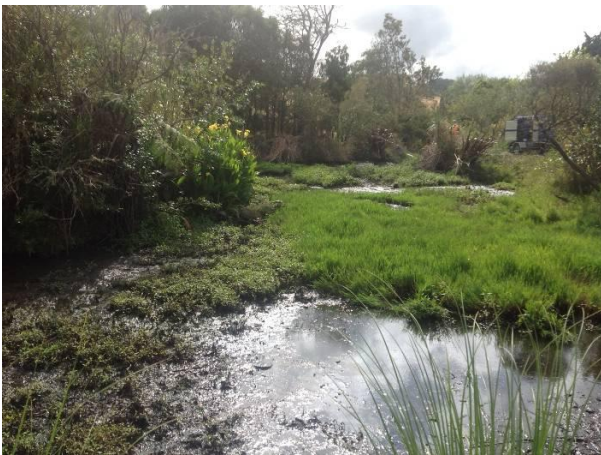
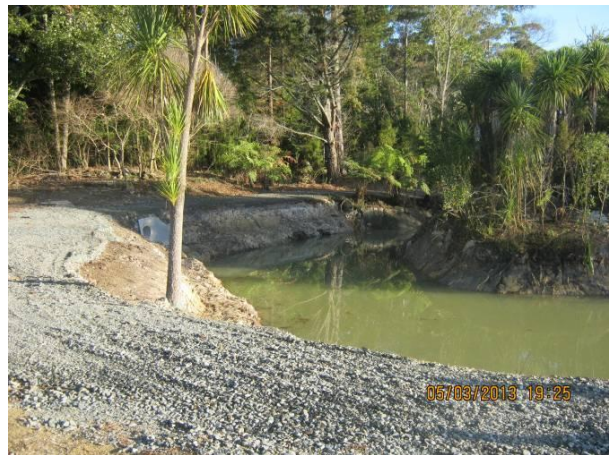
Site 1 Before and after silt removal

A total of 10 ponds with significant sedimentation were de-silted over the past two years.

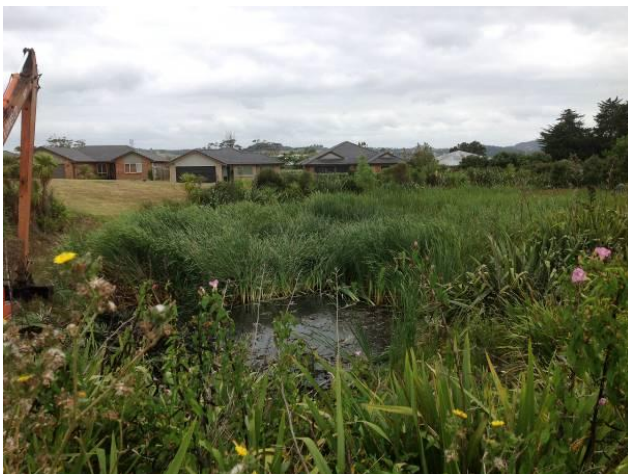
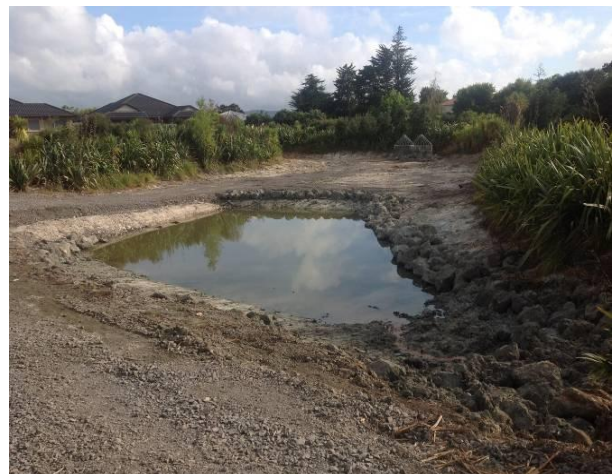
Site 2 - Before and after silt removal

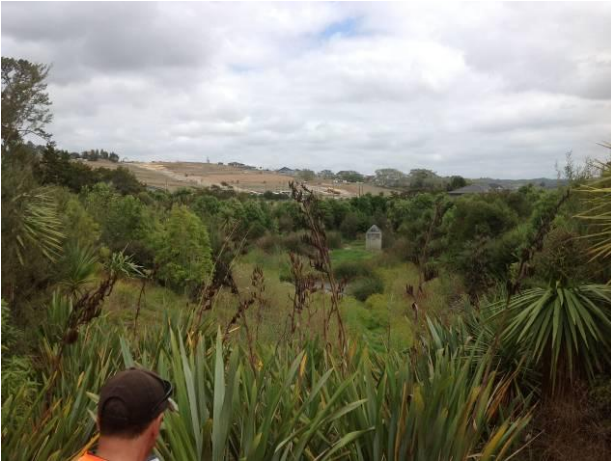
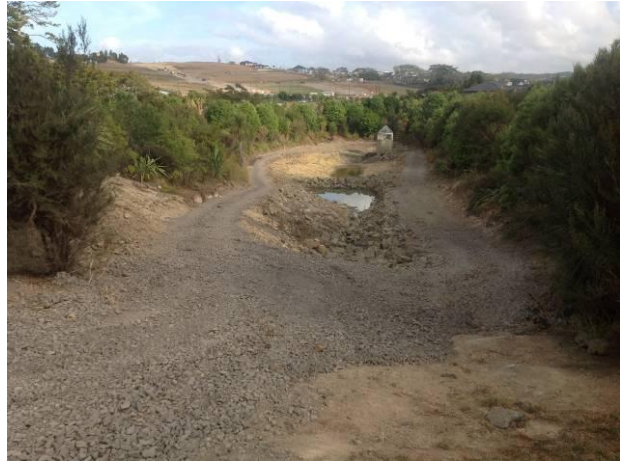
Site 3 - Before and after silt removal

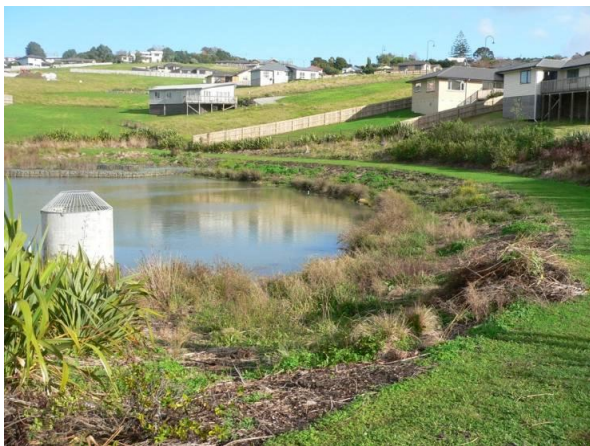
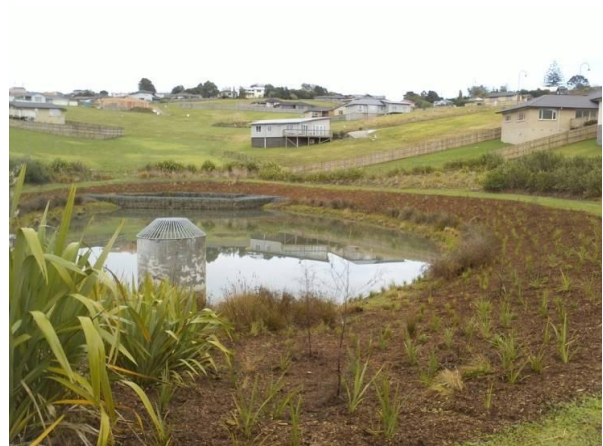
Site 4 - Before and after landscape restoration

Between 2011 and 2013, a formal contract for landscape planting was implemented and working in close collaboration with the Stormwater Group Project team, 37 ponds were greatly enhanced through implementation of major planting programmes. 50,000 trees and shrubs were planted around 37 ponds across the northern area. As a result, this has greatly enhanced the amenity and ecological value of these ponds.
