PEGASUS – MANAGING A NEW LAKE IN AN URBAN ENVIRONMENT

South, S. Golder Associates (NZ) Limited

ABSTRACT

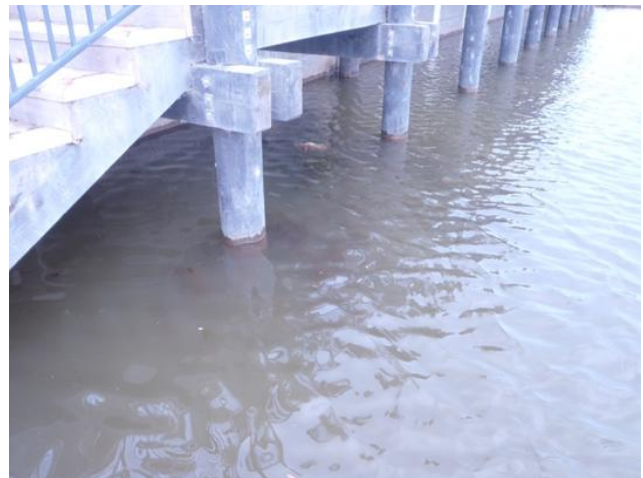
In September 2012 concern was raised about lake aesthetics when the lake appeared to be orange-brown in colour, had visible weed growth and iron-stained precipitate was visible (Photograph 2). In response to these aesthetic changes, Golder, on TPPTL's behalf, undertook additional dissolved iron, chlorophyll *a*, cyanobacteria and total algae sampling at the regular sampling site Jetty 1. To assess the extent of the influence across Pegasus Lake, sampling for a suite of 15 parameters was undertaken at 3 additional sites on Pegasus Lake on 12 September 2012.

Earlier laboratory analysis of groundwater results were reviewed and this indicated that groundwater in the area contained dissolved iron (0.28 g/m³). As groundwater has been noted to naturally enter Pegasus Lake this was considered a contributor to the aesthetic changes noted above.

Throughout 2012, testing for levels of total algae had also occurred on a monthly basis. Through this additional testing, it had been noted that in September 2012, the total algae count was almost twice as high (21,084 cells/mL) as any other month monitored to date. It is suggested that, combined with higher concentrations of iron in seasonally high influent groundwater, the algae became iron-stained, effectively making the water column appear browner and more turbid than normal.

Weed growth also appeared to accelerate at the time, which contributed to the overall poor aesthetics of Pegasus Lake.

Photograph 2: Images of discolouration in Pegasus Lake during September 2012.

TPPTL undertook immediate measures to improve the aesthetics of Pegasus Lake. The lake outflow weirs were manipulated to increase throughflow and flush the lake. Weed was removed manually and also sprayed in early November 2012. The spray programme was successful and led to the removal of all significant visible weed.

It is considered that the decline in clarity observed in September 2012 was a seasonal phenomenon driven primarily by high groundwater levels and an increase in lake water temperature causing algal growth. During the following sampling rounds, the colour and clarity of Pegasus Lake improved, and total algae counts reduced.
