# **LOW IMPACT DRAIN MAINTENANCE IN THE WAIMAKARIRI DISTRICT**

G J Bennett, Waimakariri District Council

This paper provides examples of low-maintenance waterways and compares the effects of low impact cleaning versus traditional cleaning methods.

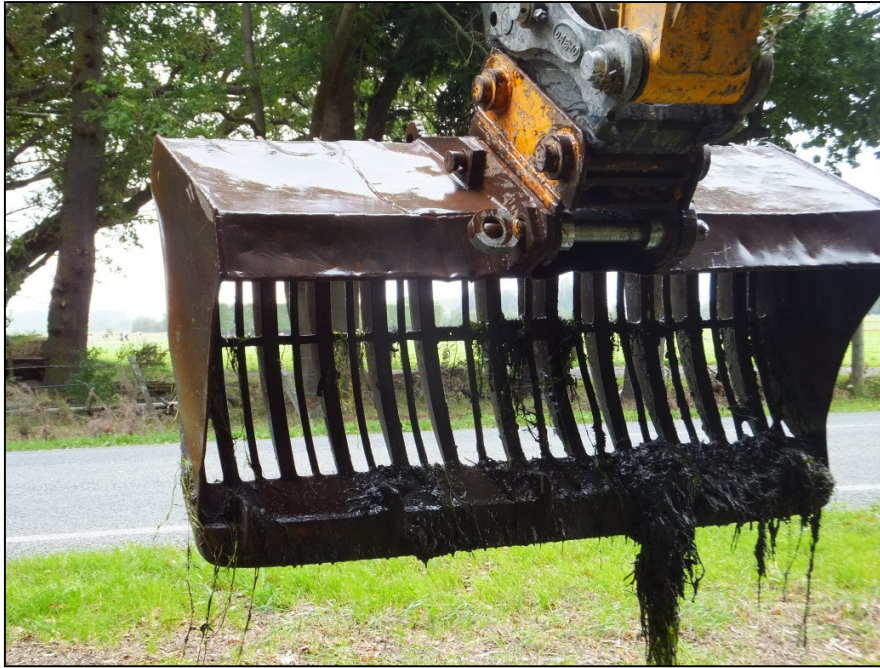
*Picture 1: Weed bucket*

The weed bucket has a cutting edge so the cleaning operation excavates the stream substrate along with silt and weed from the drain. The operator has to pivot the machine to deposit the cleanings alongside the drain. This results in messy piles of cleanings beside the drain which mount up over successive years or require subsequent removal because the lifestyle block owner does not like his lawn damaged by unsightly piles of silt and decomposing weeds. The operator can only deposit the weed onto the near bank. The narrow slots and dish shape of the bucket causes the water to excessively slosh about hindering the cleaning operation and making a mess.

In 2008 Council staff in collaboration with the drainage maintenance contractor started to experiment with the use of a rake instead of the traditional silt / weed bucket. The spacing between the tines on the rake is 300mm as opposed to the width of the slots in the weed bucket which are 40 - 50mm (see pictures 1- 8).

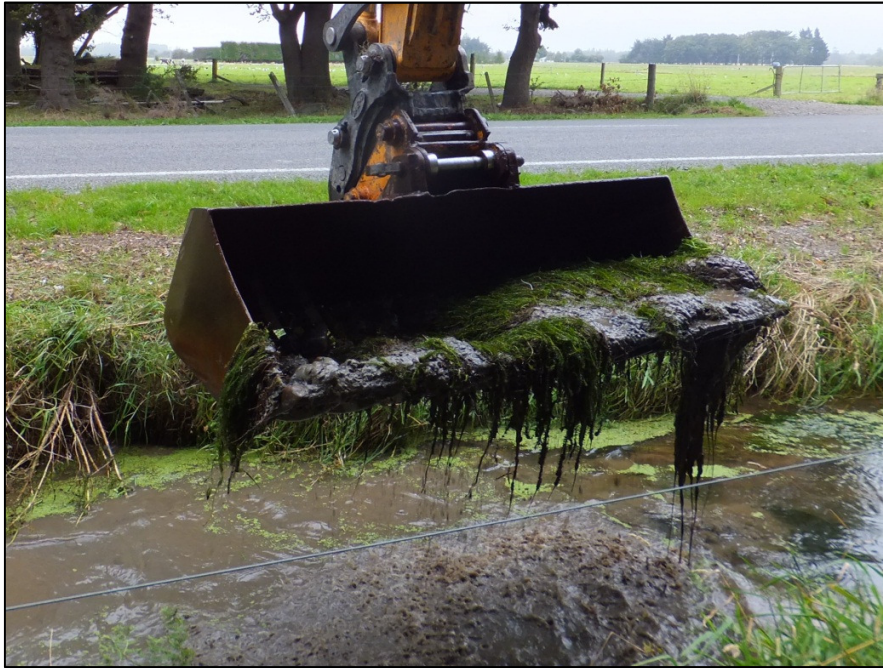
*Picture 2: Weed bucket with silt and weed*

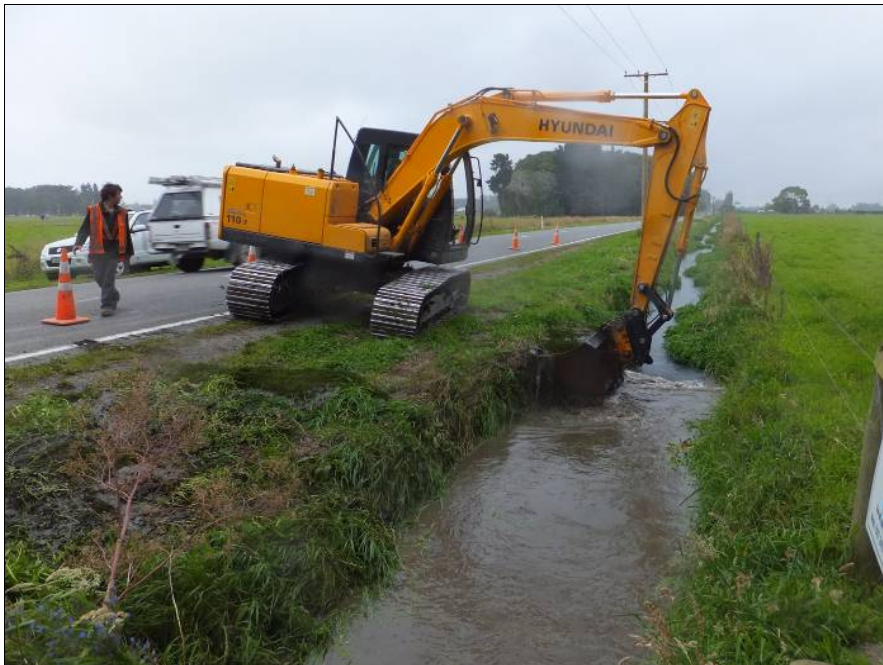
*Picture 3: Cleaning with weed bucket*

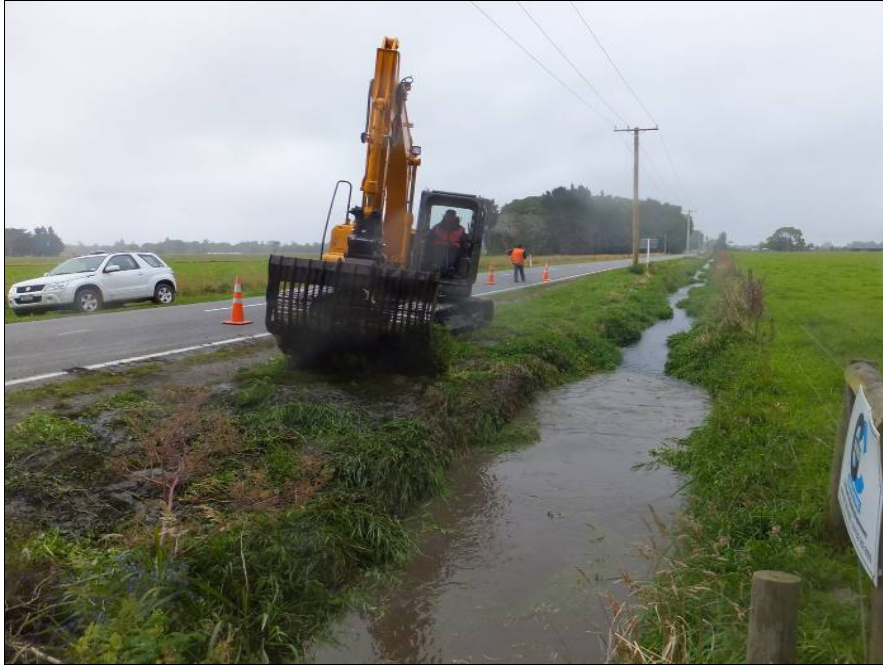
*Picture 4: Cleanings placed alongside drain*

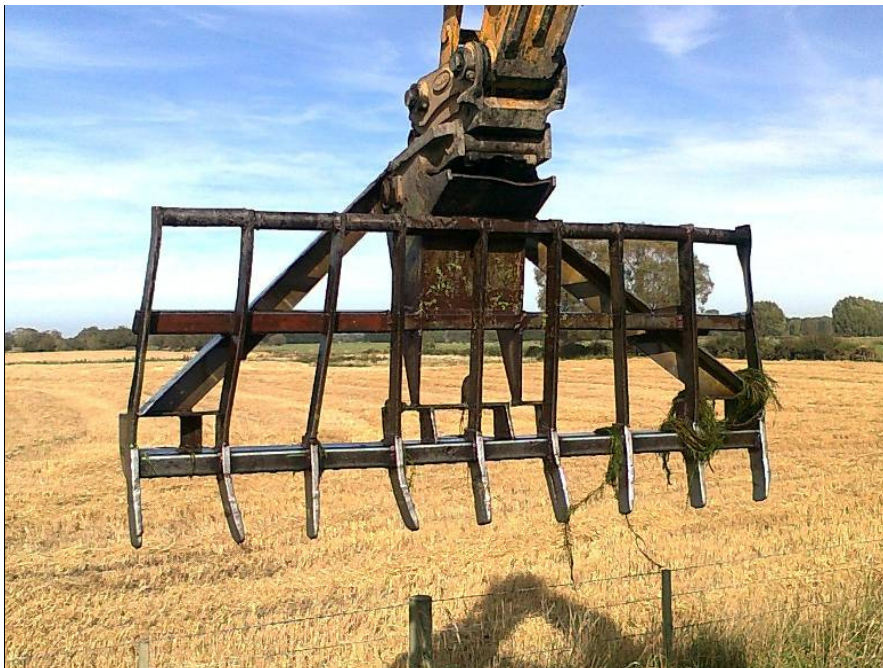
*Picture 5: Rake*

The rake is effective in removing the majority of weed and allowing in stream fauna to pass through. The rake has no cutting edge so the cleaning operation drags the excess weed from the drain without excavating the substrate. The experienced operator can flick the weed onto the edge of the drain with minimum disturbance to the waterway and surrounding land. In stream fauna removed with the weed is able to easily migrate back into the drain. The wide gaps between the tines enable the rake to drag through the water without causing too much displacement. The operator can either flick the cleanings onto the

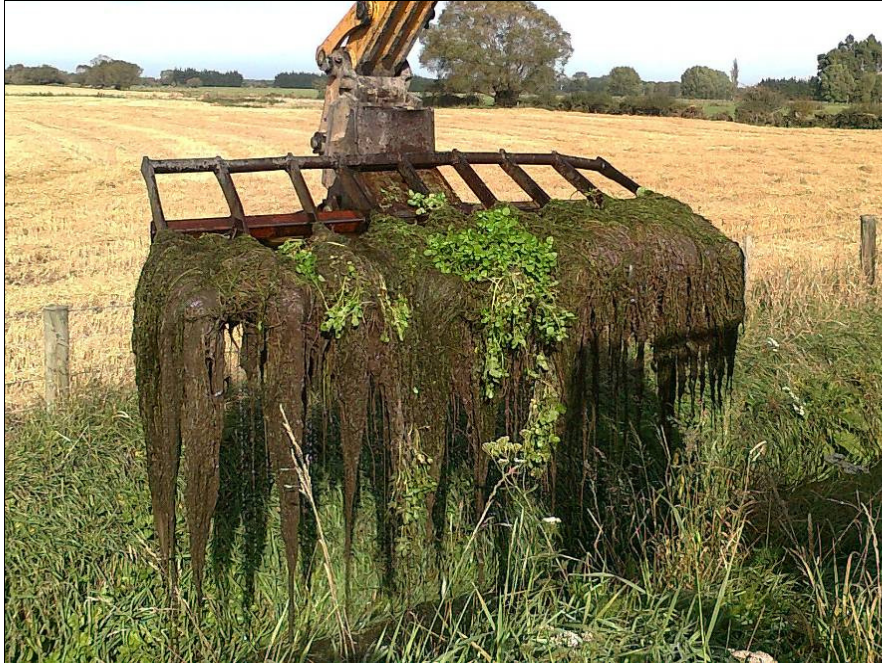
*Picture 6: Rake with weed*

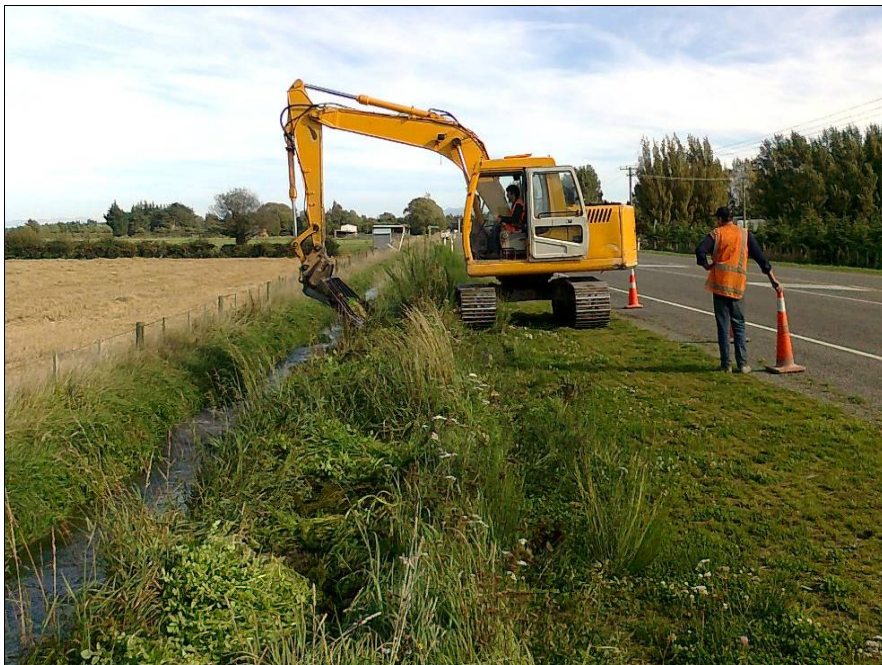
*Picture 7: Cleaning with rake, weed is flicked onto edge of drain*

near bank or far bank without having to pivot and deposit the cleanings on the bank. The operation is quicker, cheaper and less impact than the traditional cleaning method.

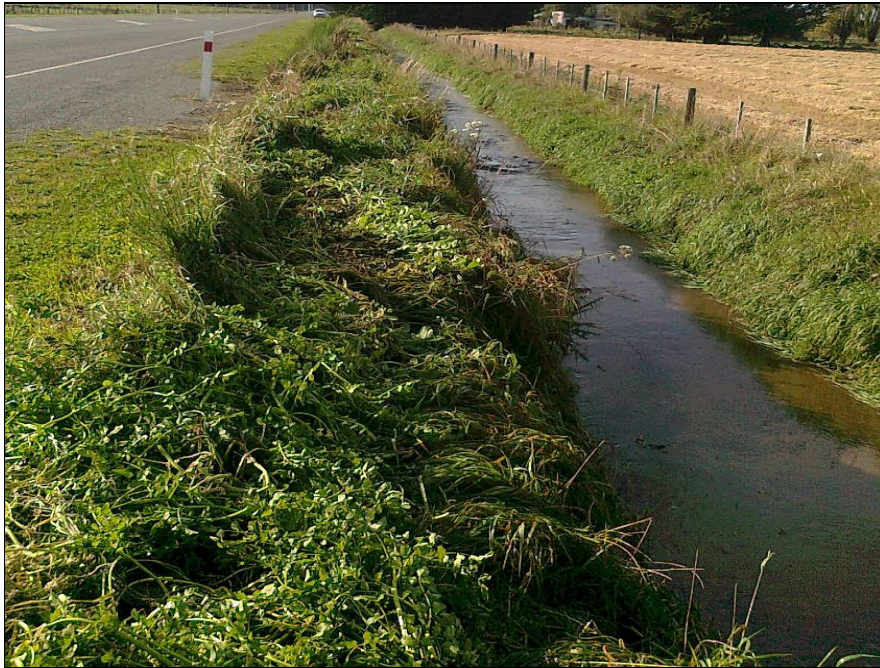
*Picture 8: Drain cleaned with rake*

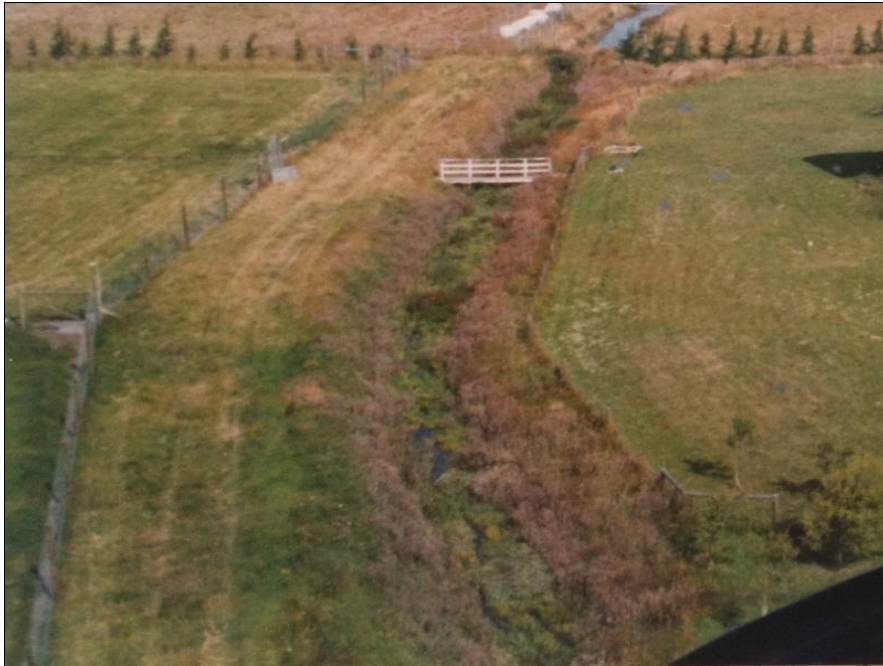
*Picture 9: Aerial photo of farm drain 2000*

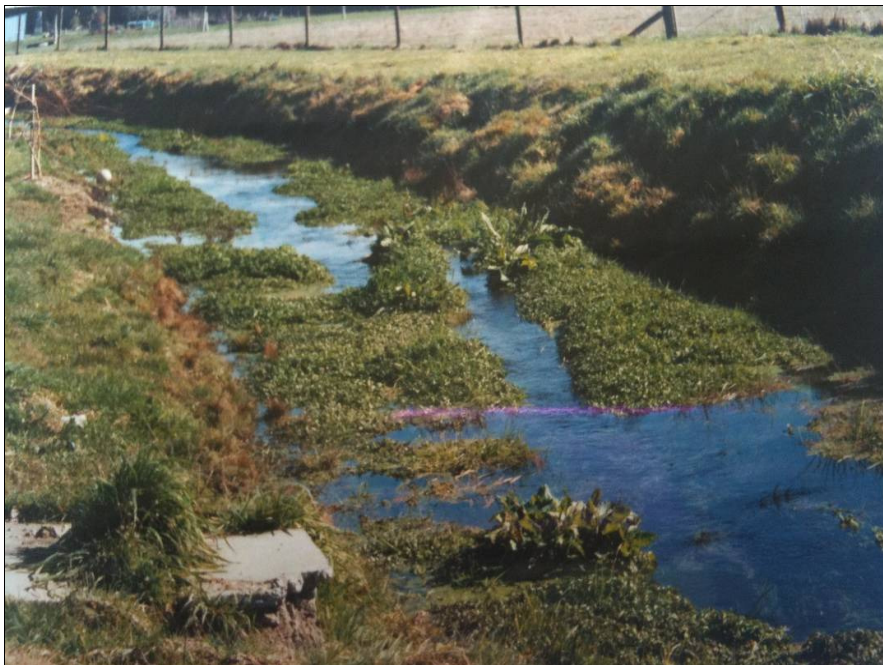
*Picture 10: Farm drain 2000*

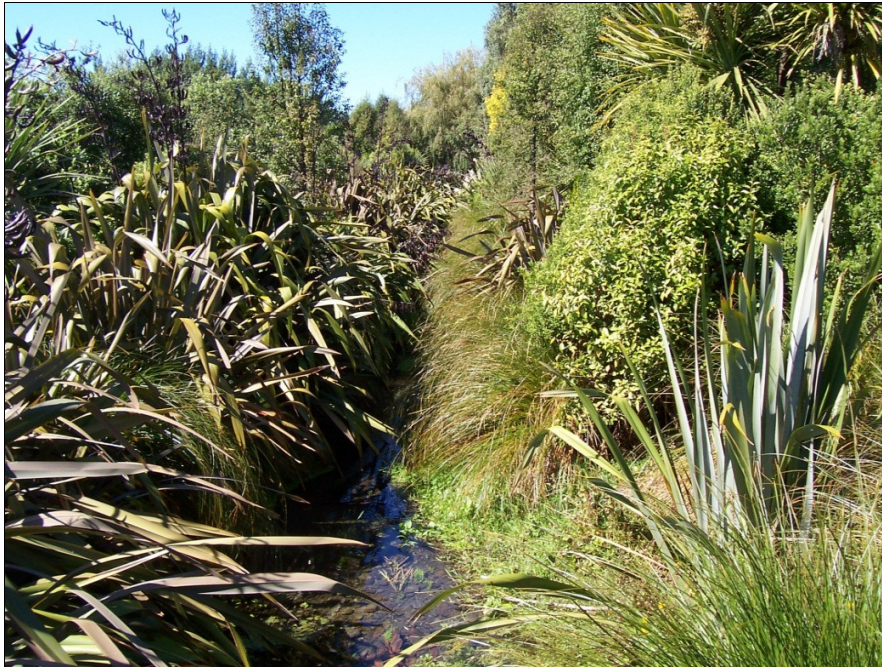
The use of *Carex secta* and *Carex Virgata* (pukio, tussock sedge) and *Phormium tenax* and *Phormium cookianum* (Flax), as shown in Picture 11, along the lower banks of waterways illustrates many benefits including reduced maintenance costs. Well vegetated banks are stable even if planted with pasture grass (Hudson (Ed) 2005). The plants provide shade which is effective in reducing aquatic and land weed growth and provide many other benefits that are classified under the term; ecosystem services (Wikipedia 2012).

*Picture 11: Farm drain 2012*

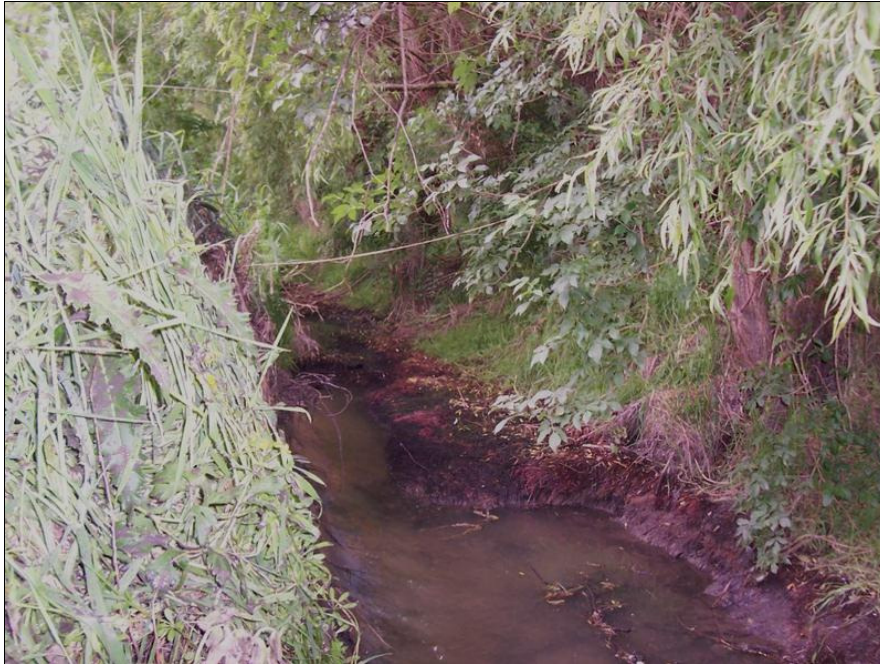
As Ian identified in 1951 willows have remained a problem plant in the Waimakariri. They will often drop branches and the older ones are prone to falling in high winds. The tree roots will seek out the nearest watercourse sometimes from several meters away and form a dense root mat that will cause the invert to raise and erosion of the nearby banks. The only recourse in these situations is to cut the root mat away and the problem will repeat unless the trees are removed altogether and the stumps poisoned to prevent regrowth.

*Picture 12: Willow root infestation*

The cost of willow control in the district has been considerable in recent years. In 2008 the cost was 25% of the annual drain maintenance budget. In 2009 it was 9% and in 2010 it was 10%. These willow operations have been reactionary i.e. having to act when there is a problem such as fallen tree or branch and blocked waterway. Willow control involves removing whole willows or branches, cutting away willow root mats and spraying regrowth.
