SEATON VALLEY STREAM UPGRADE: CASE STUDY OF IMPLEMENTING A CHANNEL UPGRADE ON MULTIPLE PRIVATE PROPERTIES

*Denis O'Brien (MWH New Zealand Ltd) and David Stephenson
(Tasman District Council)*

ABSTRACT

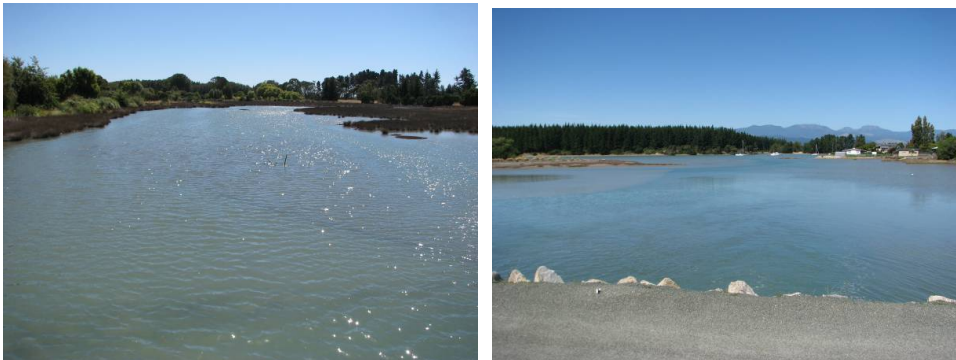
Photographs 1 and 2: Upstream and downstream Toru Street causeway

The second storage area is located immediately upstream of the estuary causeway. This storage area was created by the construction of the Toru Street causeway embankment in the 1950s to gain access to the peninsula during all tides. This property has subsequently become a very popular holiday camp ground. This lagoon had a total area of 120 ha.

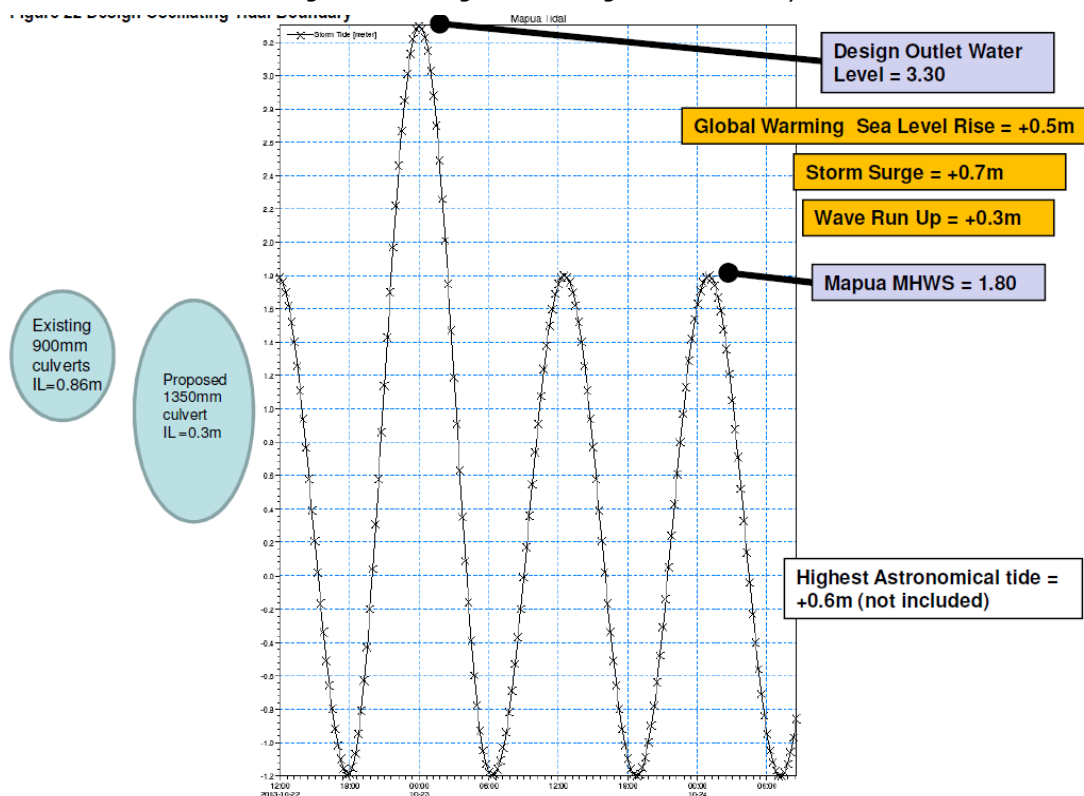
Figure 2: Design Oscillating Tidal Boundary

The peak design outlet water level of the estuary was set at 3.3m RL to account for the combined effect of wave run up, storm surge and future sea level rise from global warming. Figure 2 details the tidal oscillating boundary relative to the existing and new outlet culvert levels.

The critical model scenario simulated a 72 hour duration event, with a 36 hour initialisation prior to the start of rainfall (to develop a tidal effect), 24 hours of rainfall, and 12 hour simulation after the design rainfall stops to model estuary levels. In all cases, the peak top water level occurred prior to rainfall ending. This implies that the system response time is less than the 24 hour rainfall duration.

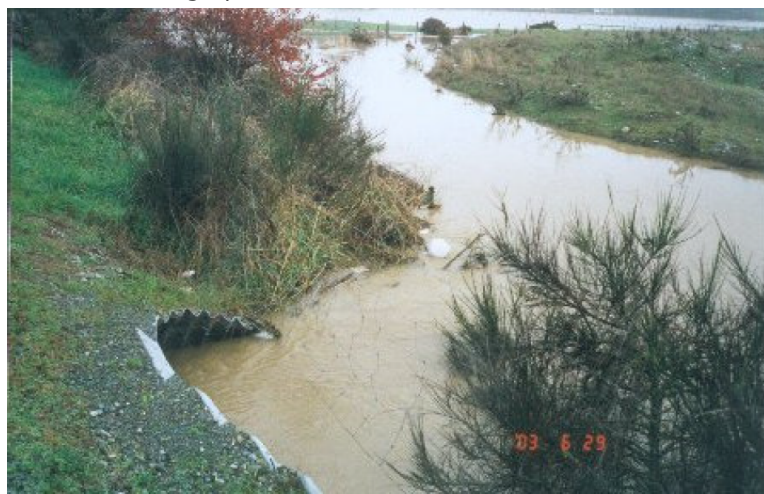
Photograph 3: Armco Culvert under Stafford Drive in flood – June 2003

Model calibration was carried out against photographic evidence of the minor rainfall event in June 2003. The June 2003 event at Mapua was a 7 year ARI, 3 hour event, but was a 3 year ARI 24 hour event. ~~Widespread flooding upstream of the SH60 culvert was photographed by MWH staff one hour after the heaviest rainfall ceased. Survey levels were taken subsequently of the highest water levels at a number of structures.~~

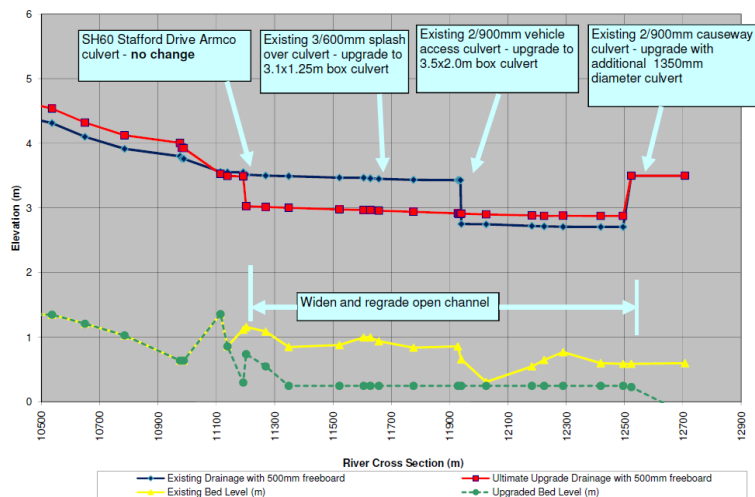
Figure 3: Seaton Valley Waterway – top water levels

The model indicated that significant headloss at the four main culverts along the Seaton Valley Stream. The backwater effect from these culvert constructions was increasing the flood area in the upper catchment. Figure 3 shows the longitudinal section of the stream with the top water level shown for both existing and upgraded scenarios.

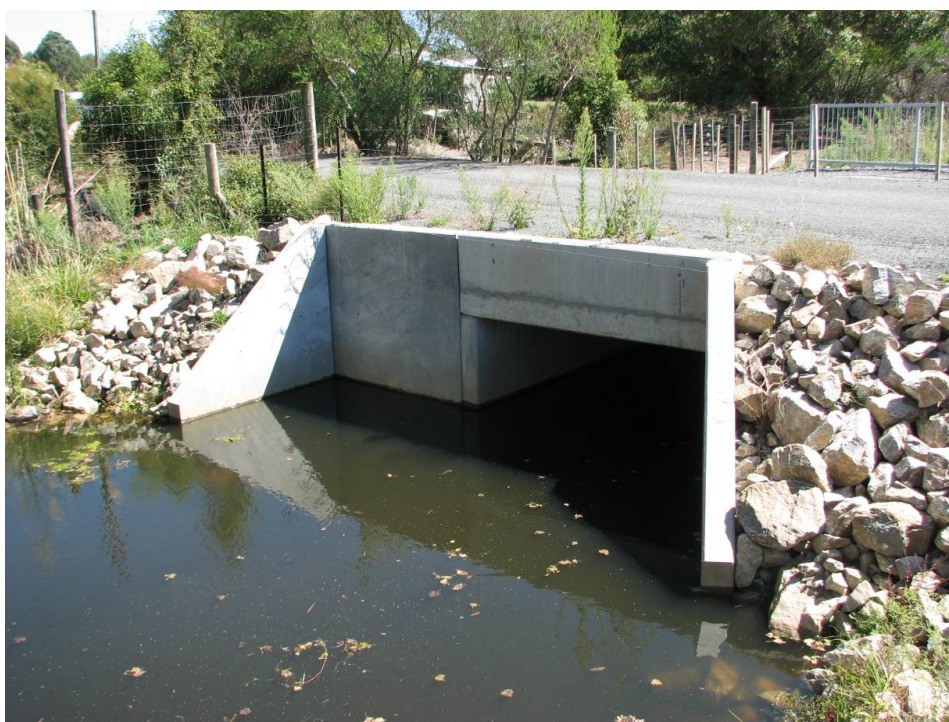
Photograph 5: Completed culvert construction

The first intermediate culvert (working upstream from the causeway) had a twin 900mm diameter culvert with a vehicle access which was to be upgraded to a 3.5m by 2m box culvert. The second intermediate culvert is a triple 600mm diameter vehicle access-way which has been upgraded to a 3.1m x 1.25m box section concrete culvert.
