# **(ALMOST) REBUILDING KAIAPOI**

Rob Kerr, Director, Kerr and Partners, formerly; Infrastructure Recovery Manager, Waimakariri District Council

## **ABSTRACT**

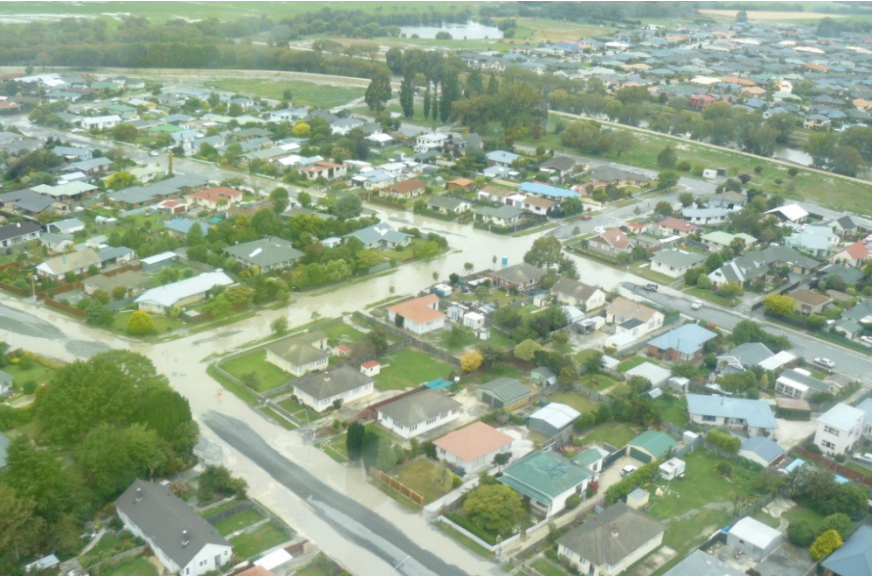
Figure 3: Aerial view of Kaiapoi immediately after quake showing flooding and silt accumulated on ground

A state of 'soil liquefaction' occurs when the effective stress of a soil is reduced to essentially zero, which corresponds to a complete loss of shear strength. This can be caused by a single sudden occurrence of a change in stress, however is better known as a result of earthquake shaking. It is more likely to occur in sandy or non-plastic silty soils, but may in rare cases occur in gravels and clays. Liquefaction then occurs when the vibrations from the earthquake cause the soil particles to lose contact with one another. As a result, the soil temporarily behaves like a liquid, loses the ability to support weight and can flow down even very gentle slopes. See figures 3 and 4 for examples of what can happen.

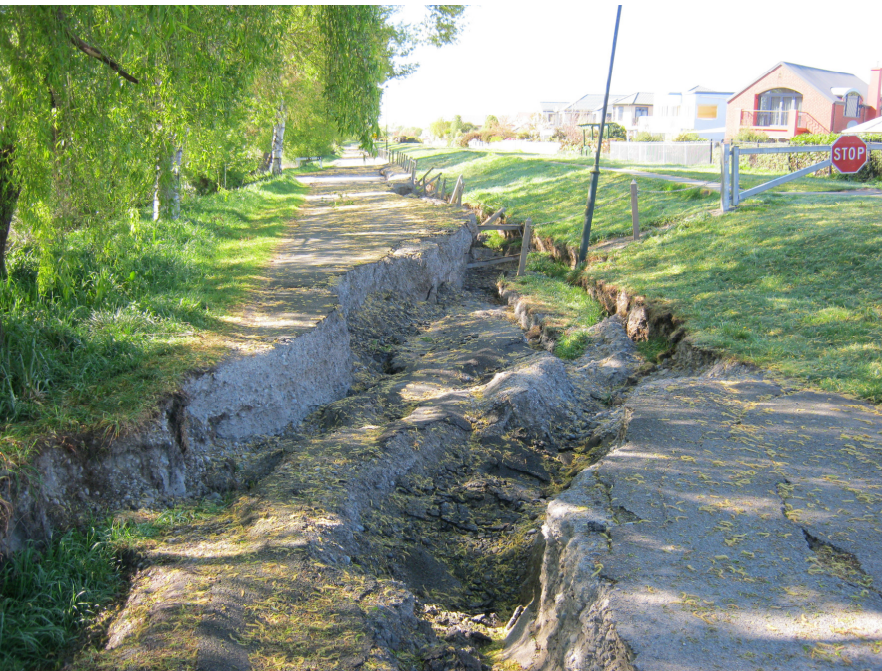
Figure 4: Lateral spread tension cracking on south side of Kaiapoi River adjacent to Bowler Street Stormwater pumping Station

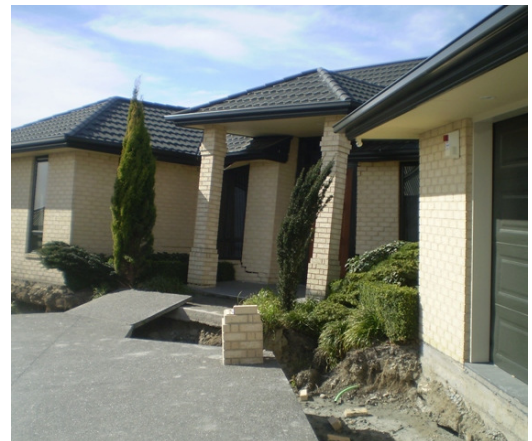
Figure 5 (right) : House damaged by lateral spread

Figure six shows an initial estimate of the status of damage of many homes in one part of the Kaiapoi. It was clear from the information that a significant portion of the homes were damaged such that they would require complete replacement. Figure five shows a home severely damaged by lateral spread. It is remarkable that this home did not collapse.

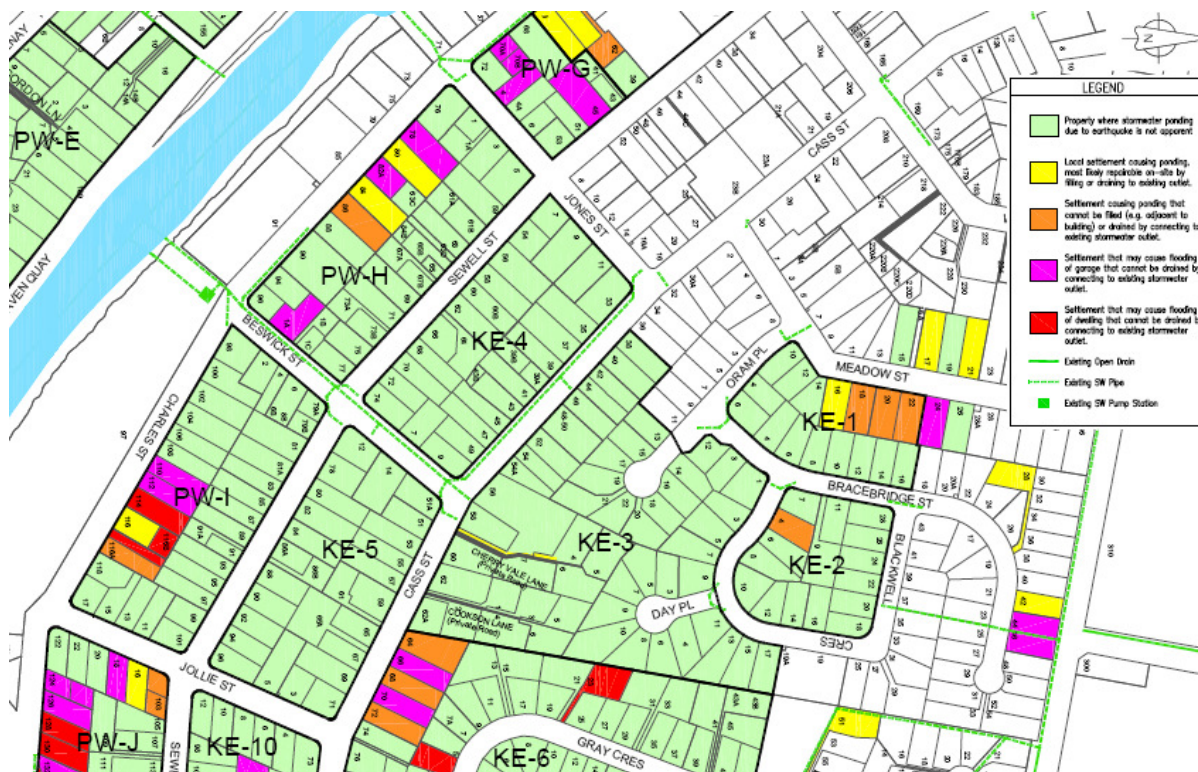
Figure 9: Localised ponding map

At a more local level, there were a large number of properties that were, or appeared to have sunk below the level of the road, and were now at risk of ponding during rain events. At an early stage, a full topographical survey of the roads and manholes was undertaken. In addition, spot levels were taken in the corners of each section, plus the floor level of the house. Coupled with LiDAR, inspection of properties, and a survey of residents coming to public meetings to gather observations, these properties were identified, and options developed for each one to resolve the issue. See figure 9 below for an example.
