CHLORINATION OF CHRISTCHURCH WATER SUPPLY AFTER THE EARTHQUAKE; THE PLANNING AND THE REALITY

R Rose, GHD, F Resl, City Care Ltd

ABSTRACT

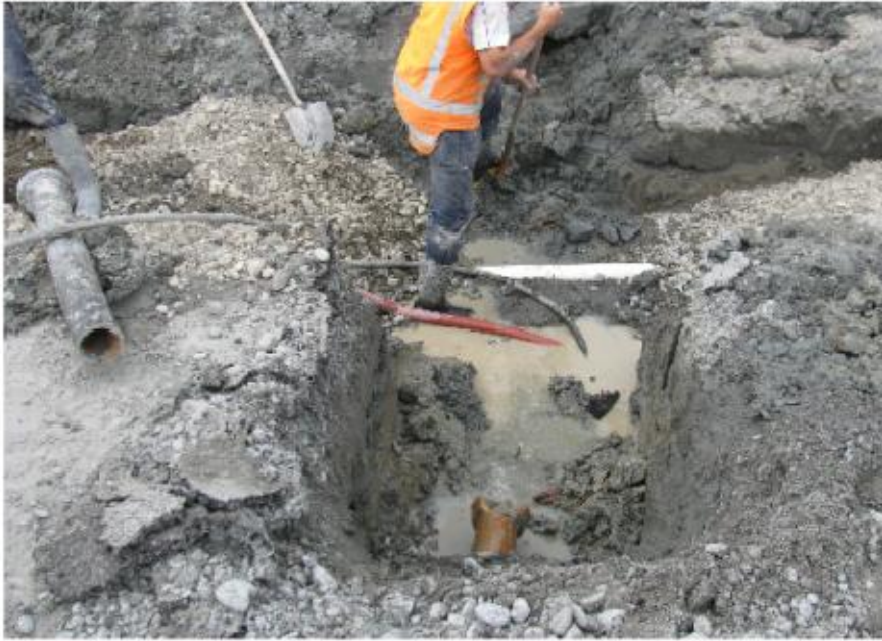
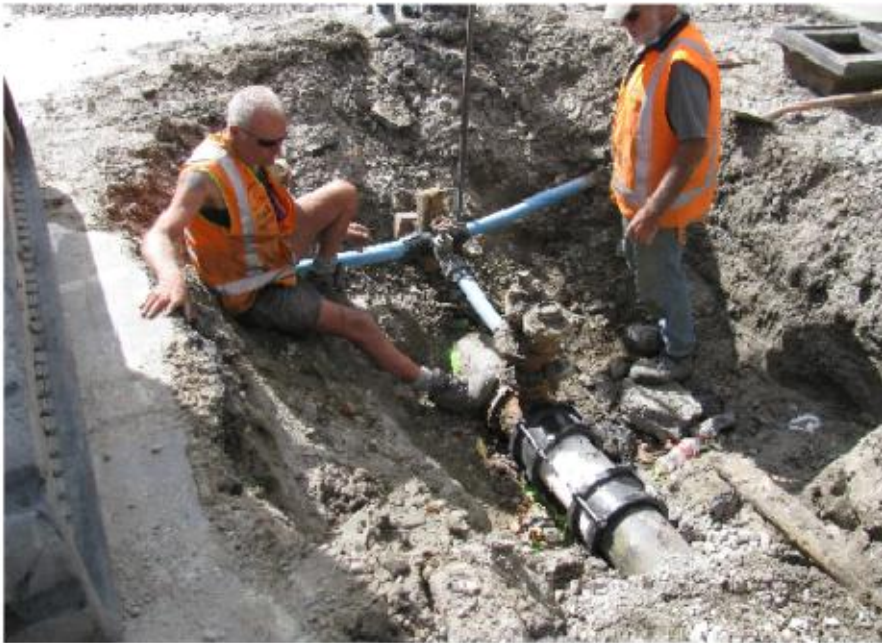
GHD observed three repairs of watermains on Wednesday the 2nd of March 2011. One of the repairs observed had a wastewater lateral above the watermain, and the watermain being repaired was in a pool of wastewater. The photographs attached below illustrate both this repair, and another repair which was being undertaken in a dry excavation.

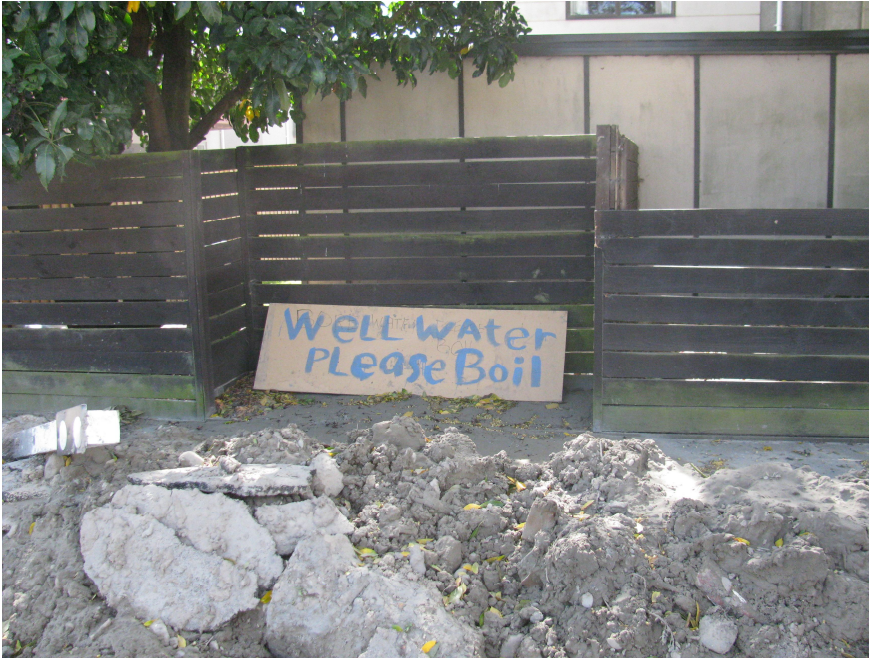
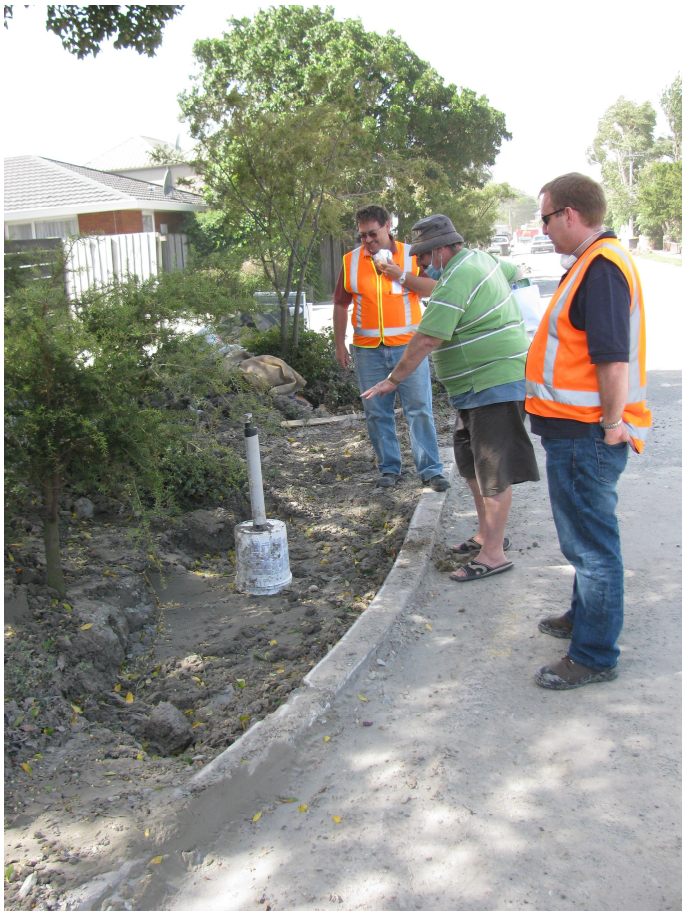
While water was off to some areas, the use of local private bores and “innovative” use of water leaking from pipes were used. This is illustrated by the photo below showing a plastic bucket and riser pipe that had been placed over a watermain leak and used to obtain water by residents. Private bores were also used as a primary water source, and were made available to other users.

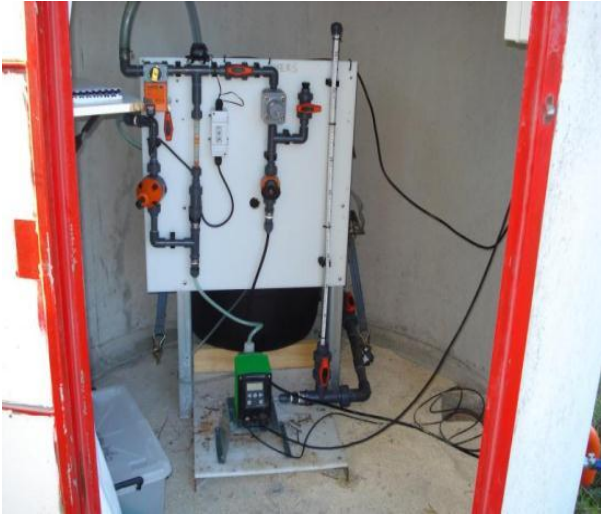
Dosing station installed in concrete container

Watercare from Auckland demonstrated their professional calibre. Their approach to design, procure, build and commission the 26 stations for dosing Sodium Hypochlorite reflected top level professional standards. The set up was clear and straight forward- tailor-cut for the task. The team was absolutely committed, working round the clock for about 3 weeks, offering their overtime for free to help Christchurch people in troubled times.

All the plants were built in Christchurch, tested and pre-commissioned in the workshop, installed on-site, tested and commissioned to check settings were okay and plants were working according to process design requirements. The time pressure got critical around process commissioning and start-up. There were just a few days left for the team on site. The stations were switched on without the opportunities to test run them for a given timeframe.
