INFRASTRUCTURE RESTORATION AND RESILIENCE AFTER NATURAL DISASTERS-WHAT CAN WE LEARN FROM CHRISTCHURCH, PACIFIC ISLAND AND AUSTRALIAN EXPERIENCES?

Steve Carne, GHD Ltd, New Zealand

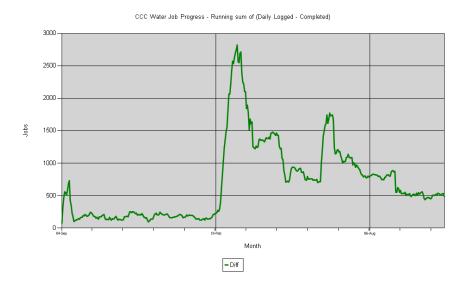
Figure 1 - Water Supply System Works Requests

Figures 1 and 2 illustrate this increase in demand for this work for the water supply and wastewater network respectively with significant differences apparent in the volume and timing of these requests.

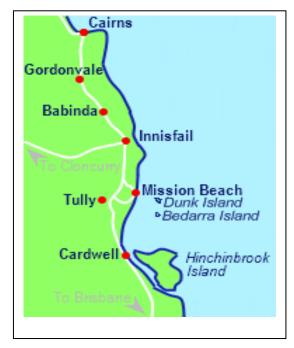
Figure 4 Cassowary Coast Region

As shown on Figure 4, The Cassowary Coast covers 4,701 square kilometres from Garradunga in the north to Cardwell in the south and the East Palmerston district in the west. Its major population centres are Innisfail, Tully, Cardwell and Mission Beach. The region is home to almost 30,800 people and hence is similar in size and population spread to a number of New Zealand councils.
