# AN INVESTIGATION WORTH ITS SALT: TARGETING SALINE INTRUSION

*T Osborn and L Sinclair:  
Dunedin City Council*

## ABSTRACT

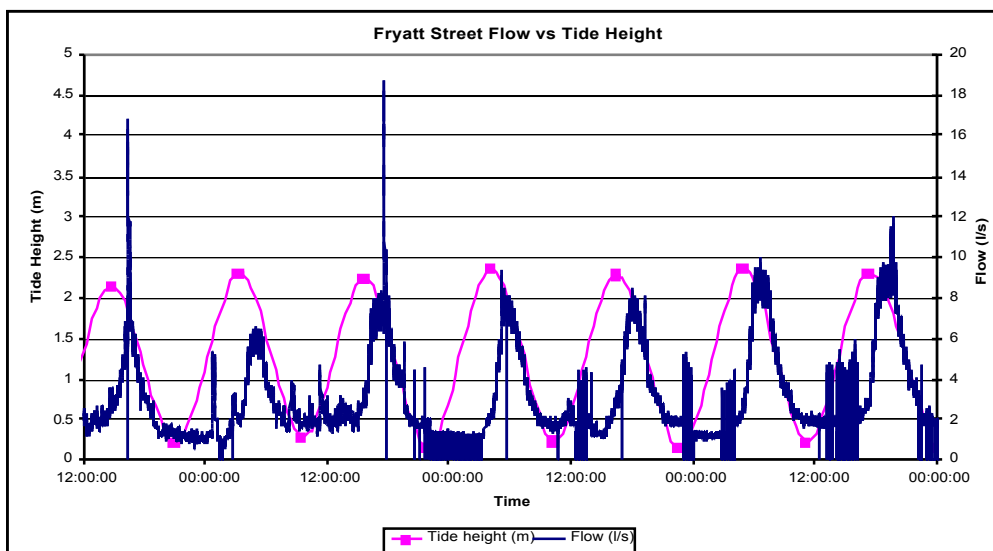
**Figure 4 – Correlation between tidal cycle and flow in the Fryatt Street catchment**

Figure 4 shows the correlation between the total flow and the tidal cycle that was typically found for the Fryatt Street catchment.

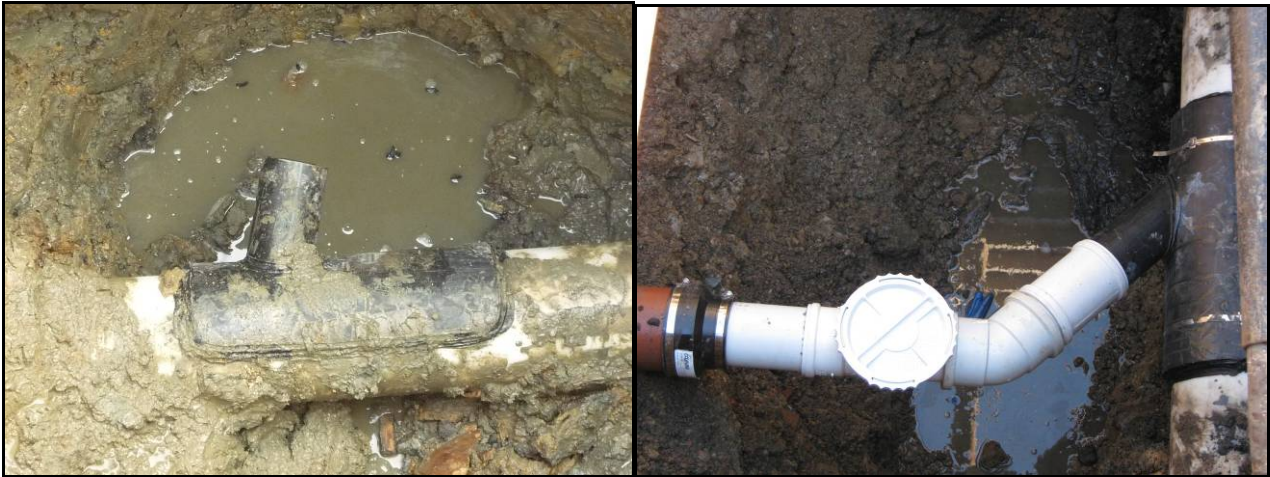
**Photograph 1 and 2 – The lateral junction repair on the Progressive Plastics lateral**

The sewers being repaired, in some cases, were old earthenware hosting an old PE liner which in turn hosted the spiral wound liner recently installed by Interflow. The preferred method of connection was to remove the crumbling old earthenware host pipe from the area; Hume bond the connection between the new liner and the PE liner (to stop water from tracking in behind the spiral wound liner); and then PE weld a Y-connection on to the outside of the PE.

This method is shown in Photograph 1 and 2, where the connection is conveniently located on the lateral connection belonging to the buildings of Progressive Plastics, who completed the PE weld. The junction was then strapped for additional security and connected on to the existing lateral well above the level of MHWS.

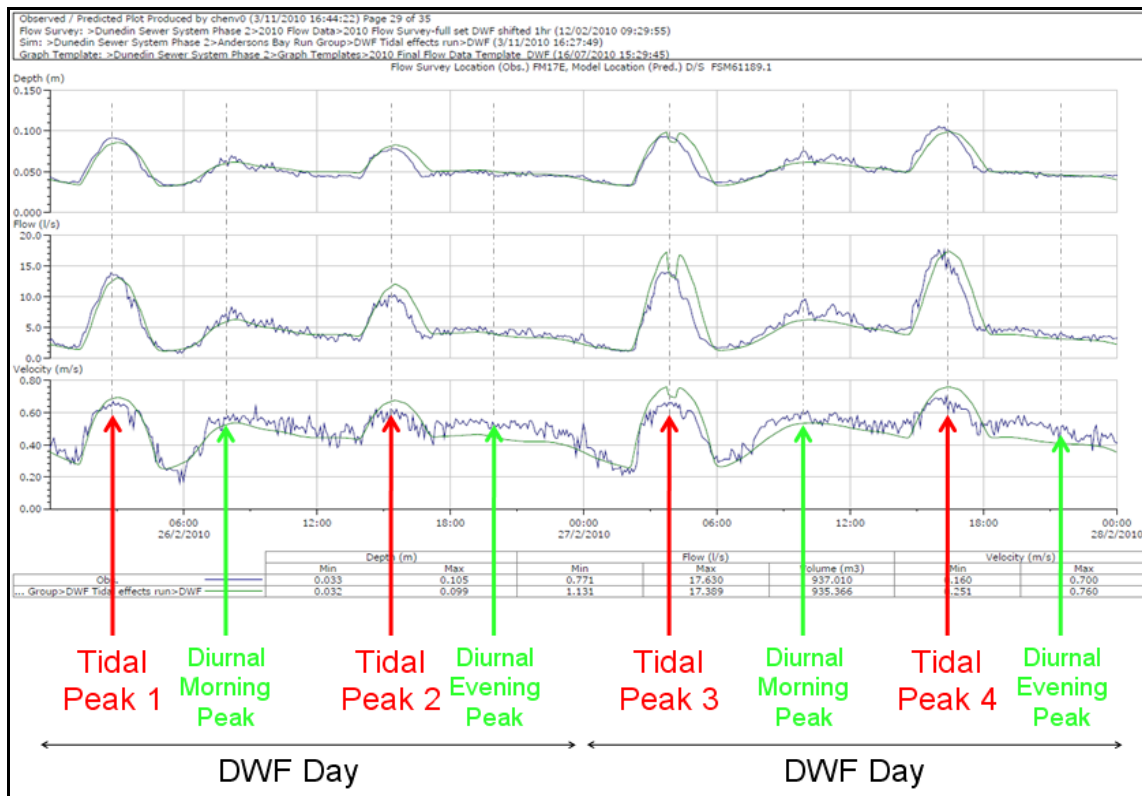
**Figure 6 – Results from flow monitoring of Marne Street**

Whilst work was underway in the Fryatt Street catchment, a flow monitoring programme was being conducted in the separate catchment of “Marne Street” for the purpose of model calibration. The monitoring identified a flow pattern which also appeared to closely mimic the tidal cycle of the Upper Harbour, a sample of which is shown in Figure 6.

Conductivity readings at the Marne Street site were almost 40,000 $\mu$ S/cm at peak concentration. This is within the conductivity range of waters of the Upper Otago Harbour and suggested that flow at this point and time was predominantly influenced by the water body. At this sampling point the contributing catchment is approximately 450 domestic properties and it was thought unlikely to be any significant saline influence from other sources.

The rapid increase to peaked flow at approximately 1 hour after high tide, lack of ‘flat top’ and the more gradual tail, with additional flow evident to approximately 4 hours after high tide suggested that the source of the additional flow was more likely to be multiple infiltration points than a single point inflow.

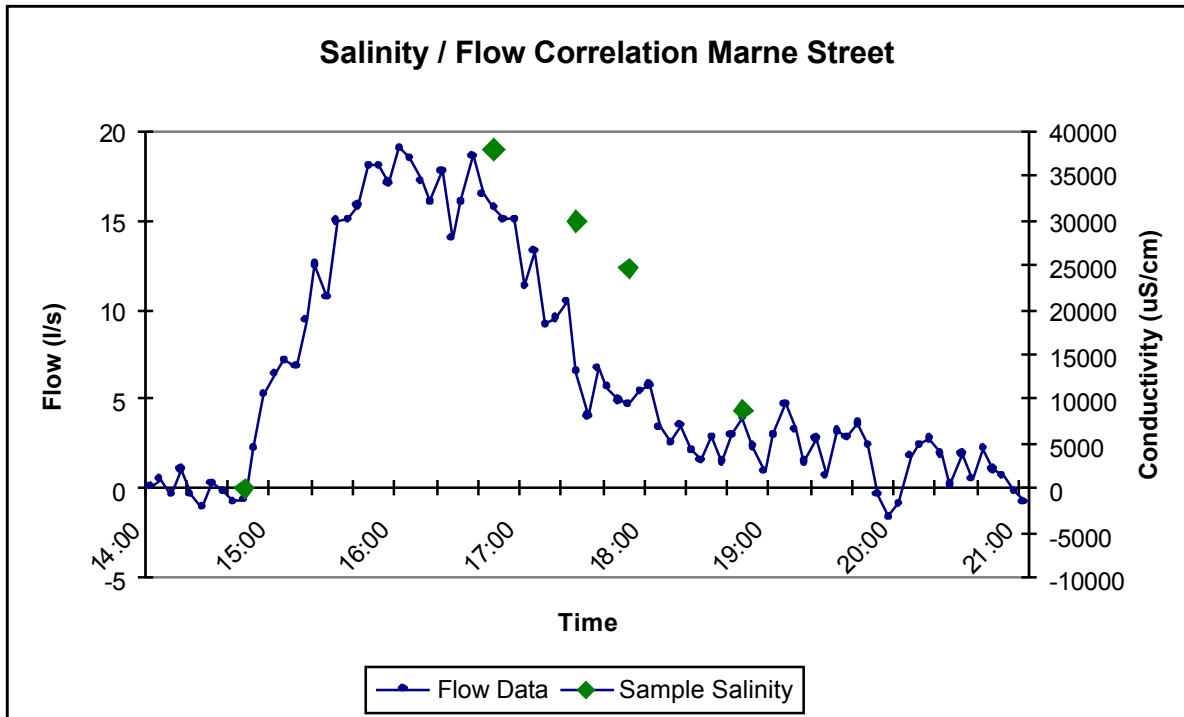
**Figure 7 – Salinity / flow correlation**

Grab samples were correlated with the flow data. Figure 7 shows the correlation between conductivity readings of the grab samples flow against the additional flow data over the same time period.

The strong correlation between conductivity and volume of additional flow suggests that it is almost exclusively attributable to saline inflow/infiltration.

The base flow to additional flow ratio also strongly reflected this. For example where 25% of flow was attributed to base flow and 75% to additional flow; the conductivity reading was approximately 30,000 $\mu$ S/cm. A reading you would expect from a 75% harbour water solution.

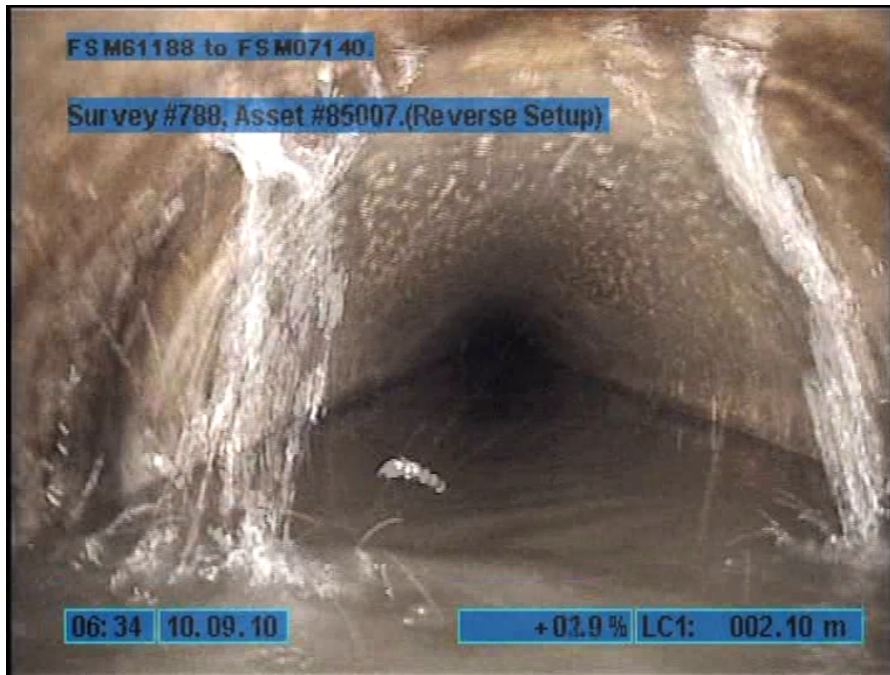
Photograph 3 – Still image from CCTV of the Marne Street line

Subsequent CCTV inspection at high tide identified the cause. Multiple points of saline intrusion were visible along the 1.4km of sewer, with almost every joint contributing at least some volume (see Photograph 3).

The initial relining contract in the Fryatt Street area had been generally successful. The Marne Street area comprised of 1.4km of sewer that needed rehabilitation with only 10 connections, subsequently the contract was awarded to Interflow to apply the same technology.

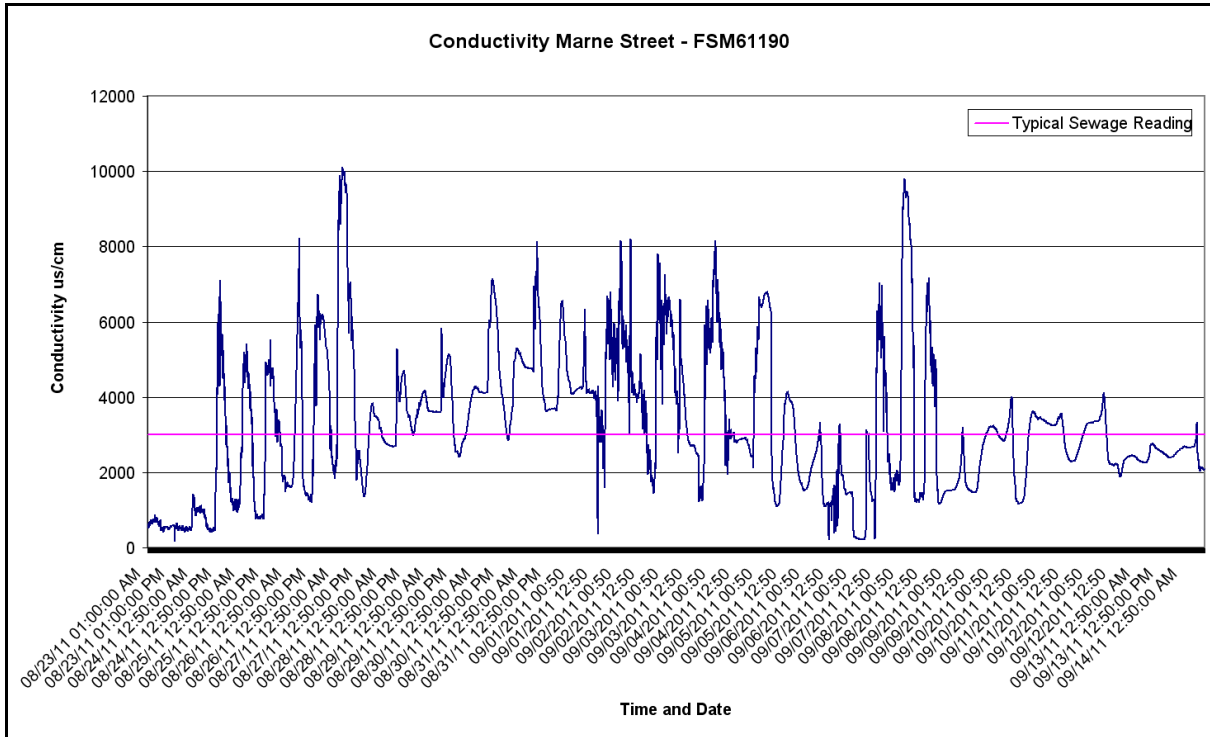
**Figure 9 – Marne Street conductivity following relining works**

Following the completion of the works both the flow and conductivity of the sewer was significantly reduced; however, there was still an element of saline influence evident, manifested in readings as high as 10,000 $\mu$ S/cm, suggesting a 20% to 25% solution of harbour water (see Figure 9).

It was noted during the relining and subsequent re-sampling works that a number of manholes were the cause of infiltration. Initial repair work consisting of copious grouting was carried out as a temporary fix on the manholes that were assessed as being in the worst condition.

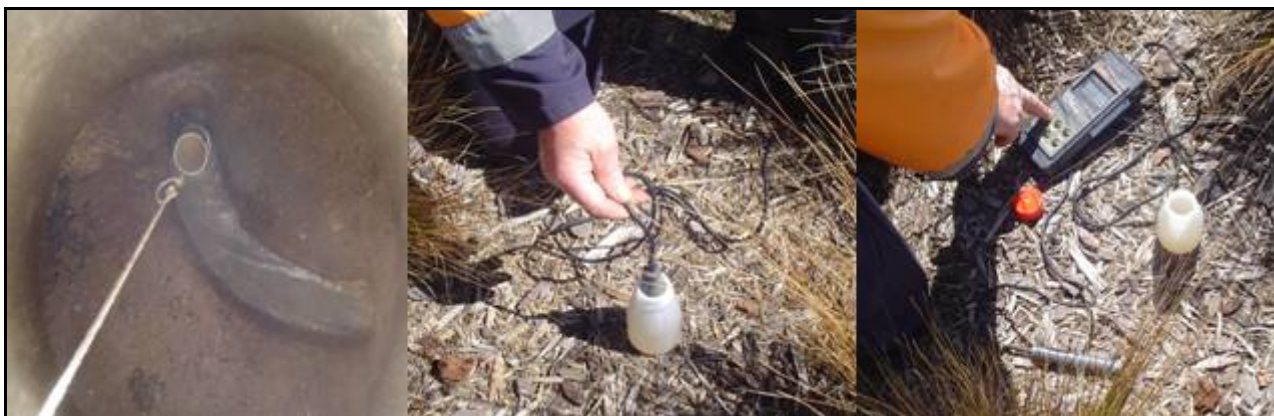
**Photograph 4, 5 and 6 – Sampling procedure**

The desk top study focused on establishing manageable catchments to review during these sampling windows. The first round of testing involved taking a conductivity meter to site and testing each sample as it was retrieved. Taking samples involved a piece of simply engineered capped pipe on a string; excellent alignment skills and great patience (see Photograph 4, 5 and 6). Results were noted against the sample time, location and commentary on the flow conditions. This method covered a significant catchment area and highlighted issues for further investigation. However, a single reading was not sufficient other than to signal further investigations and a low conductivity result could not always be completely ignored as the timing of some samples was critical.

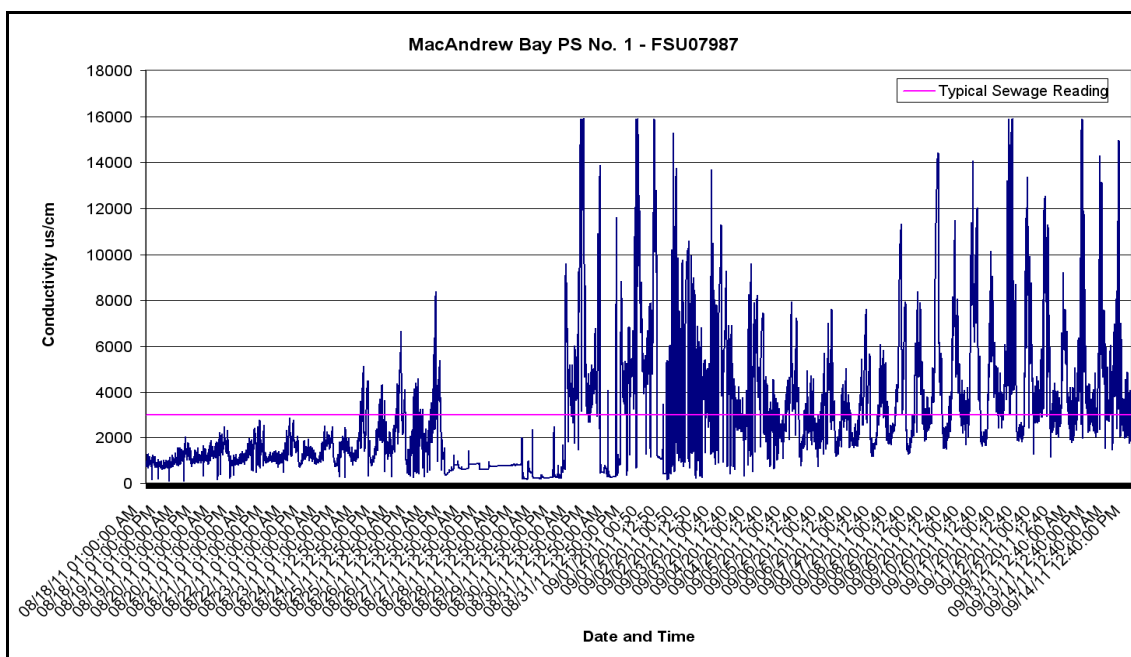
Figure 10 – Example data from the long term monitoring

The benefits were two fold in that it would enable assessment of sites that had lower conductivity readings; and it would enable the severity of the intrusion to be established across a longer timeframe. In addition these monitors would provide confirmation that works carried out at specific locations had successfully reduced conductivity (see Figure 10).

In a number of locations; the first set of results that were retrieved showed readings that were beyond the conductivity range of the meters, manifested as 'flat tops' on the graphs. The long term monitors were based on an existing model located at the Tahuna WWTP and hence were not equipped to measure highly concentrated saline water. In order to monitor the anticipated reduction in conductivity as repair work was completed a number of locations had a second monitor installed to cover a higher range of conductivity.

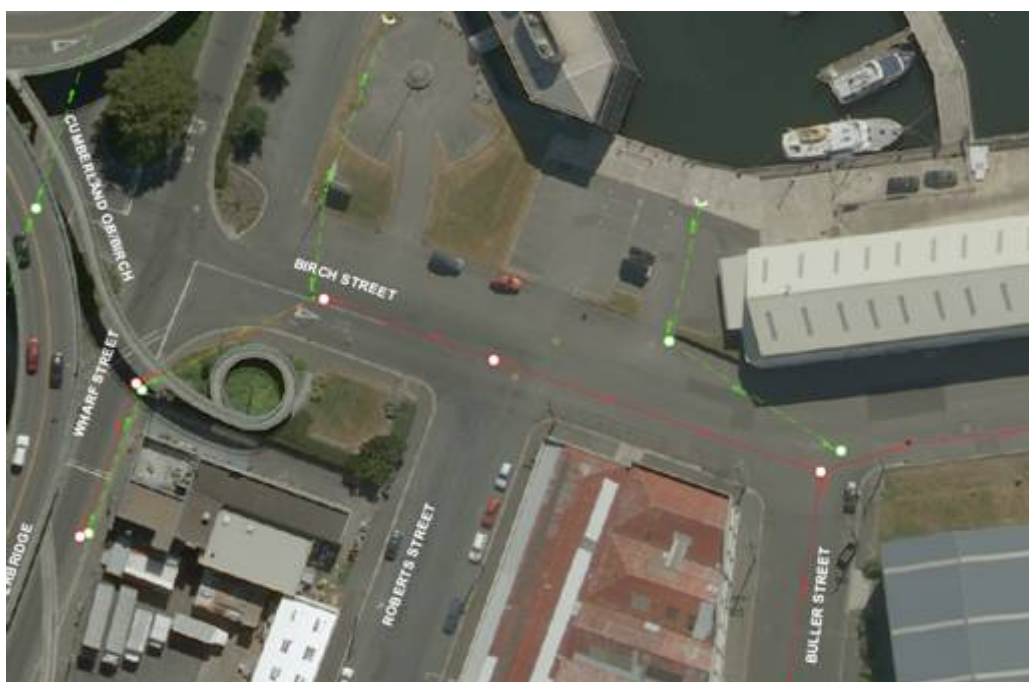
**Figure 11 – The Birch Street Area**

The catchment known as ‘Birch Street’ was investigated following high conductivity readings in the sampling programme (see Figure 11). This area was also subject to a trade waste query following the site visit as the elevated conductivity at low tide seemed to be related to a trade flow.

The flow in the sewer was a milky colour and investigation was required to determine if the salinity was generated from the known trade waste customer located upstream or whether there was a saline intrusion issue from the harbour at various states of tide. The answer was the later.

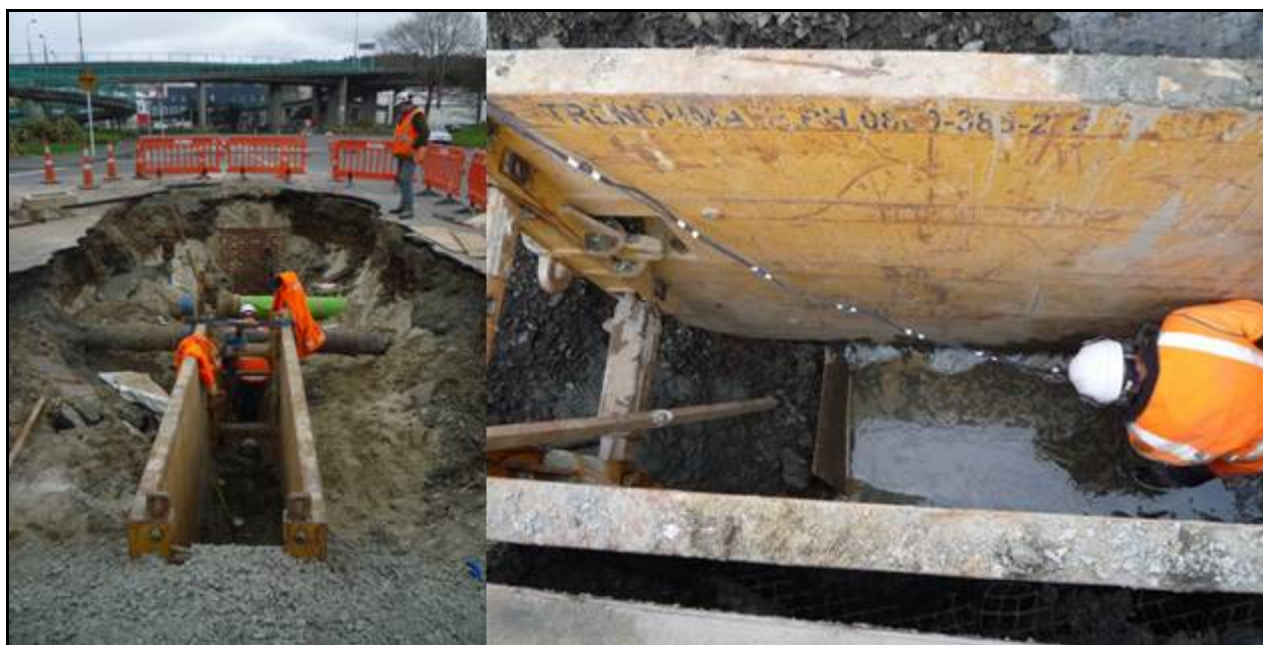
**Photograph 7 and 8 – Photos of the Birch Street dig and lay of 80m of 225mm foul sewer**

This project has been slow work due to the poor ground conditions; particularly the running sand which visibly 'oozed' up underneath the trench shield. These conditions are clearly evident in Photograph 7 and 8 with the ground literally opened up. The 300mm diameter distribution water main that can be seen crossing the trench had to be shut down and temporary feeds set up. The original sewer was installed on B haunching of reinforced concrete and rather than remove this altogether the old pipe was removed and the new ceramic pipe was installed in its place using the original bedding.

The trench fills with water and then drains again with the rising and falling tide but interestingly the salinity of the trench water varies significantly. This suggests that groundwater is forced up into the trench initially, followed by the saline harbour water as the tide rises. This relationship is likely to vary between wet and dry periods and would therefore dictate conclusions from sampling results taken at these different times.

The short turnaround required for this project and the availability of Interflow resulted in relining not being a viable option. A dig and lay contract was awarded to Delta and at the time of writing the replacement of 80m of 225mm diameter sewer is in its fourth week.

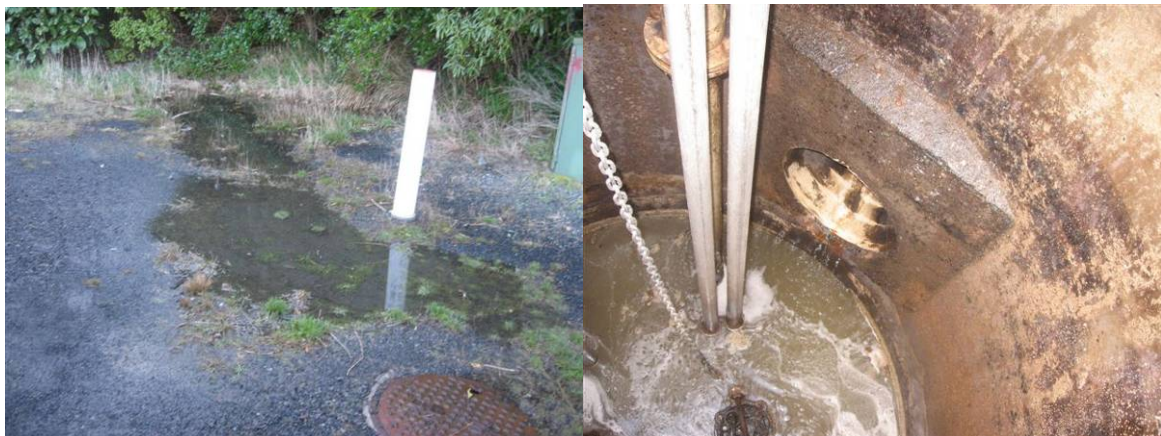
Site visits to obtain samples at high tides also revealed other obvious issues. At one particular pump station location it was evident that ground water (potentially saline) was bubbling up through the surface, ponding and draining through manhole covers. A sample was taken and resulted in a reading of 55,500 $\mu$ S/cm – significantly saline. During the site visit the bubbling ground water did dissipate and stop draining through the manhole covers. Without being at this specific location at the peak point of a high tide this aspect could have been missed. Discussions with operational staff during this visit resulted in confirmation that this had been seen in the past and was a known issue. This pump station also has wet well and upstream manhole issues so further investigations are being under taken (see Photograph 11).

During sampling of another pumping station wet well it was clearly visible that the joint of the wet well with a large diameter storage line had significant infiltration. A sample was taken and resulted in a reading of 55,700 $\mu$ S/cm. This pump station is undergoing further investigation to review the wet well for points of infiltration other than the clearly visible location (see Photograph 12).

**Photograph 11 and 12 – Upwelling of tidally influenced groundwater and saline infiltration in a wet well**
