HAMILTON'S WATER TREATMENT PLANT– A REVIEW OF RECENT PERFORMANCE

M. Porter, Water Operations Manager, Hamilton City Council
R. Rose, Principal Engineer, GHD

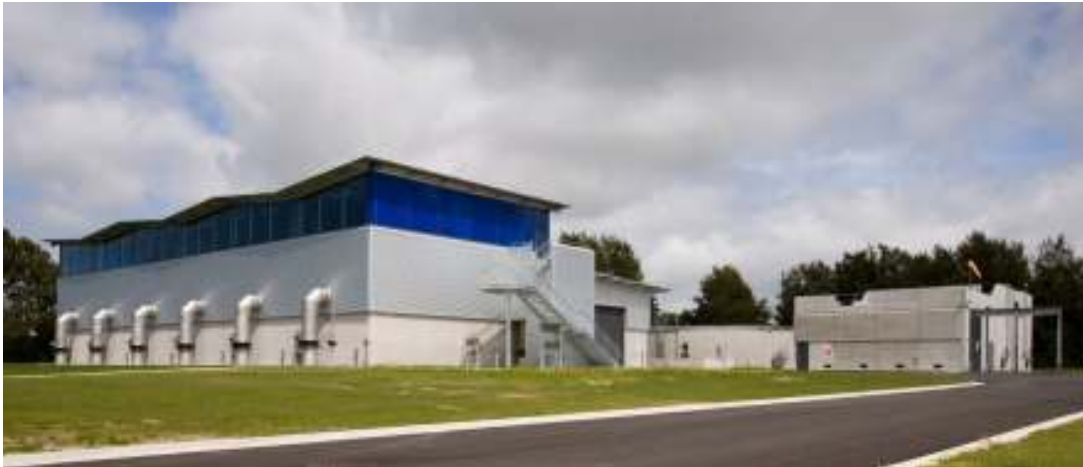
Photograph 1: Overall Upgraded Facilities

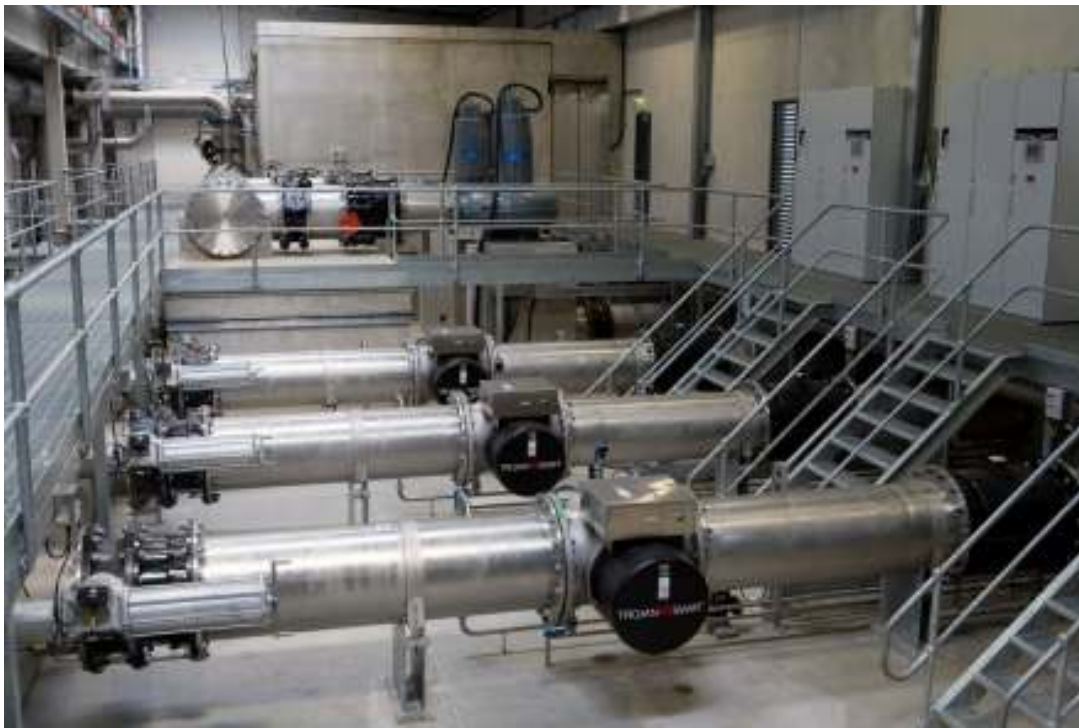
Photograph 2: The UV Units

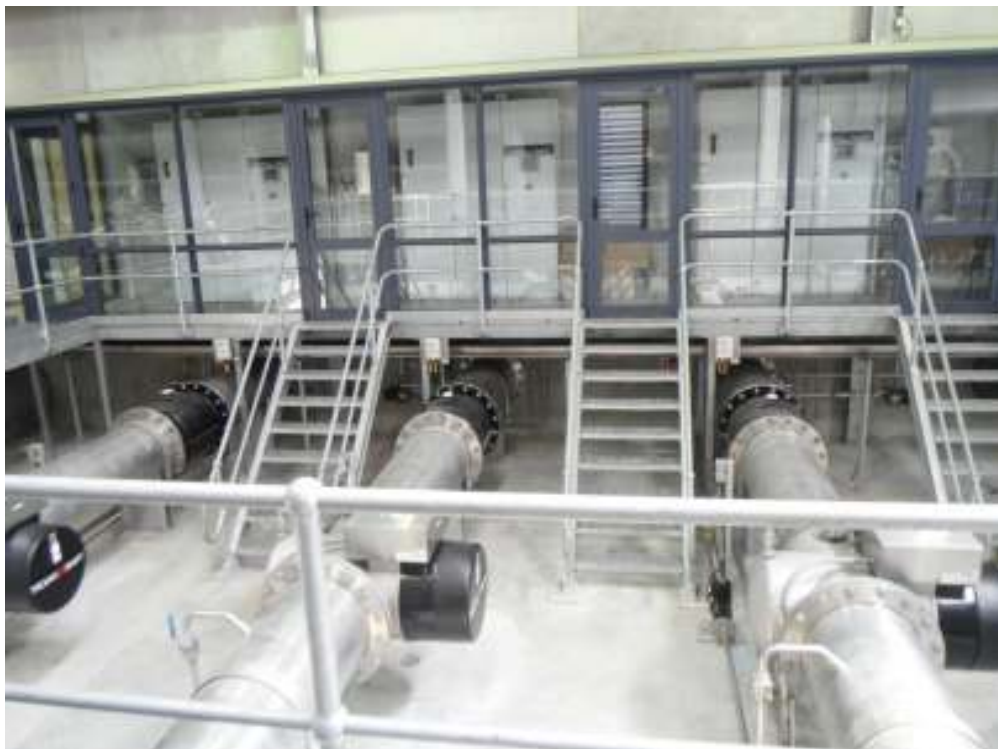
Photograph 4: UV Ballast Covers

- The entire GAC filter and pipe gallery building was designed to be naturally ventilated, however it still experienced very high humidity levels inside the building. This resulted in repeated issues with the ballast units for the UV system and was identified as potentially compromising warranty provisions. To better control moisture in these ballast units air-conditioned glass enclosures have been built and placed over the UV units. This is illustrated in Photograph 4 below.

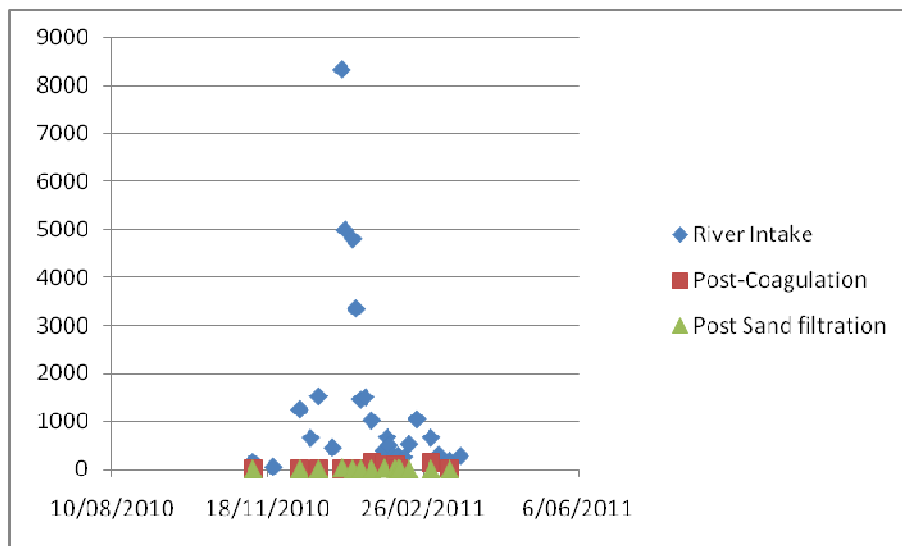
Figure 5: Overall Number of Cyanobacteria Algal Cells in Samples during the 2010-2011 Summer Event by Location at Hamilton WTP

Figure 5 shows the overall numbers of blue-green algal cells per ml through the season at various points through the treatment train.

As can be seen from Figure 5 the intake algal cell count peaked at just over 8000 cells/ml and the treatment plant achieved good removal of the physical cyanobacteria cells through the coagulation and filtration process., However cell counts in the upper Waikato River system exceeded a level of 60,000 cells/mL as can be seen in Figure 6.
