WAIHI BEACH COASTAL PROTECTION CONSEQUENCE OF 1930'S STORMWATER CONTROL MEASURES

Kelvin HILL / Western Bay of Plenty District Council, Glen NICHOLSON / Tonkin and Taylor, Christian DULLNIG / Western Bay of Plenty District Council

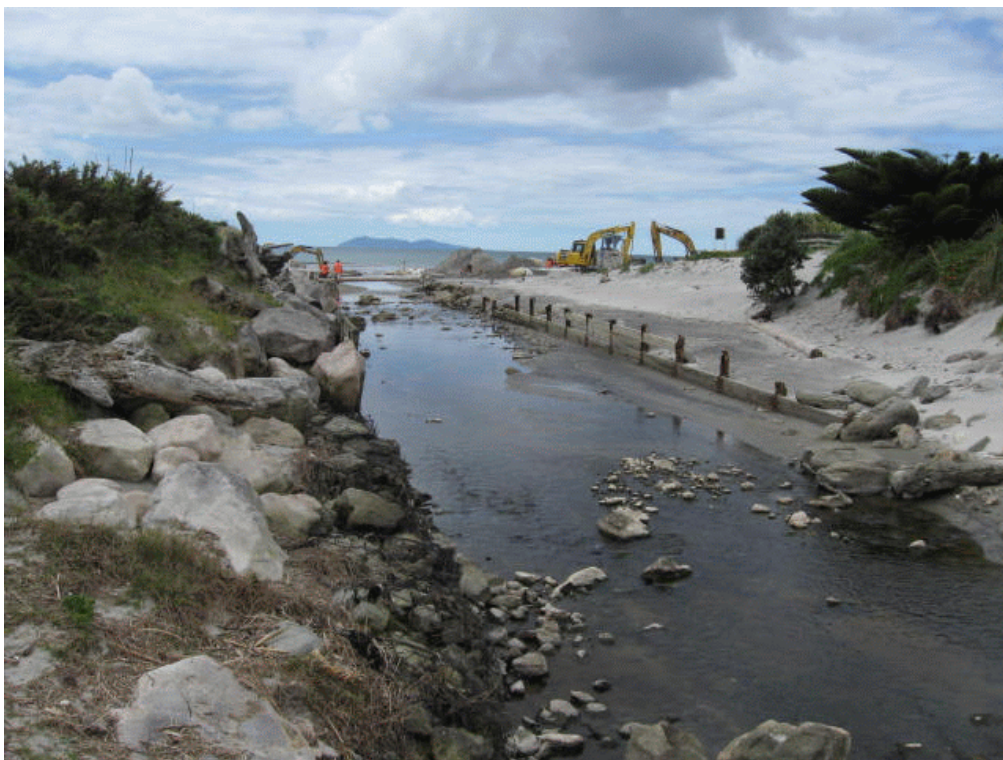
Photograph 1: Three Mile Creek during construction

The Three Mile Creek outfall was causing ongoing erosion of the adjacent dunes, especially during storm events. The built training groynes effectively relocated the mouth of the creek seaward to ensure an uninterrupted flow of stormwater through the frontal dunes. The physical works for this part of the coastal protection measures were completed in December 2009.

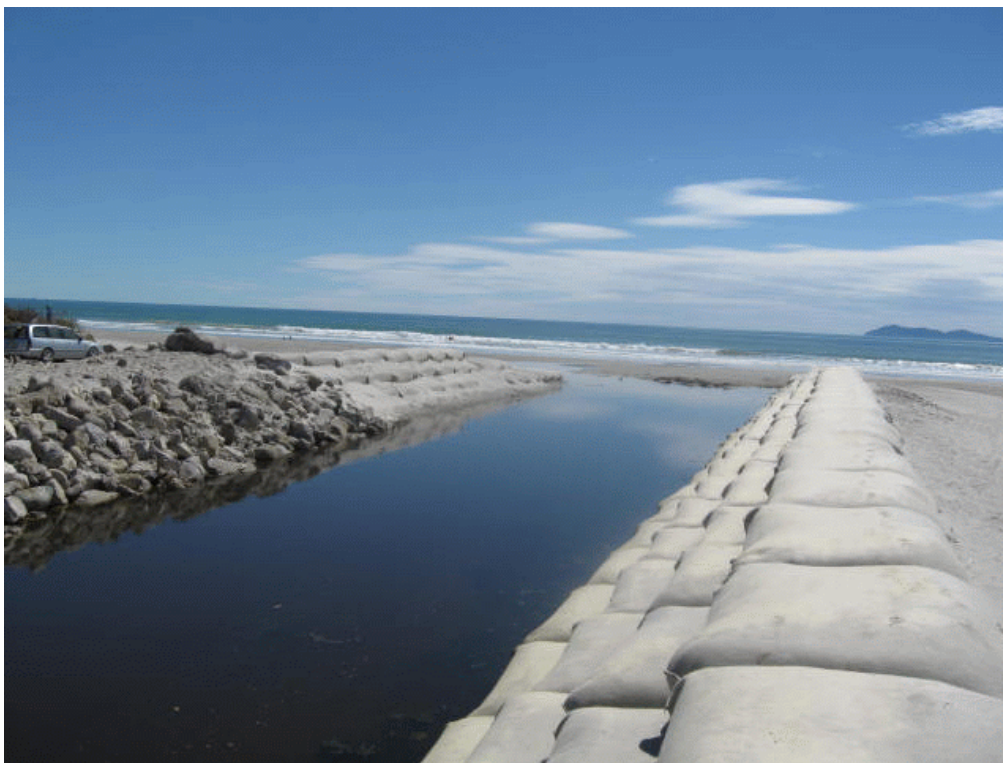
Each side of Three Mile Creek now has a groyne wall, 12m high and 3.25m wide, constructed of geosynthetic containers filled with 4.5 tonnes locally derived beach sand. Each bag has the dimensions 2.4m long by 1.8m

wide by 0.65m high. This was the first time a specially designed geo-composite container of this size, weight and configuration has been used in New Zealand.

Photograph 2: Three Mile Creek after construction

Excavation of the beach was required to found the bags an adequate depth to minimise the potential risk of underscour. The southern groyne extends a distance of approximately 50m from the former creek mouth and the northern groyne is some 10m shorter (40m long).

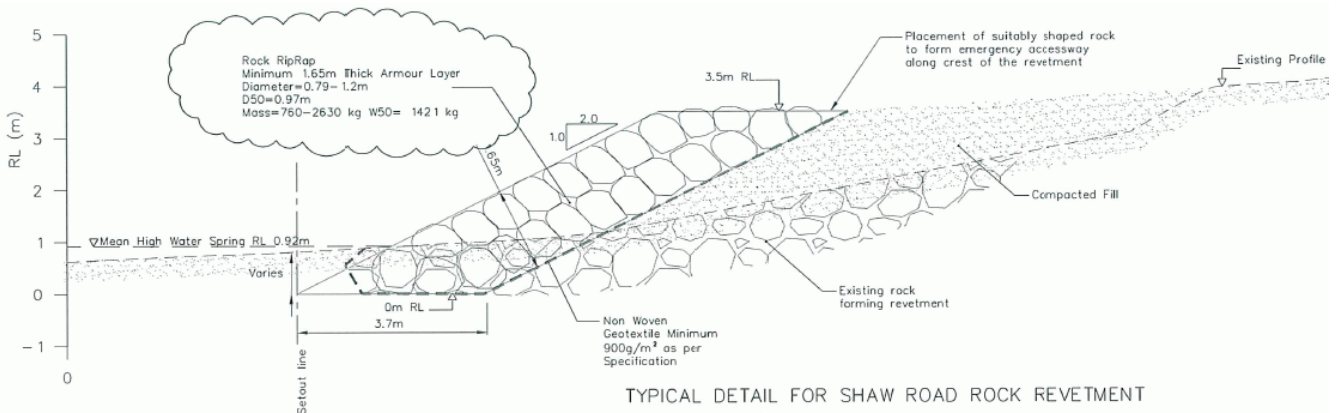
Figure 2: Typical Detail Rock Revetment Shaw Road

The section of shoreline affected by the **Rock Revetment** is approximately 1,050m long and was characterised by the extensive tipped rock situated both seaward and behind a defunct steel and timber seawall. The construction works required the excavation and construction of a rock revetment within the remnants of the existing frontal dune and the rehabilitation of the existing rock wall where no dune existed. The works were located both within Council reserves and private properties.

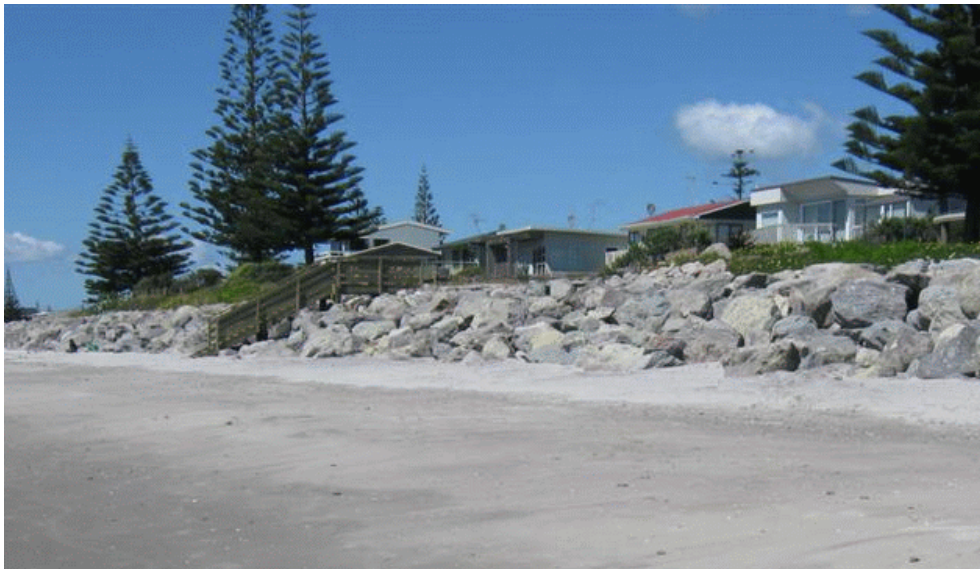
Photograph 3: The Loop after construction

The rock revetment along The Loop (see photograph 3) was finished at Labour Weekend 2010. By comparing the designed / constructed revetment with the old ad hoc erosion protection (see photograph 4) it becomes obvious that the shoreline protection measures improved the landscape, amenity value of the beach and public safety whilst accessing and enjoying the beach environment.

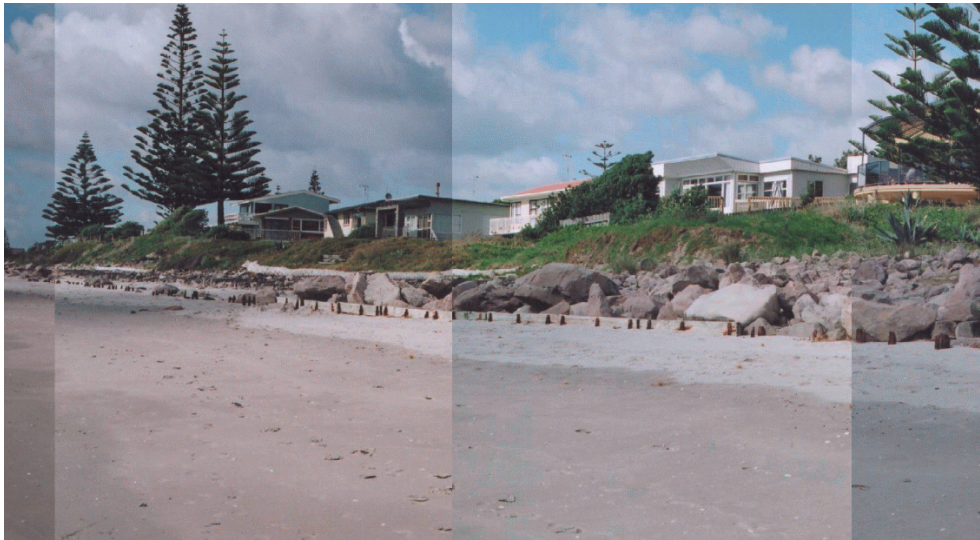
Photograph 4: The Loop before construction

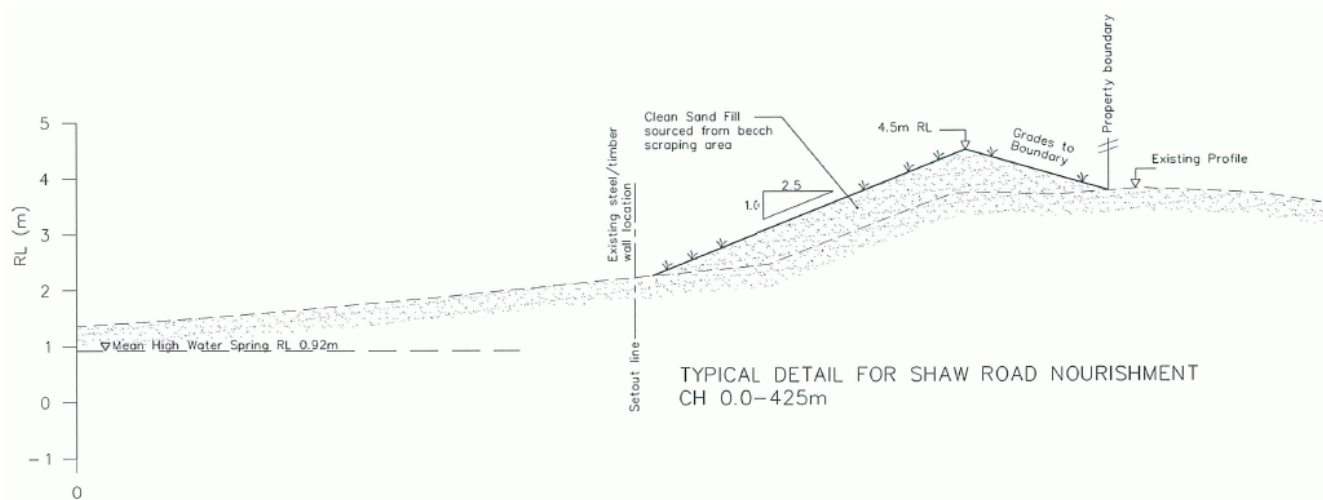
Figure 5: Typical Detail Dune Enhancement Shaw Road

timber seawall. The front dunes were rebuilt with a crest level of 4.5m RL, generally matching existing ground levels, but sometimes being up to 1m above the existing ground level.

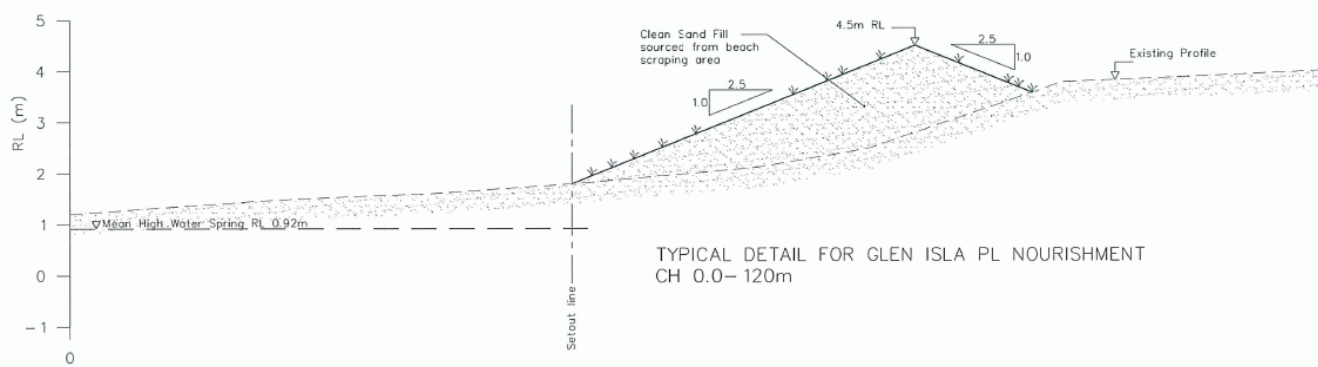
Figure 6: Typical Detail Dune Enhancement Glen Isla Place

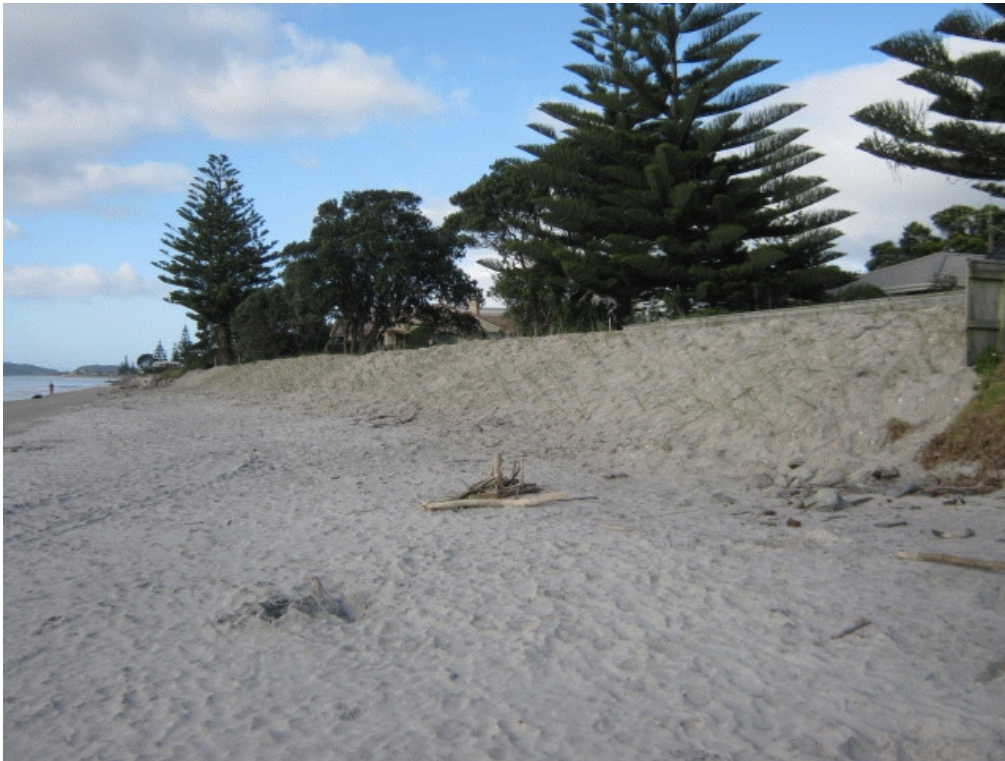
Photograph 5: Dune replanted during School Planting Day, 18th May 2011

Sand fencing and replanting of the dunes took place soon after the enhancement was completed. Spinifex, Pingao, Pohuehue and Wiiiwii were used for the planting, the dominant species being Spinifex.

Most of the planting had been completed, when Waihi Beach experienced a series of significant storm events in late June which destroyed more than half of the replenished dunes.

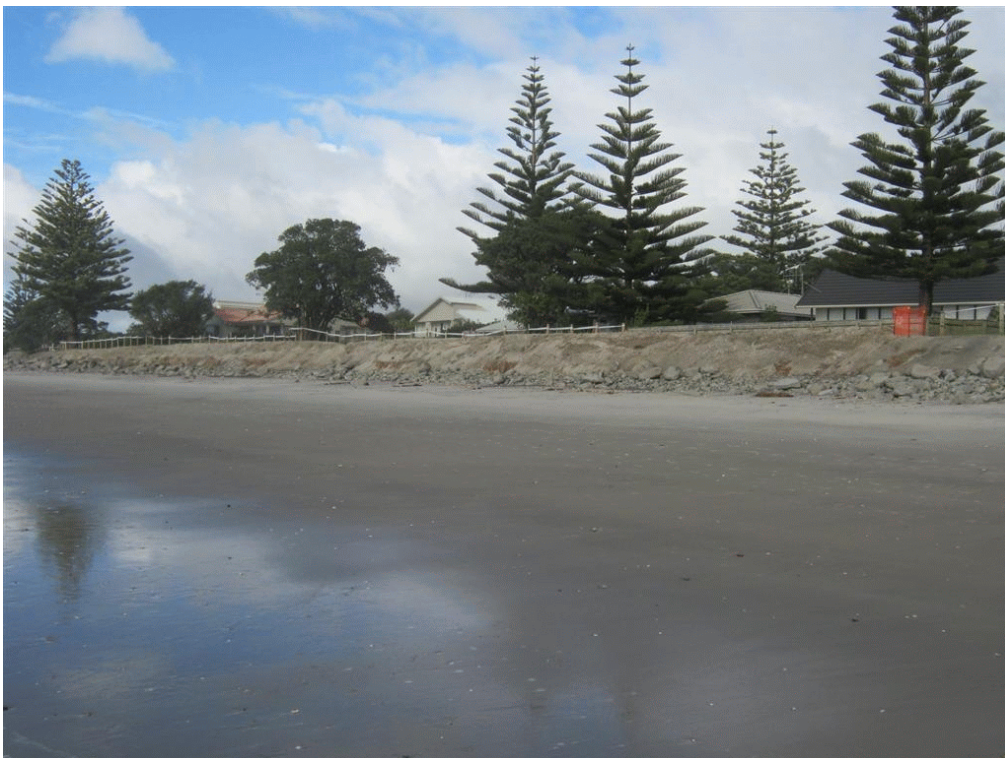
Photograph 6: Dune replanted during School Planting Day after the storm events

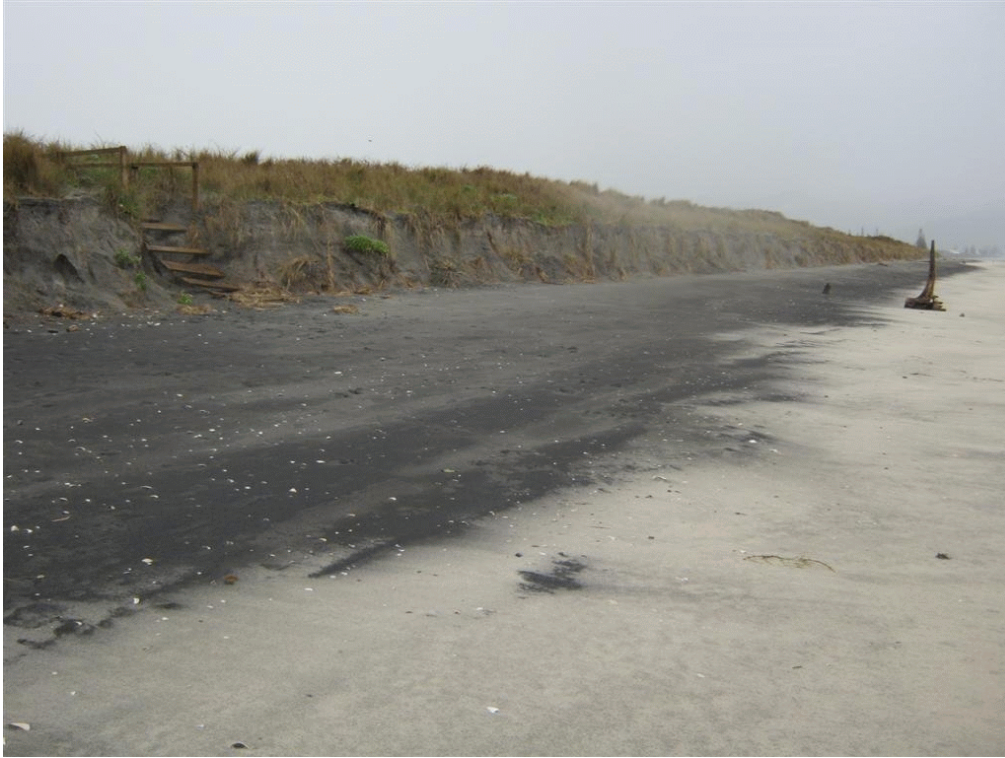
Photograph 7: Dune erosion near Beach Access 27 (outside work area)

Low beach levels and dune erosion were a common occurrence at that time along the entire Bay of Plenty coastline. The cause for these phenomena was likely to be a combination of a number of factors, including:

- Seasonal variance with the beach being lower in winter than in summer.
- Sand wave mitigation along the Waihi Beach shoreline.
- La Niña climate cycle causing above average easterly winds / waves and increased frequency of storm events.
- Tidal levels near their highest following a natural 18.6 year tidal cycle.

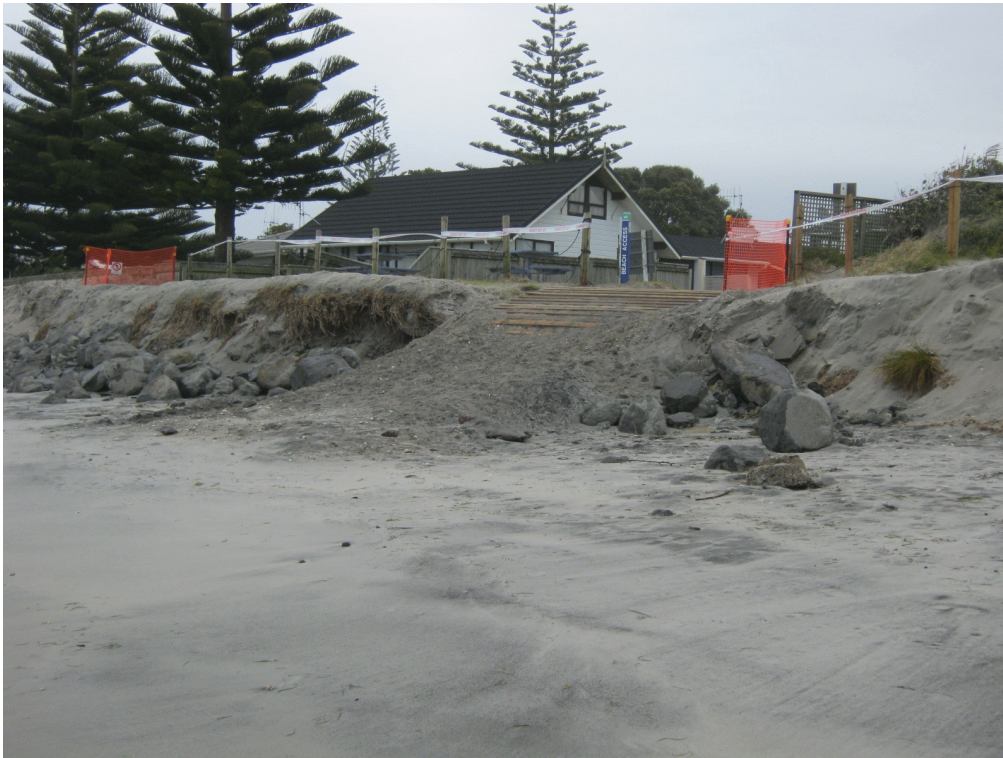
Photograph 8: Dune erosion at Beach Access 14 (inside work area)

The low beach levels then caused another issues, exposed rocks previously buried beneath damaged dunes required removal. There was a view held by some members of the community that the previously covered rocks were the main reason for the beach lowering and dune damage.

Council's engineering consultants, T&T advised the rocks provided some protection against erosion, though minimal, and should be left on the beach. Even with the rock being of mixed size and generally undersized to provide effective ongoing erosion protection, the rock was noted to provide a marker for coastal erosion and some minor energy dissipation during extreme high tide events. With regard to ongoing management of the shoreline fronting the dune enhancement, T&T suggested:

- Remove any exposed gabion baskets and steel timber retaining structures.
- Retain rock that was originally located behind the steel and timber retaining structure.
- Relocate rock, greater than 200mm, to the base of the dune, should rock be dispersed on the upper beach.

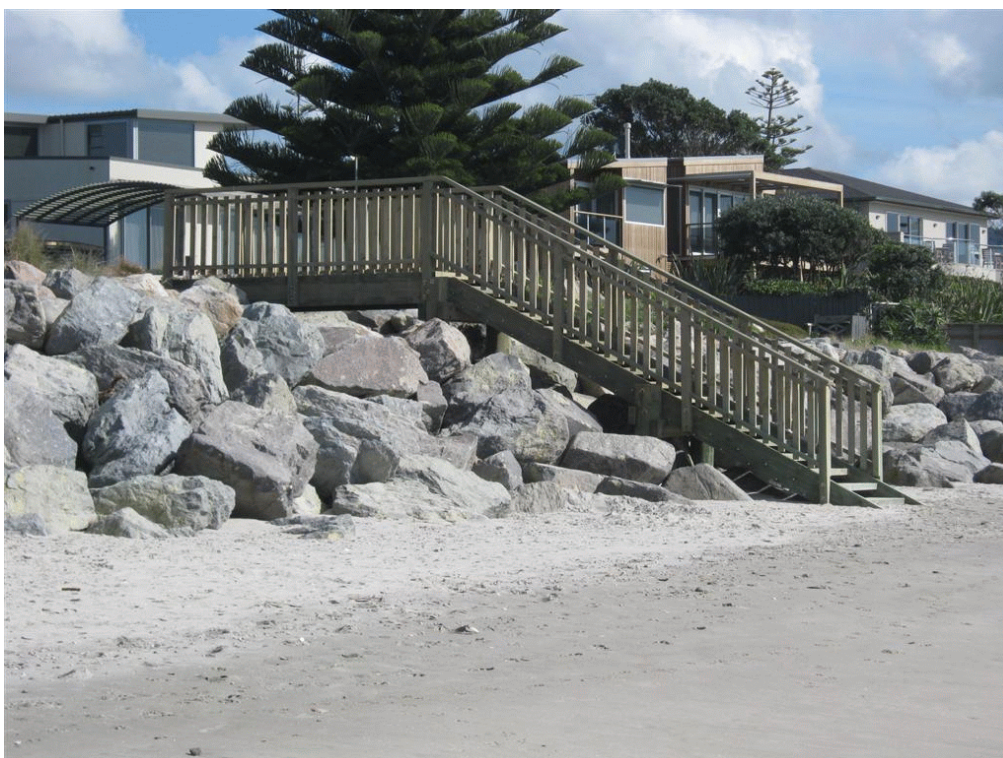
Photograph 9: Public Beach Access 21a

- Property owners adjacent to public beach access points are expected to utilize the formal access structures.
- Along the revetment, beachfront owners can use the emergency exit / informal access points (flat rock stairs) to get off / onto the beach (1 access point per 2 properties).
- Beachfront owners behind the enhanced dunes will share 1 access point between 2 (3) properties with a short fenced walkway to get to the access where required.

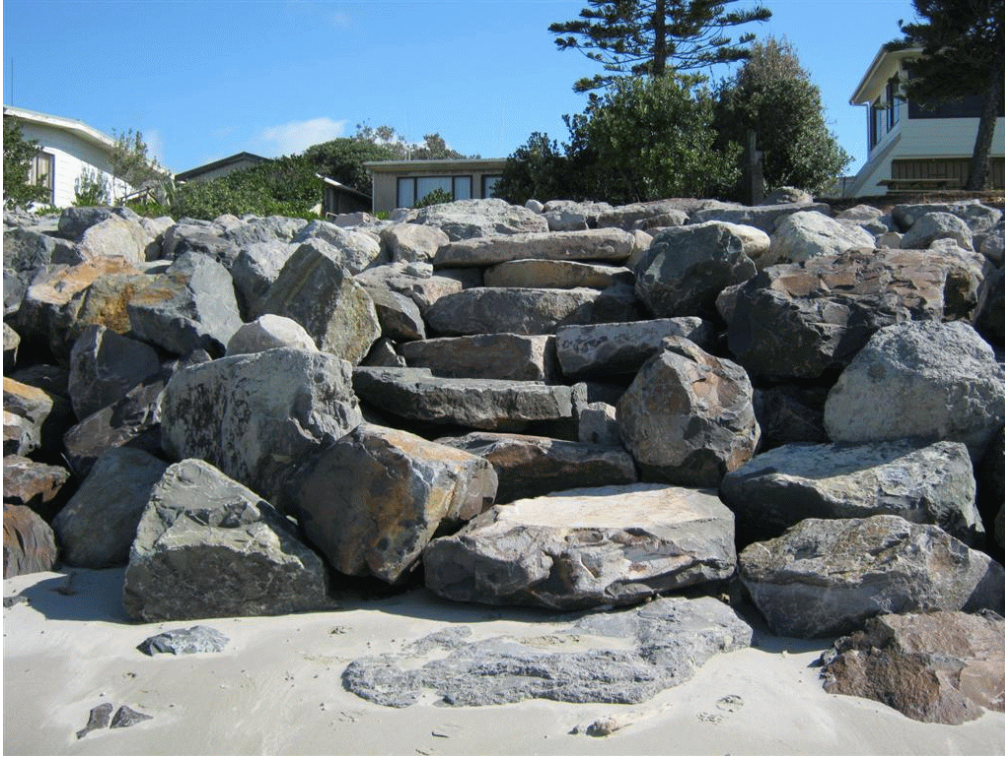
Photograph 10: Emergency Exit / Informal Beach Access 85 / 87 Shaw Road

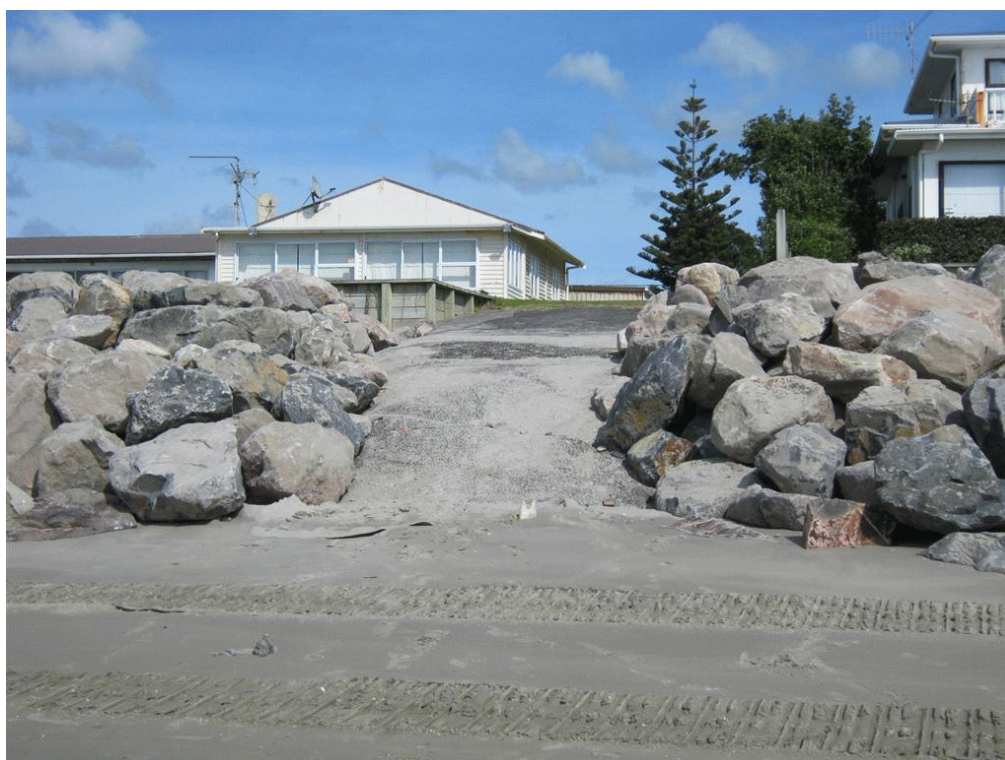
Photograph 11: Boat Ramp and finished revetment at 81 Shaw Road

- The owner grants access to his property to construct the rock revetment and an easement for future maintenance access, on the basis that the existing concrete boat ramp be incorporated in the design;
- The property owner provide written consent of his immediate neighbours to the retention of the ramp;
- It be agreed that if the ramp subsequently fails or the revetment becomes at risk because of it, that the property owner would pay for removal of the concrete ramp and Council would install the rock revetment in the format used in the balance of it.
