Remuera branch 1 & 2 rehabilitation 2009

MPG Lubbock, Principal Engineer, AECOM New Zealand Ltd

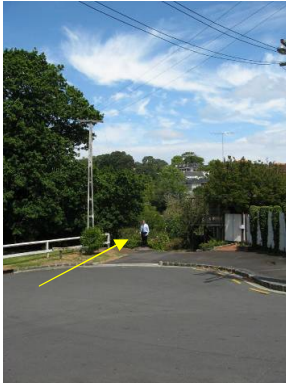
Figure 15 shows the location of MH05 in the front garden of a private property at the end of Sonia Avenue. This road is a quiet residential cul-de-sac, and it is an unsuitable location for a CIPP lining manhole since working room around it is very restricted and it lies under overhead power lines. There is also very little freeboard at this manhole, and it lies next to a wetland and stream. Similarly, MH04 lies in the front porch of the house shown in Figure 16, so it is totally unsuitable for use as a CIPP installation manhole.

Figure 15 MH05, Sonia Ave

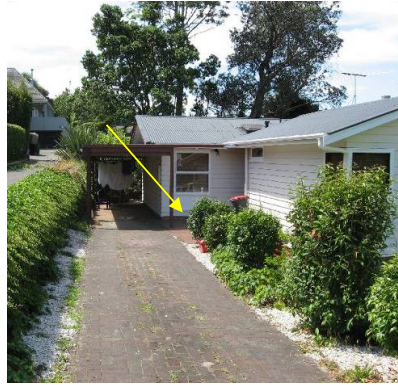
Figure 16 MH04, Sonia Avenue

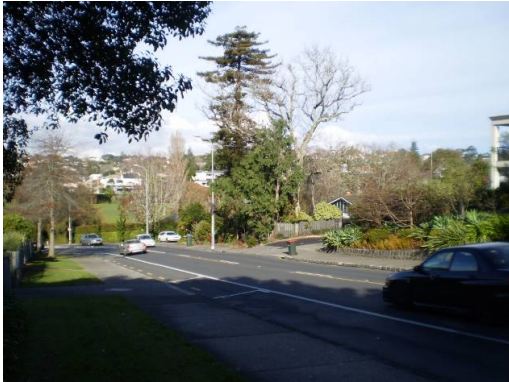
Figure 17 shows the general location of MH03. It lies in the residential property in the middle of the photo, halfway down a right-of-way which gives access to several other properties. As a result of this inaccessible location, this manhole is totally unsuitable for use as a CIPP insertion manhole.

Figure 17 location of MH03, Shore Rd

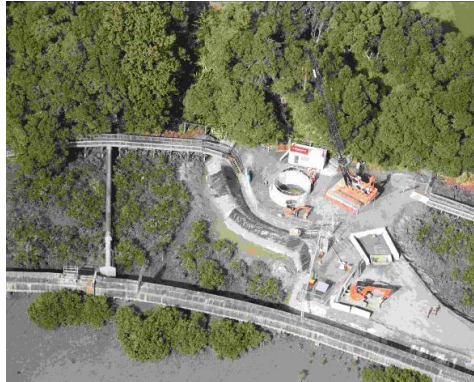
MH01, within the boundaries of Fletcher Construction's site for Project Hobson. This manhole was also inaccessible to vehicles. This manhole could therefore not be used for CIPP liner insertion, and even the minor finishing works at this manhole required all the necessary equipment to be carried to the location by hand, over a considerable distance.

Figure 18 MH01 location- in Project Hobson site

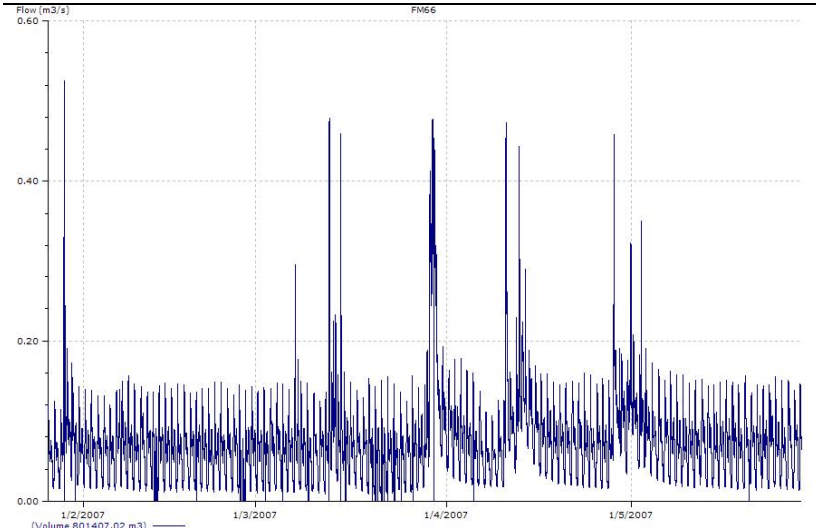
Figure 19 below shows a snapshot of the data obtained at MH03 during February 2007. The peak dry weather flow at this location is about 160 litres per second (l/s), but the flow rises to about 500 l/s during rain events.

Figure 19 – MH03Branch 1 flow monitor data excerpt, February 2007

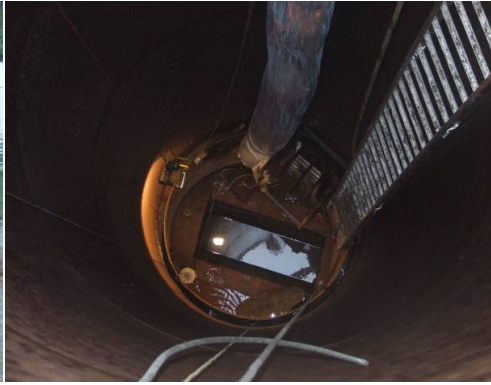
Figure 30 Sewer crown opened up

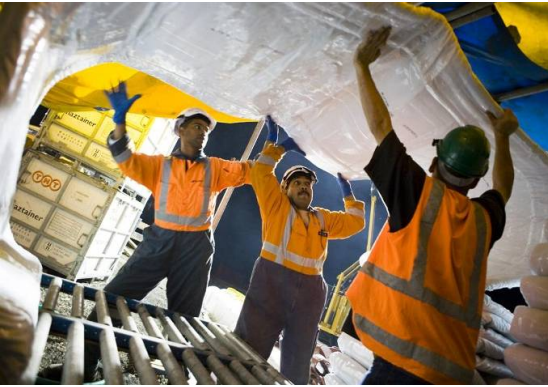
Figure 33 Liner preparation for impregnation

Figures 33 to 36 show the sequence of events involved in getting the resin into the liner tube. In figure 33, the crew are manhandling the liner off its delivery pallet, onto the impregnation conveyor. The liner is dry at this point, but vacuum has been applied to extract air from it, in preparation for resin addition. This makes the liner very stiff and unwieldy. Figure 34 shows the liner in position on the conveyor, with vacuum hoses in place. The vacuuming operation can take many hours, since all air must be removed from the liner before the resin is pumped into it. (air inclusions will reduce the strength of the finished liner)

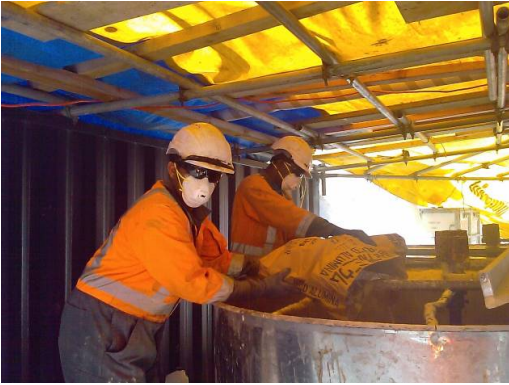
Figure 35 Resin mixing

Figure 35 shows the resin mixing taking place, and illustrates well the scale of this operation, in which approx 35 tonnes of resin were used to impregnate the liners on Branch 1. Many separate batches of resin had to be prepared to fill the liners used in these insertions, and a high degree of attention to detail is required to ensure effective coordination of the insertion and impregnation processes during on-site impregnation. Figure 36 shows the resin being pumped into the liner.

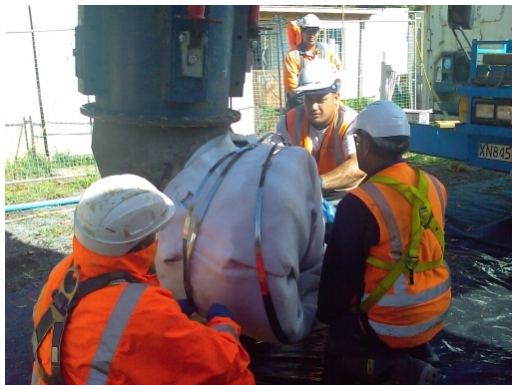
Figure 37 Liner attachment to steel chute

Figures 37 to 40 show how the liner is introduced into the sewer. After the first part of the liner has been filled with resin, it is passed through rollers to control the quantity of resin per metre of liner to the correct amount for the thickness required. It is then taken through a steel chute, as shown in figure 37, which is used to turn the liner nose through 90°, so that it will run horizontally within the sewer. Note how the liner is turned inside out at this stage, so that the resin-bearing side is now the outside surface, and the coated side is now the inside surface.

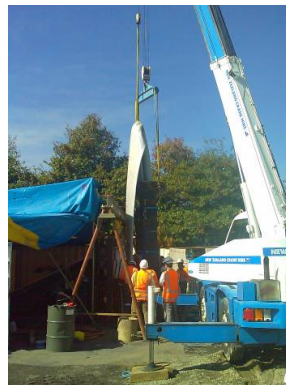
Figure 38 Liner insertion

The steel chute, with the liner attached, is then lowered into the start manhole for the liner installation. This operation is shown in figure 38.

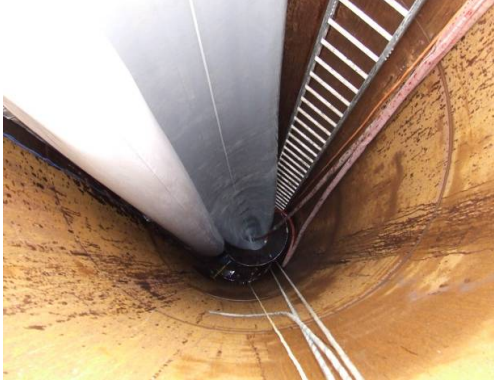
Figure 39 Liner running to inversion chute

inversion. Figure 39 shows an intermediate stage in the liner insertion, with the liner entering the top of the inversion chute. (this is visible as the funnel at the base of the ladder).

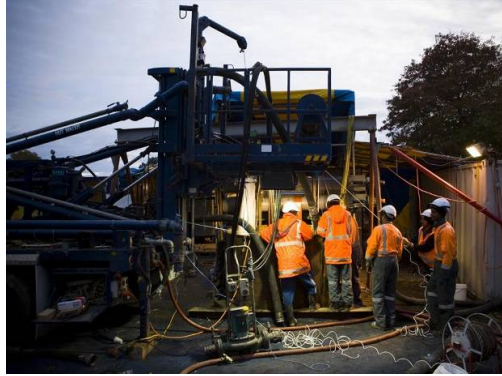
Figure 40 Liner curing

Once the liner is fully inverted, the circulation hoses are connected to the water heater, and curing begins. The water temperature inside the liner must reach approximately 60° to initiate the chemical reaction which causes the resin to harden. It is essential to monitor the liner temperature at several points to ensure that resin curing is detected, before stopping the circulation of the hot water. In these liner installations, over 200 m³ of water had to be heated to about 85°C, requiring two large heater units to be used.

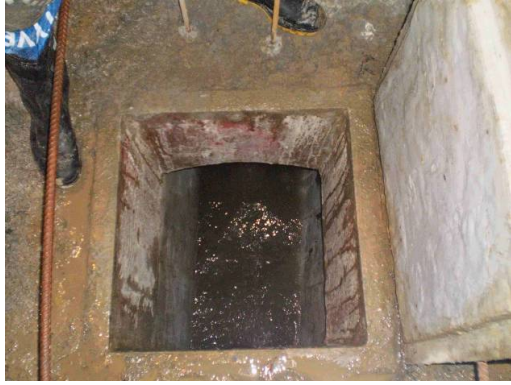
Figure 43 Shaft base, with resin lining

The liner ends were cut off and then finishing work in the manholes was carried out. Figures 41 to 43 show the process of reconstructing the base of the shaft as it is taken from its initial state to the finished state. Figure 44 shows a view of MH04 after lining. In fig 42, the internal surface of the finished liner is visible. This surface is the same coated surface that started off on the outside of the liner before it was inverted during the insertion process.
