HASTINGS WASTEWATER OUTFALL MAXIMUM LIFE VS MINIMUM SPEND

WA Hodson (MWH Global)

ABSTRACT

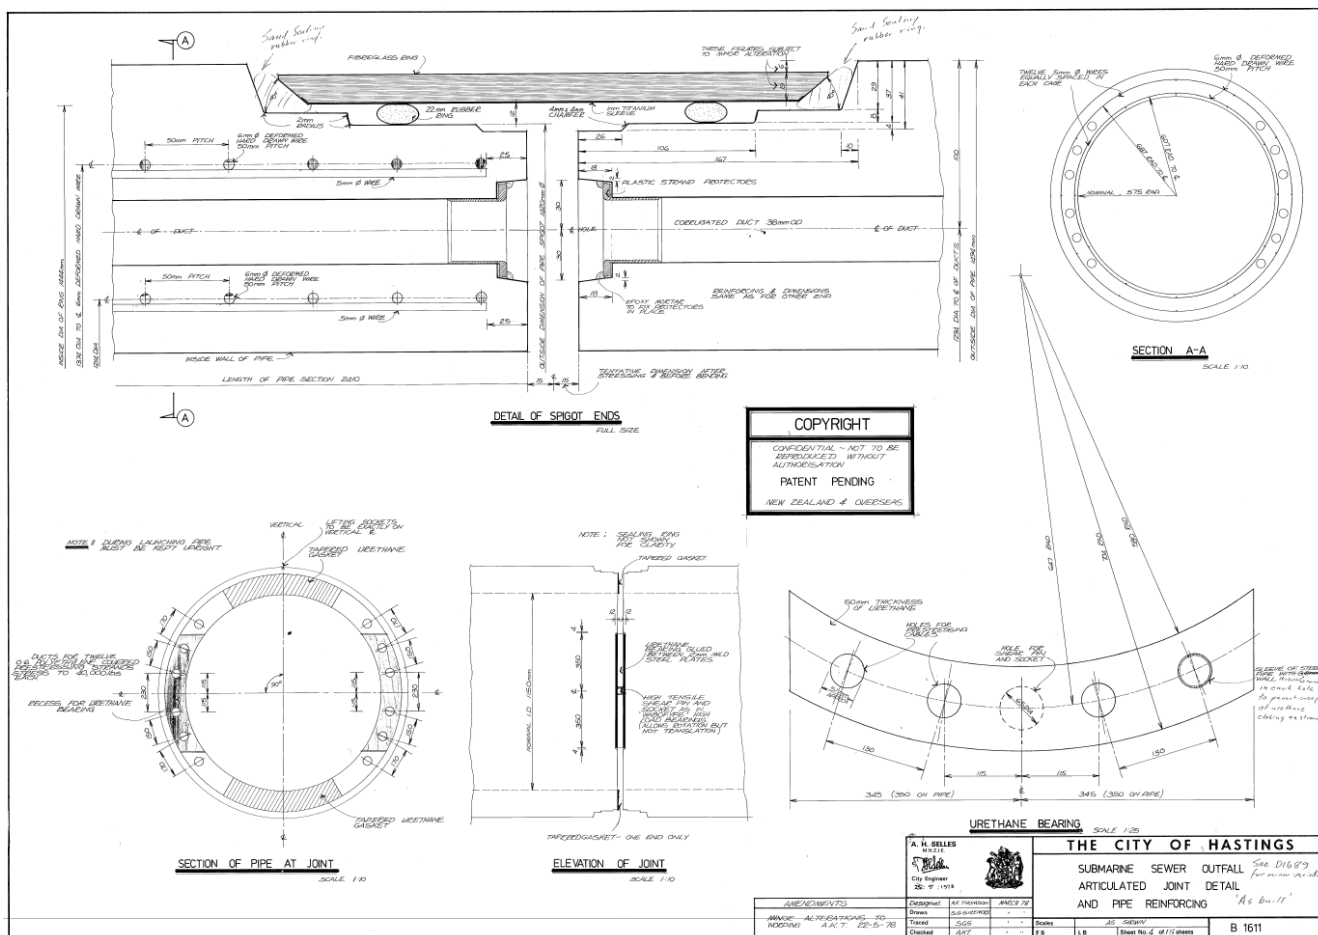
Figure 3: Pre-stressed Concrete Pipe Detail

The land based section of the concrete pipe has also suffered some internal corrosion damage to the soffit and joints. A leak was discovered from this pipe in July 2007 from the top of the pipe at a joint. A short longitudinal crack was also found on the crown of the pipe at the 12 metre point, and when a core section was taken the thickness of the core confirmed that the soffit of the pipe was severely corroded.

Repairs to the cracked section of the pipe were carried out in 2007 by placing custom made large stainless steel straps over a linotex rubber underlay, refer to Photograph 2 below.
