THE LONG-TERM PERFORMANCE OF PERVIOUS PAVING

Steve Crossland, Stuart Girvan, Firth Industries Ltd

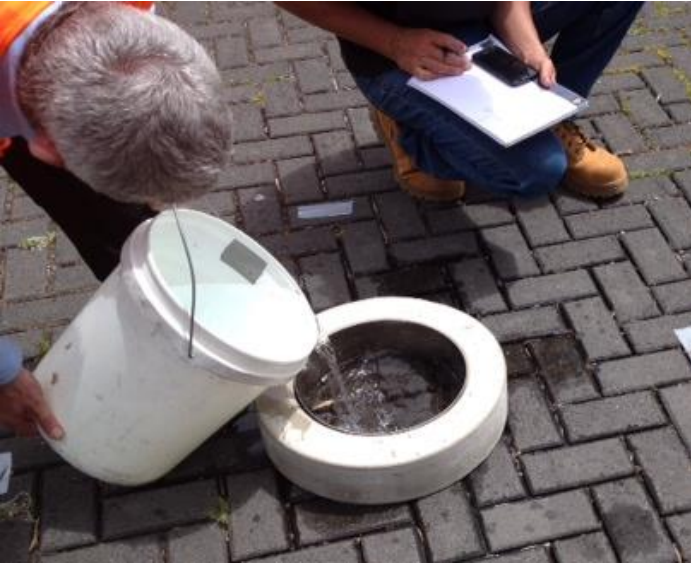
Photo 1: Timing a set volume of water, at a constant depth of 10 to 15mm, to infiltrate the pervious surface within the steel ring. Concrete surround (with a soft closed cell foam on its base, see photos 2 and 3) provides a seal to minimise horizontal leakage from under the inside ring.

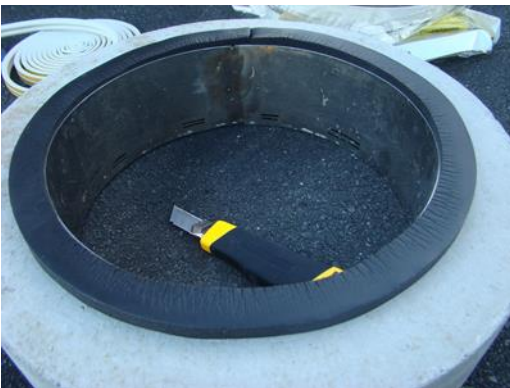
Photo 2: Soft closed cell foam on base of concrete ring.

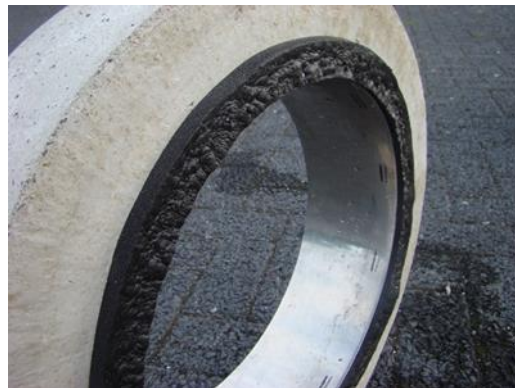
Photo 3: Indentations in soft foam from being placed on the paver surface to form a seal.

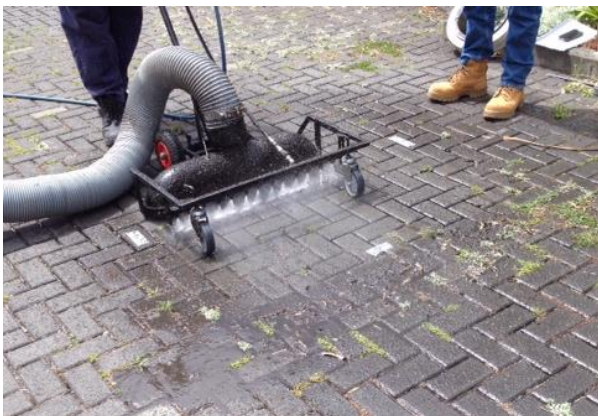
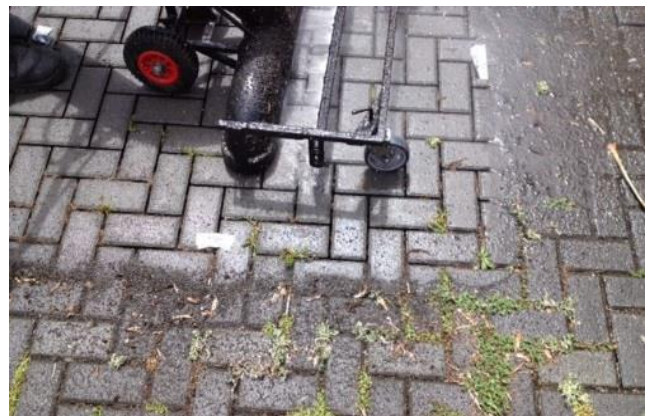
Photos 4 (left) and 5 (right): Cleaning the pervious surface. The thirteen, 1,000 psi water jets dislodge the sediments/moss/weeds from the surface and in the joints, which are then picked up with the vacuum suction. Most weeds are dislodged and vacuumed up but some weeds with long roots remain and need to be hand plucked.

- The 'Eco-pave Cleaner' significantly increases infiltration rates, up to, or greater than the recommended minimum as-built of 1,200mm/hr. With cleaning the greatest increase in infiltration is for the Porous Gaps and Porous Concrete. For example, the Porous Gaps at the Earthsong Rauni Parking increased from 1,000mm/hr to 1,600mm/hr, the Te Atatu Medical Centre from 1,800mm/hr up to 11,000mm/hr and the Upland Road Driveway from 310mm/hr to 12,600mm/hr. The Clemows Porous Concrete Footpath increased from less than 200mm/hr up to 6,300mm/hr (with 12 passes). The Porous Blocks show a lower increase in infiltration with cleaning. For example, the Porous Blocks at the North Shore Events Centre increased from 290mm/hr to 1,100mm/hr and at Birkdale Road, from 430mm/hr to 1,260mm/hr with cleaning.
