No Dig Resin Based Sewer Rehabilitation Performance Post 2014

Water New Zealand Conference
September 2017

Gerard Cody – Water Services Reticulation Engineer
Timaru District Council

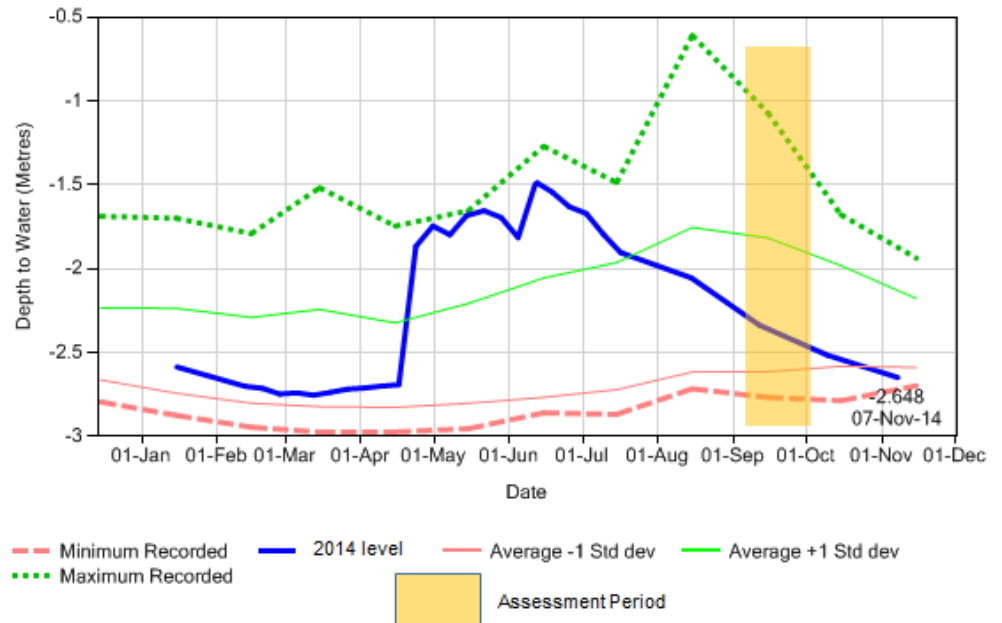
Groundwater envelope plot for well J38/0122

Sewer level vs Ground water

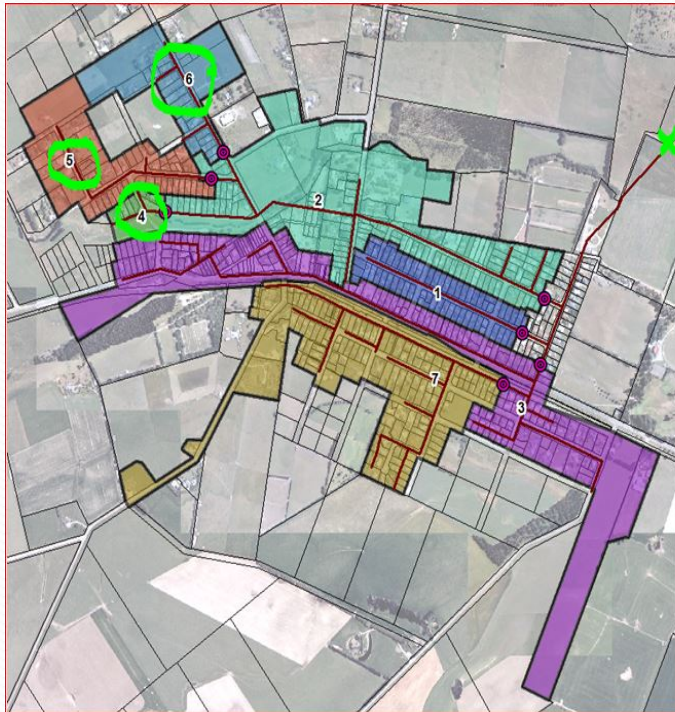
- Investigations identifying areas of infiltration into the Pleasant Point sewer scheme.

Catchment	Infiltration (Flow Difference) (ls ⁻¹)	Infiltration Factor
1	-0.03211	0.922864865
2 (With 4, 5 & 6)	21.99845	18.61468318
2 (Individual)	5.37371	8.2747521
3 (With 7)	18.06897	13.96849151
3 (Individual)	15.58124	20.73382605
4	0.78593	19.82005987
5	12.20475	49.03127572
6	3.75809	42.61785875
7	2.65719	6.551887968

* Catchments 2, 3 and 5 high infiltration observed from flow

* Catchments 4, 5 and 6 high infiltration factor

* Areas suspected to be big issues were 4, 5 and 6

* Catchments 2 and 3 have catchments feeding into them compounding the theoretical problem

* When isolated catchment 2 ceases to be an issue, however catchment 3 as a standalone is an issue

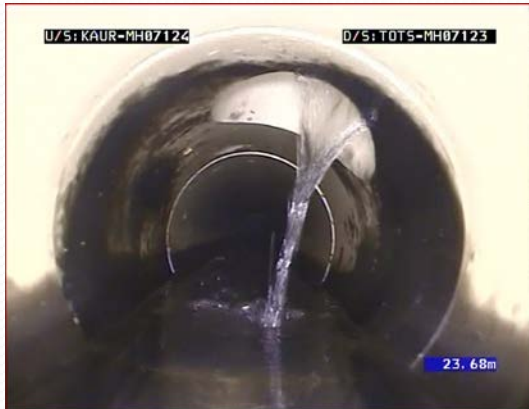
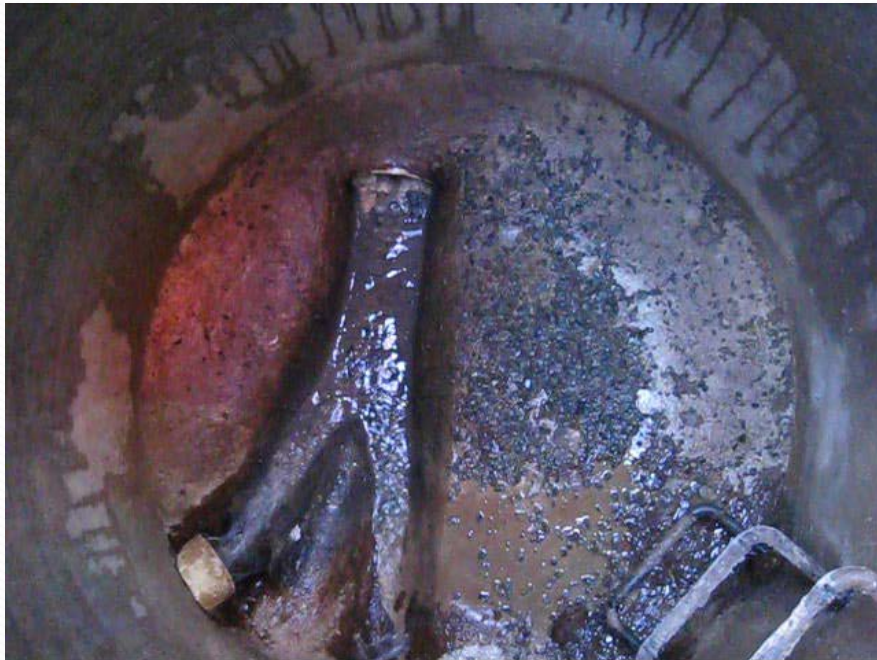
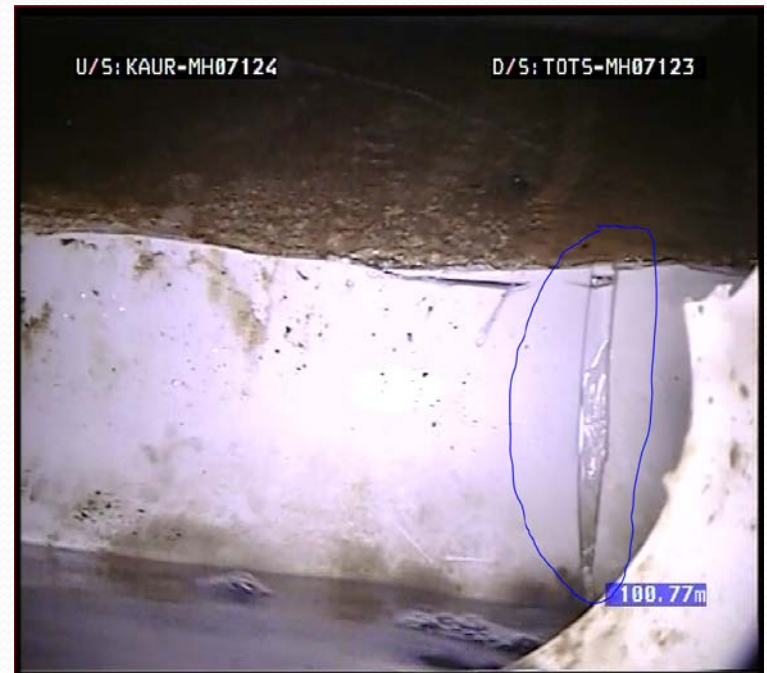
The Network – CCTV Inspection

- PVC main joints and Manholes allowing ground water into reticulation. –Installed 1984
- Ground water pressure finding weaknesses in the reticulation. Poor PVC Jointing methods and manhole base installation
- Storm water inflow from low gully traps on private property
- Downpipes directed to gully trap
- Ground Water entry the major problem

CCTV inspection of sewer catchments 3, 4, 5 and 6.
In total – 3.4 km

- Renewal cost \$1.15 million – ground conditions not favourable – running gravels – high water table
 - 70 years financial write off – asset only 30 years old.
- Rehabilitation – Grouting and lining of manholes – patching of pipe faults - cost estimate \$160,000. All no dig options
 - 50 year life

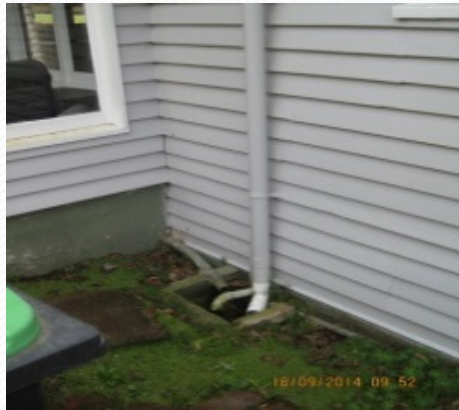
Private sewer connection inspection/smoke testing

- 541 Connections
- 8 Properties with direct stormwater connections
- 40 Properties with low or no Gully trap sides
- 15 laterals relayed
