Critical infrastructure in vulnerable locations

A near catastrophe

Adam Donaldson - Waters Operations Manager
Parvati Patel - Asset Engineer

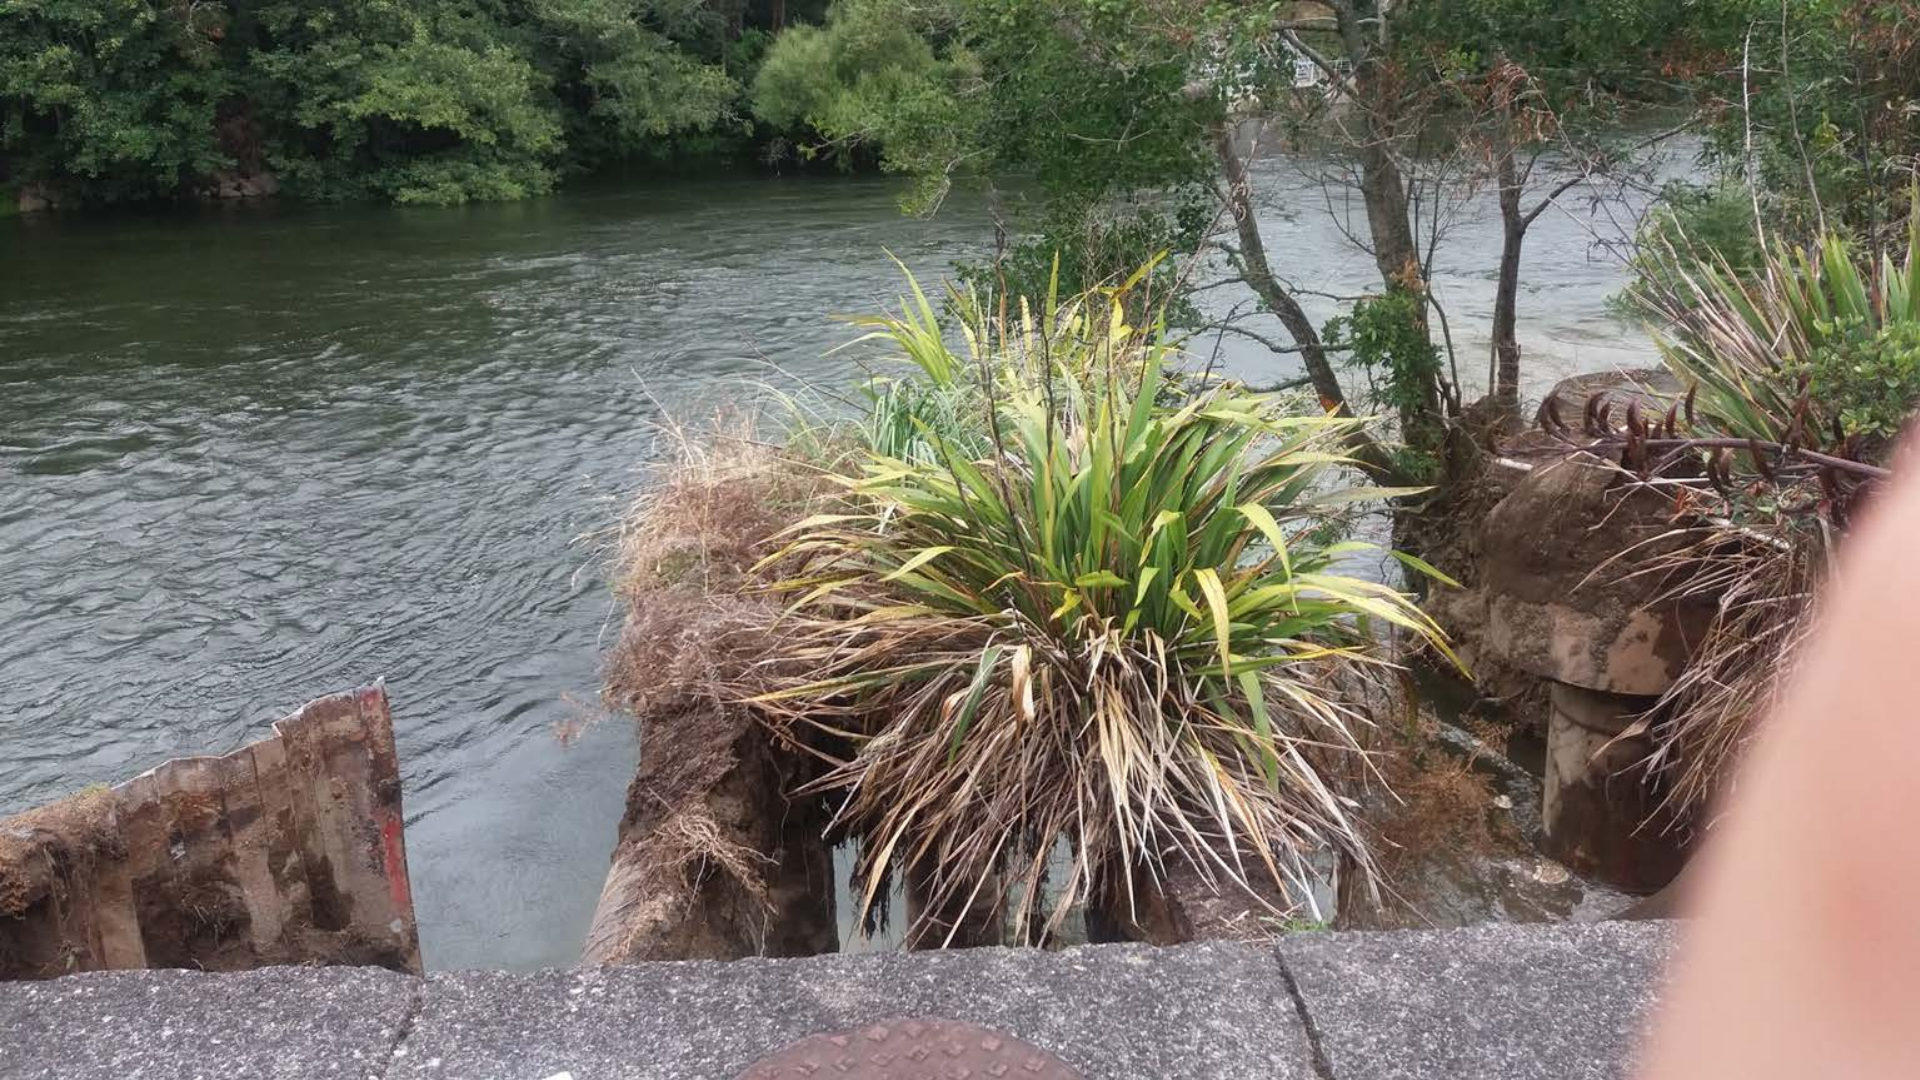
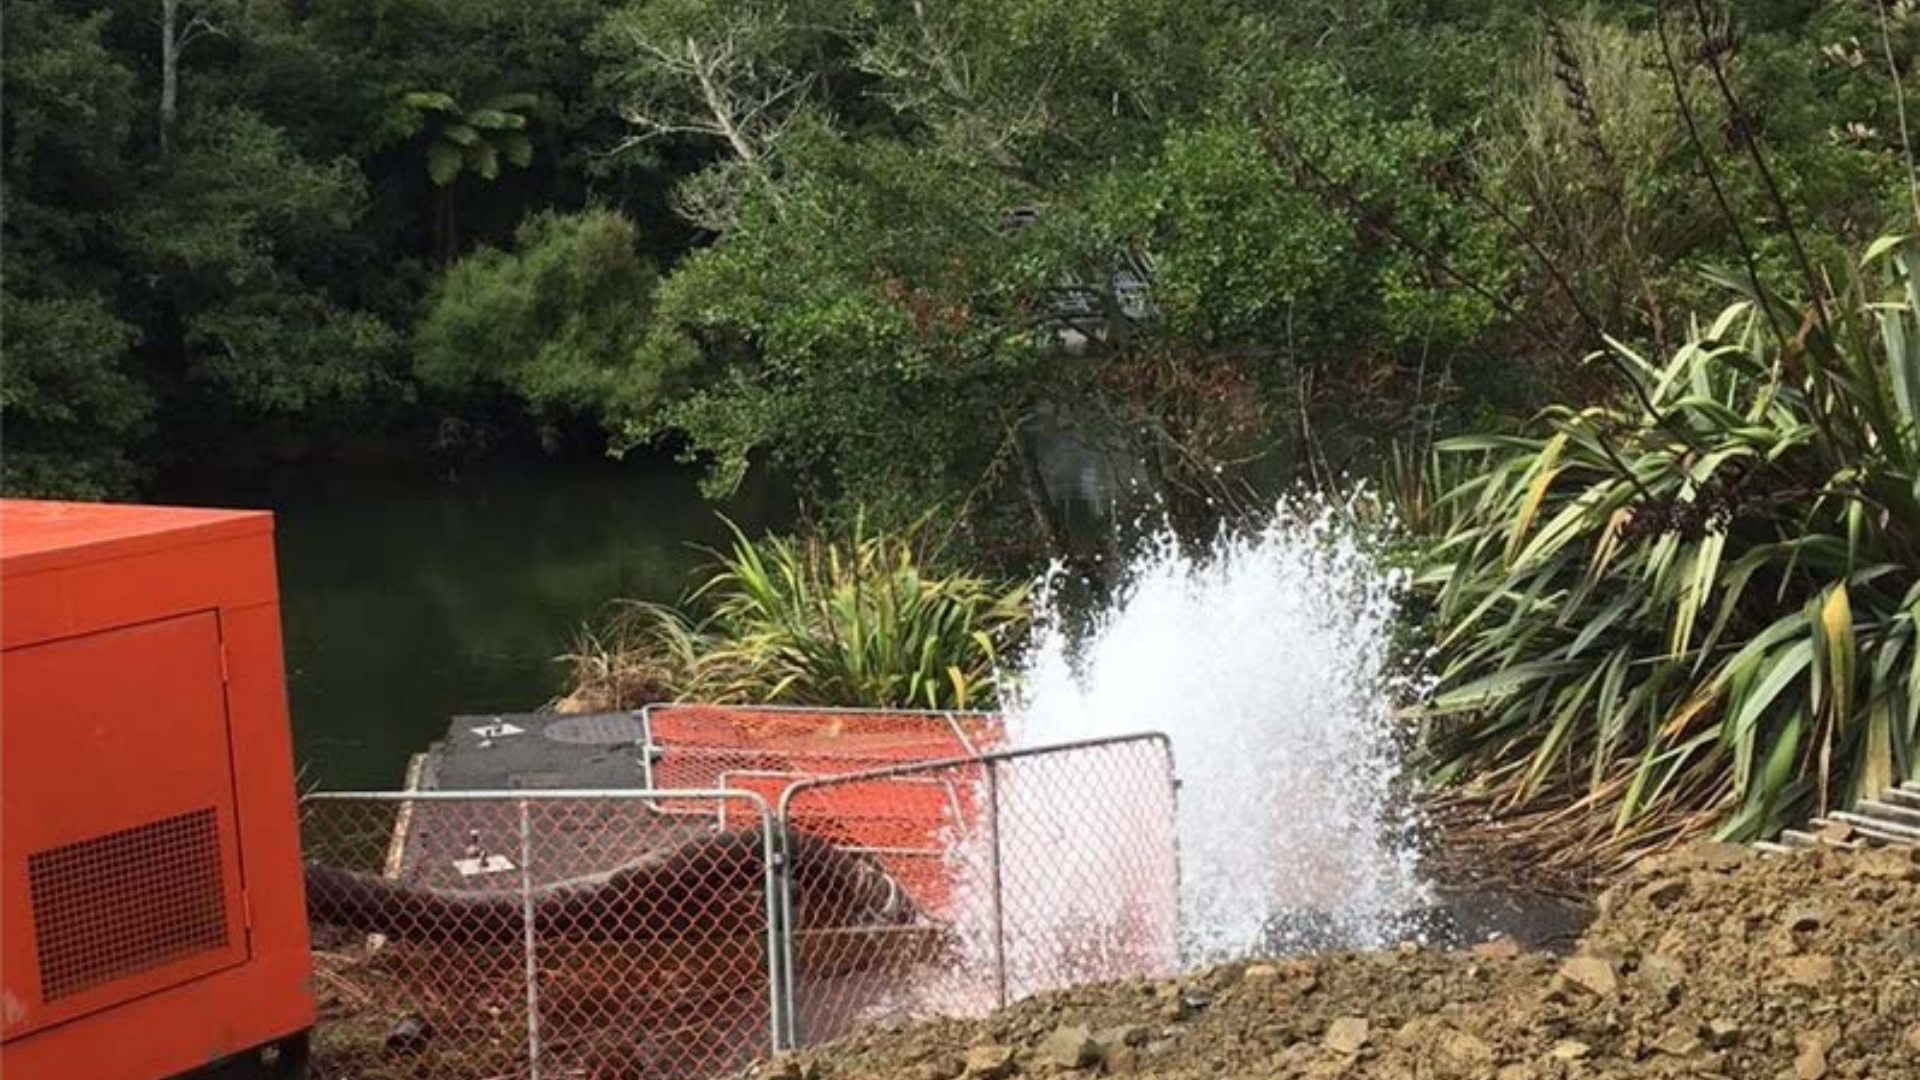
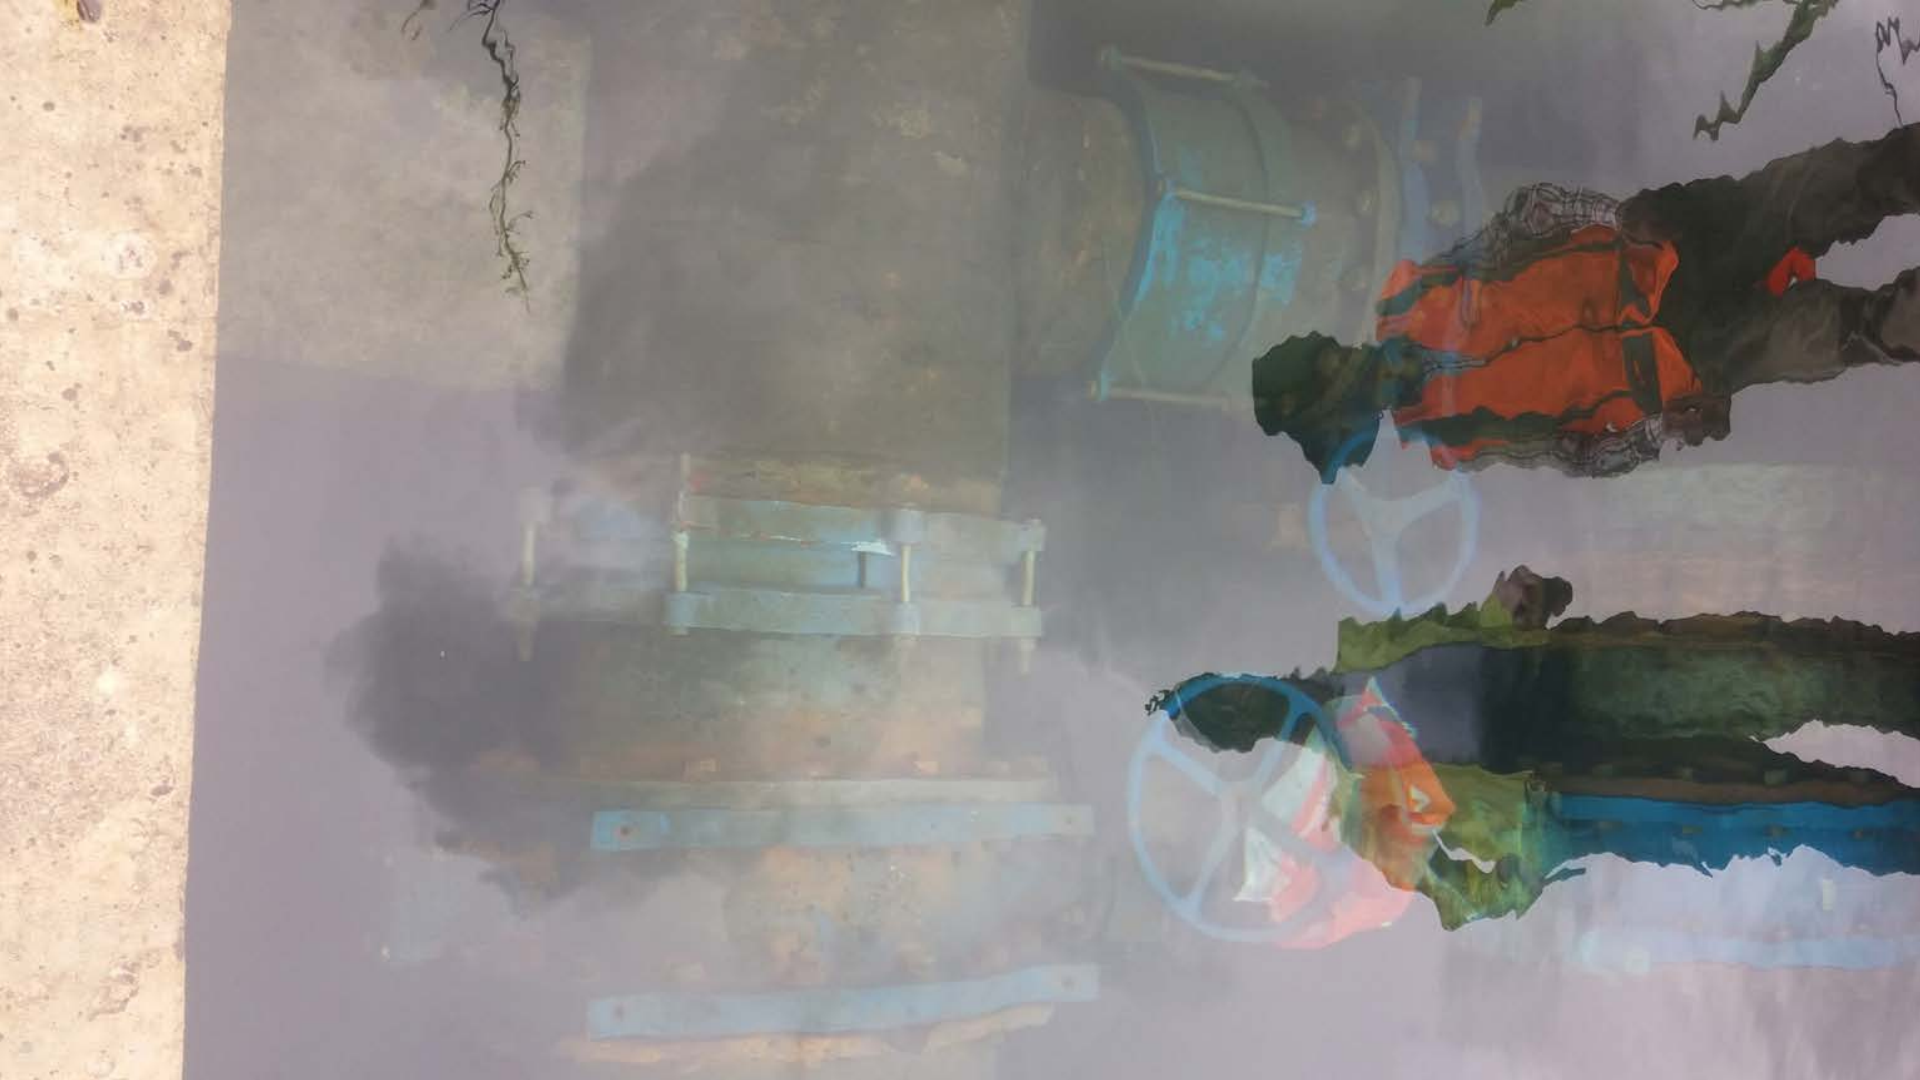
“Looks as though some stormwater has caused a slip near our bulk main valve chamber...”

- Identify source of leak
- Refer to shutdown procedures for the bulk mains
- Source necessary spares from critical spares store
- Communicate potential outage to customers
- Isolate bulk mains
- Repair leak
- Return to service
- Total time to repair → mins/hours?

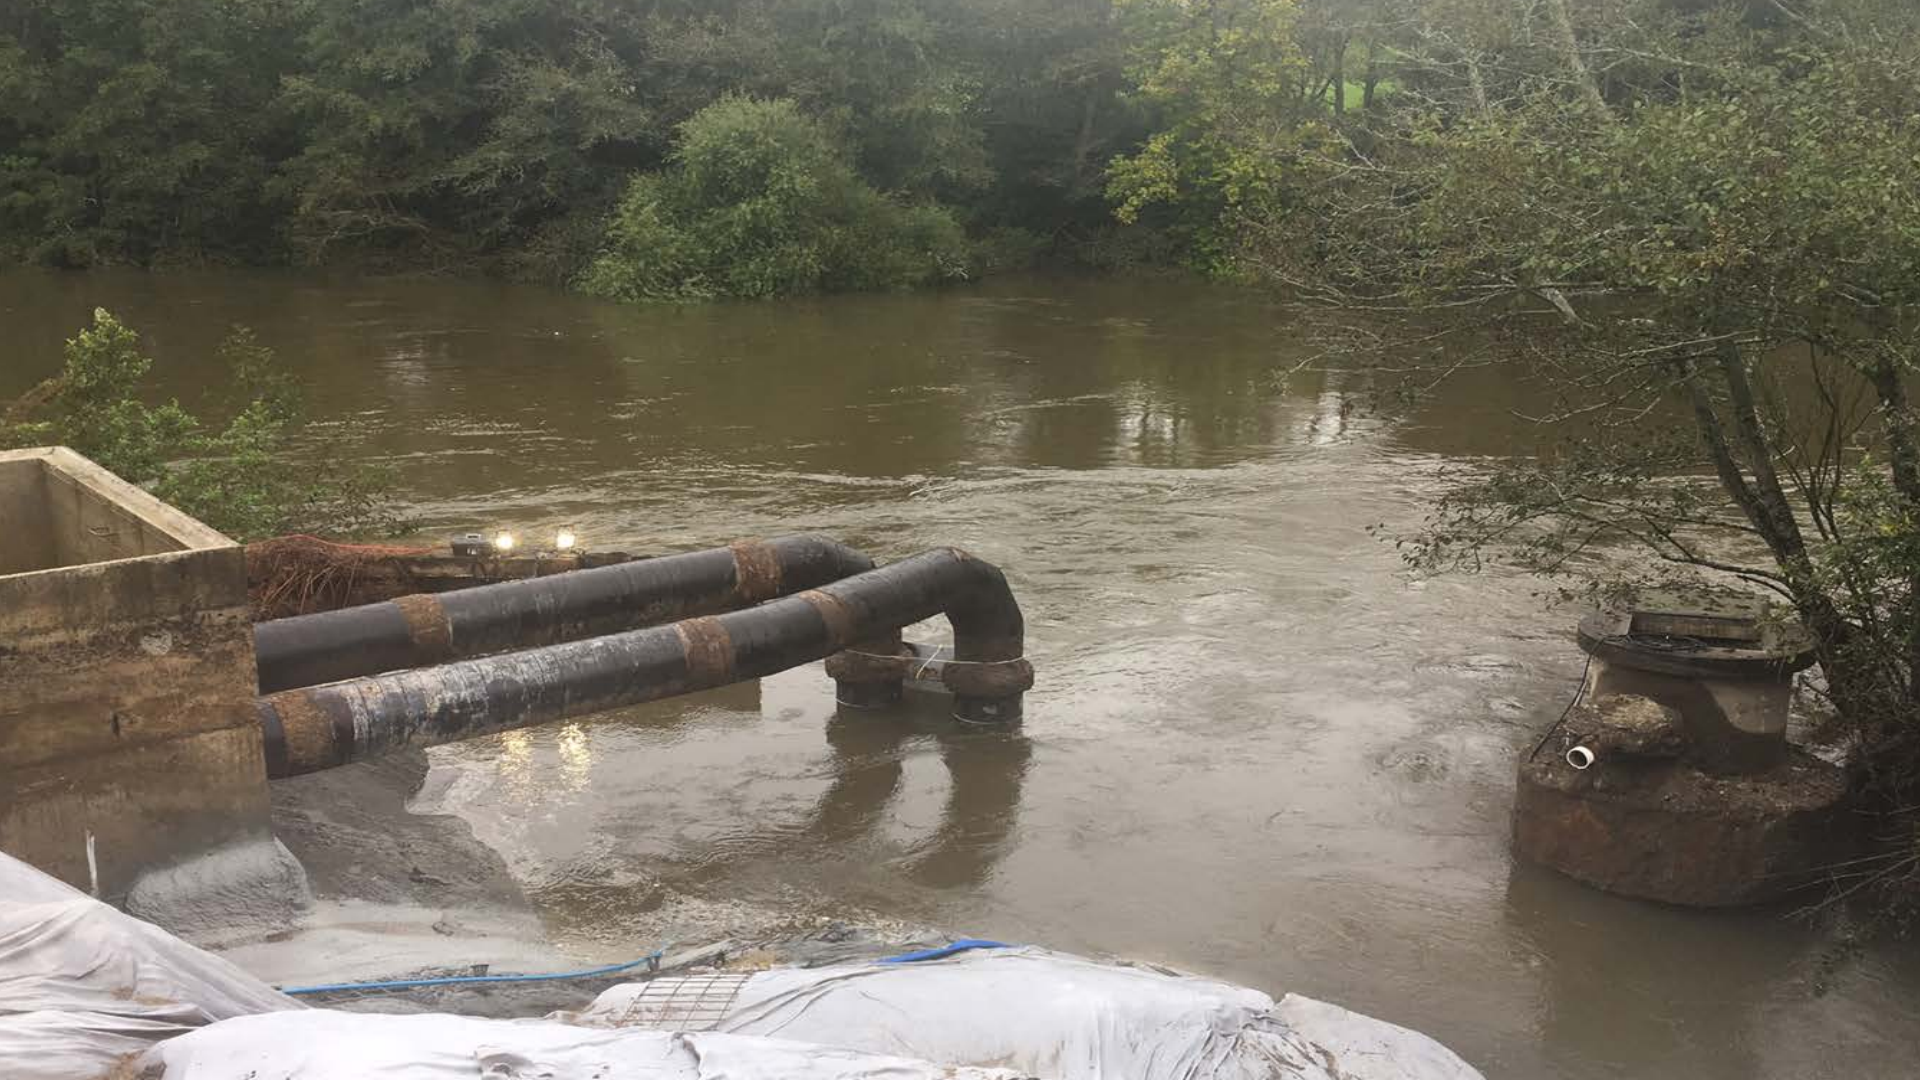
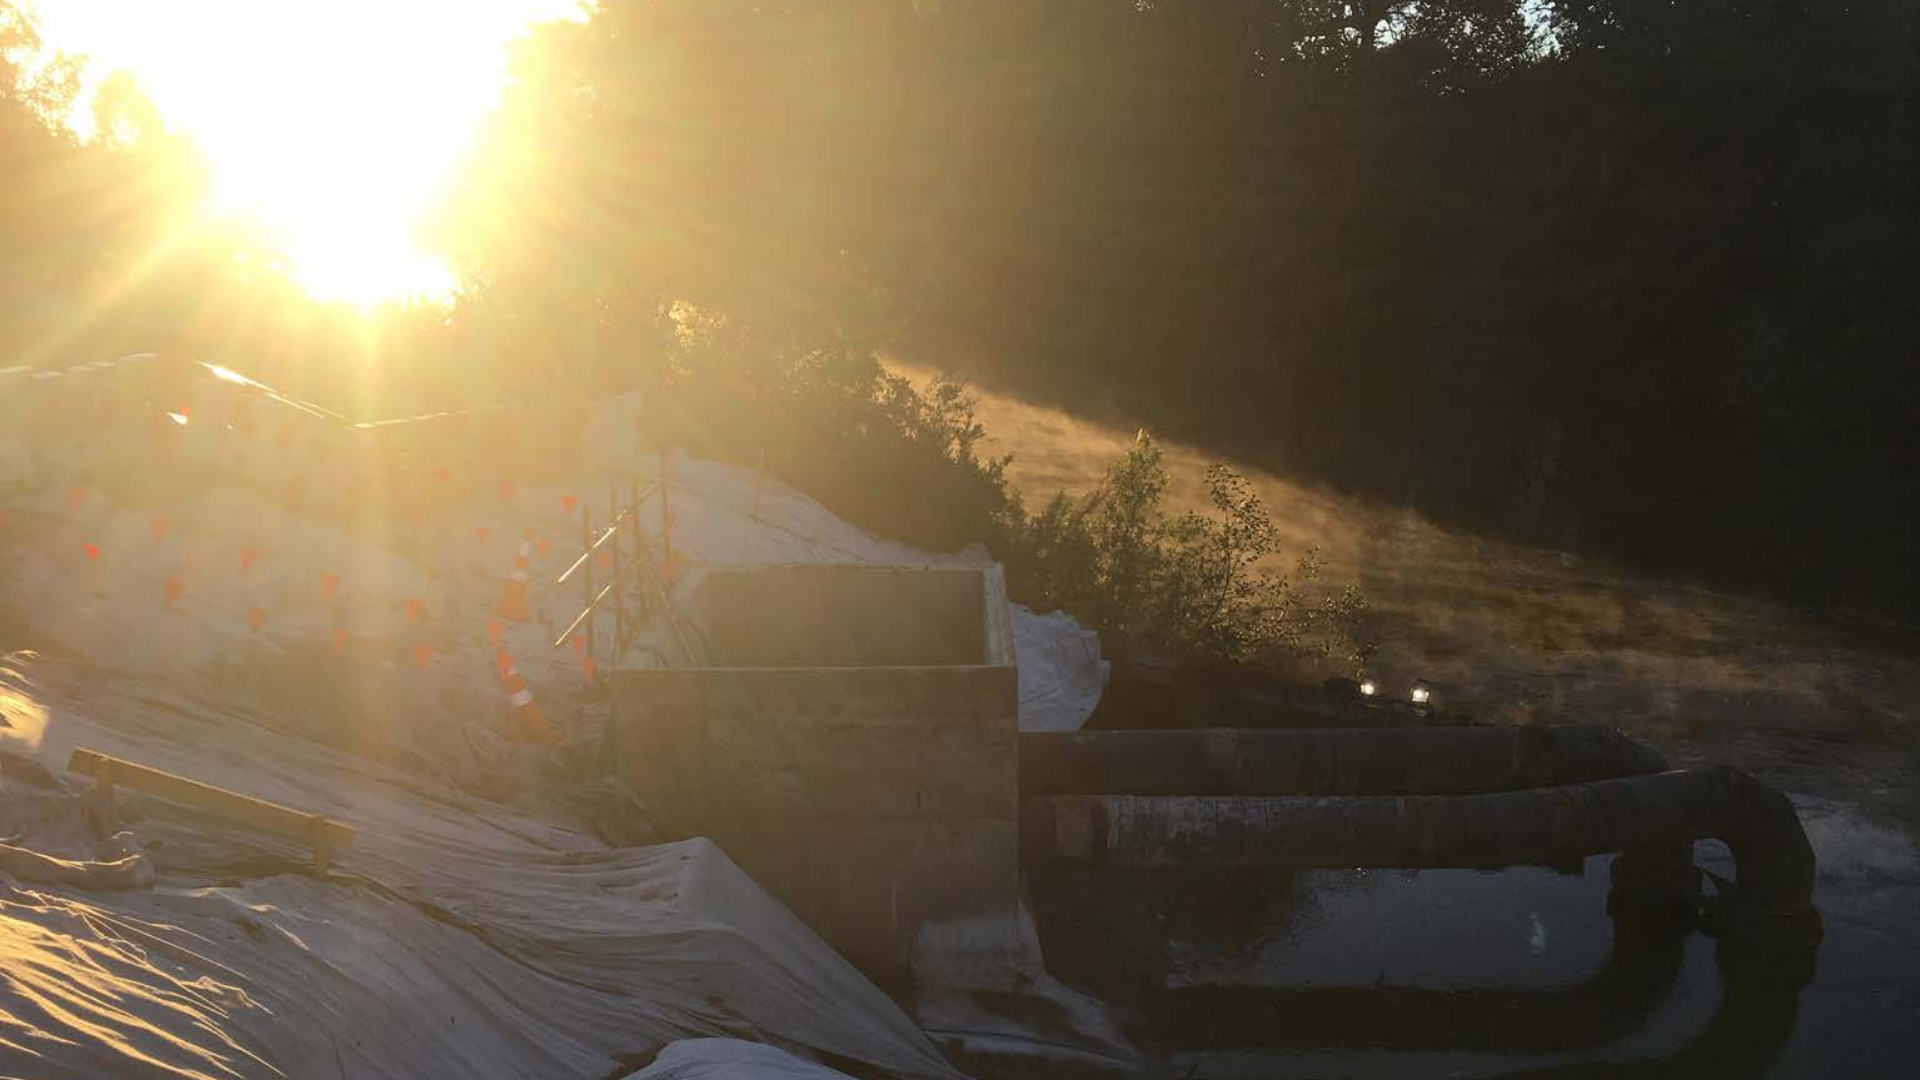
- Critical Assets no longer protected by river embankment and sheet piling
- Loss of bedding material beneath the chamber
- Stability of remaining riverbank uncertain
- Specialist engineering advice
- Undertaking a condition assessment

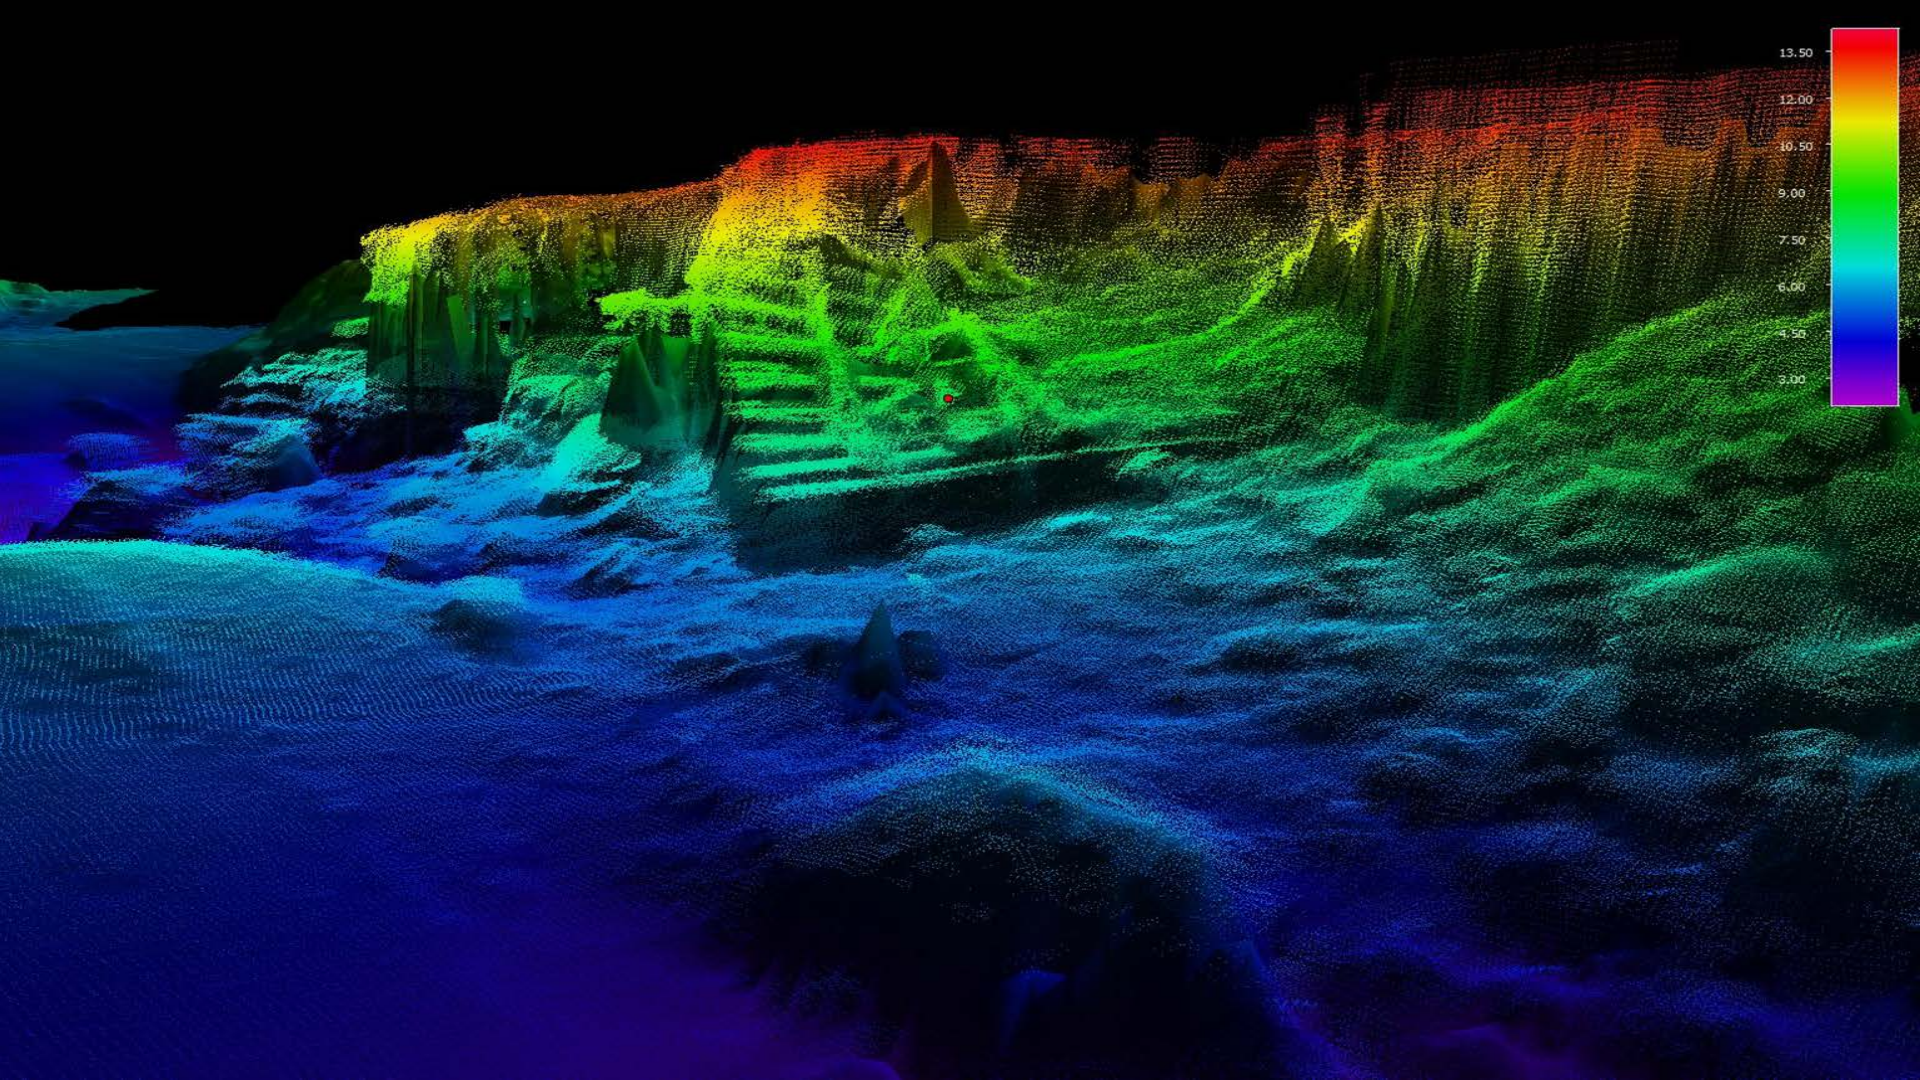
- Material holding the bank had failed, along with the sheet piling anchors evidenced from the sheet piles bent over under the water line.
- Along with exposure of the twin pipes and the water intake, material had been lost from beneath the concrete chamber.
- The remaining material in the immediate vicinity of the pipe and the chamber was classified as weakly cemented alluvial soils, hence presenting a risk of further erosion.
- Continued water seepage from the bank was observed following the isolation of the water supply.
