DON'T TEAR DOWN THIS WALL – RENEWAL OF A U SHAPED SEWER

Andrew Owen, Stantec New Zealand and Steve Hutchison, Wellington Water Ltd

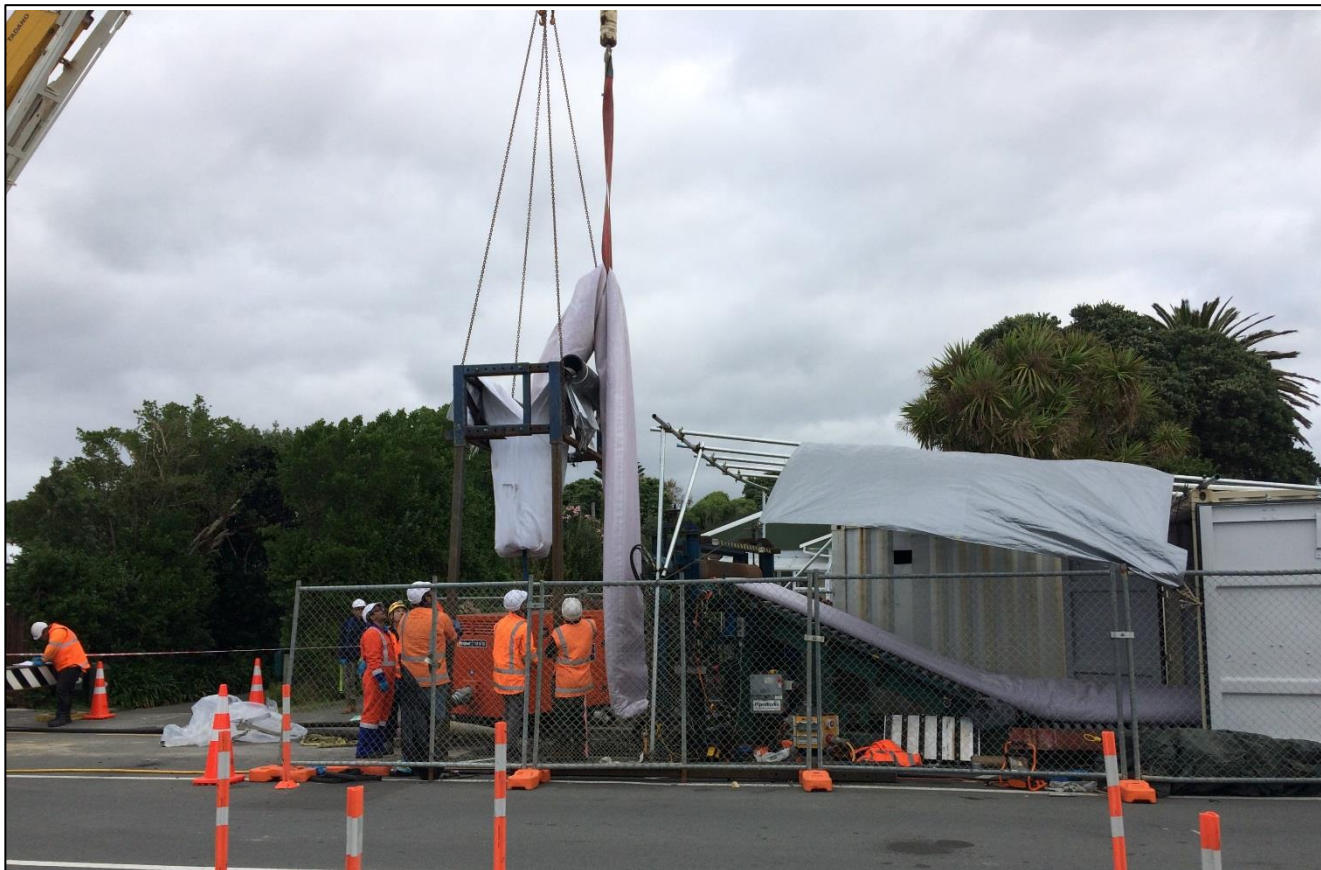
Figure 7: Liner being raised over the insertion manhole for inversion under head pressure

Feeding the liner into the main was an iterative process where a crane was brought in to guide and re-raise the liner as it was inserted, ensuring that there was a constant head pressure. Later discussions with PipeWorks identified this insertion method as not preferred as it was relatively stop-start and prevented there being a continuous insertion movement. This is identified as a lesson learnt.

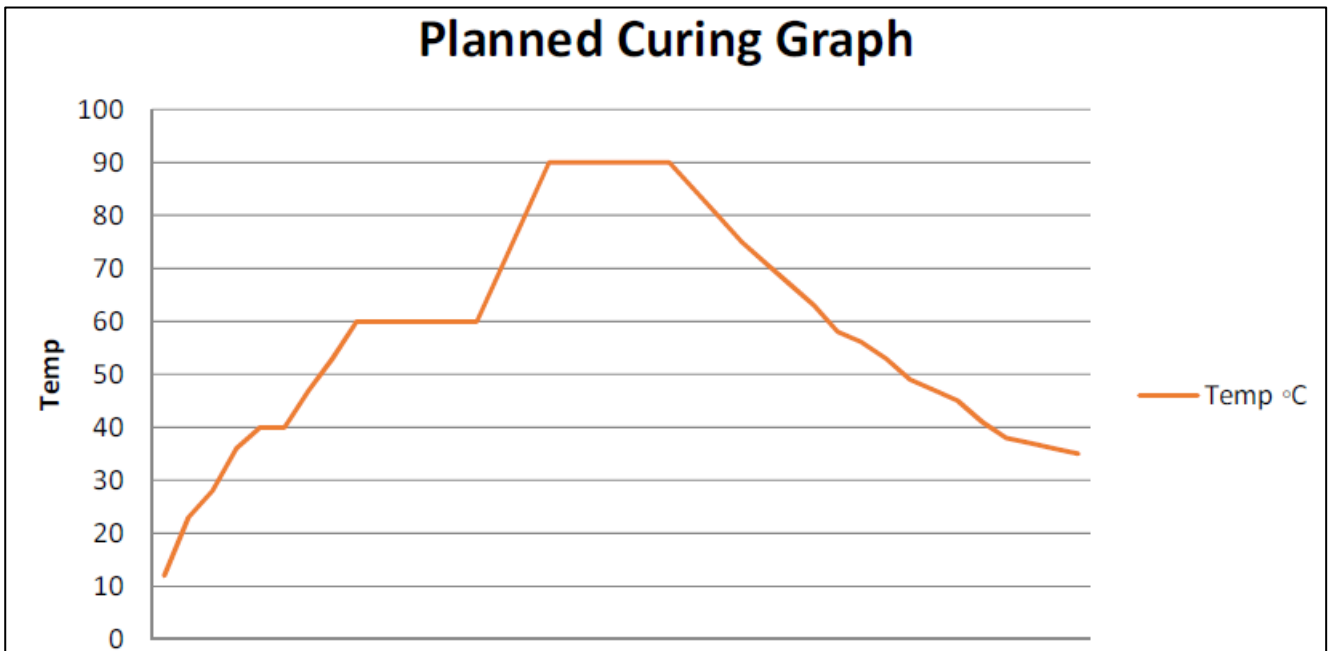
Figure 9: Liner Curing Graph Over Time

Once the liner was inserted, a boiling unit was connected to the hoses running along the liner which circulated hot water through the line to cure it. The curing process required the water to be heated to 60° Celsius, at which point the resin undergoes an exothermic reaction and heats itself to 90° Celsius. The curing graph can be seen below in Figure 9 showing the variation in temperature over time.

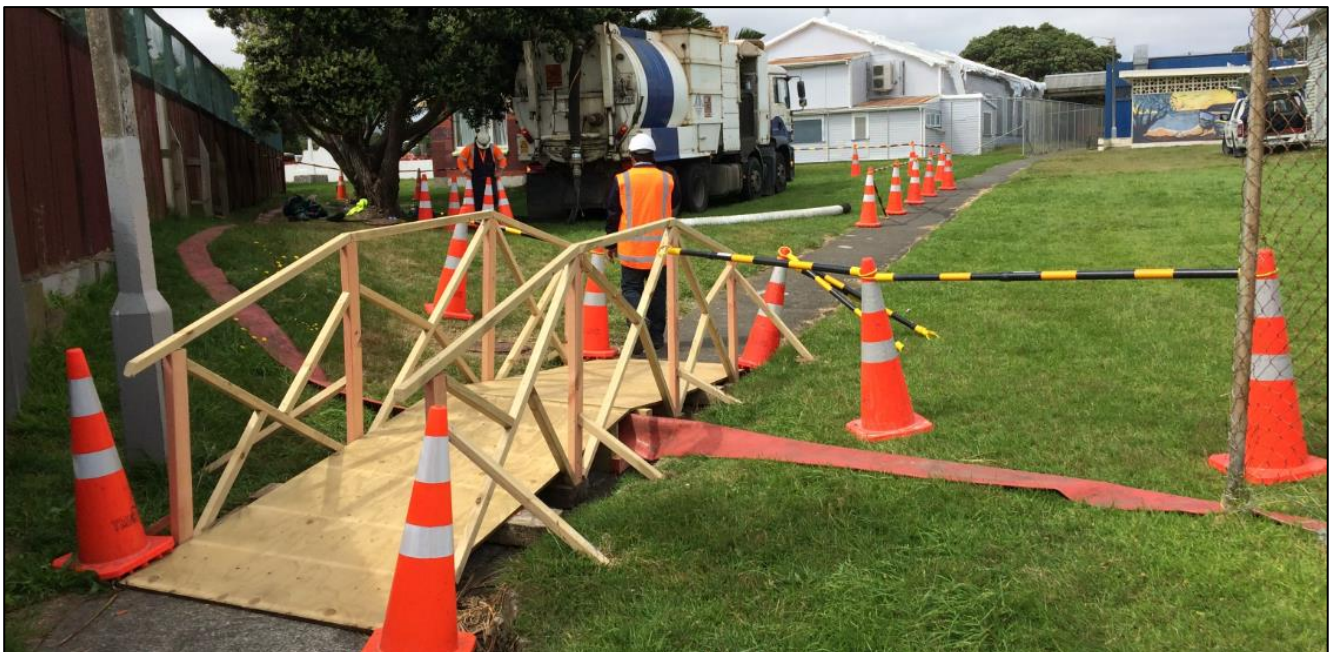
Figure 10: Bridged walkway constructed to manage over pumping alignment.

A sewer bypass system was implemented to over-pump flows. Flow monitoring of the main confirmed that dry weather diurnal peaks were 23 L/s which were managed by 6" pumps on site. Works undertaken to arrange the bypass system which included an alignment through private property as seen in Figure 10.
