# WHEN “TOO HARD” IS NOT ACCEPTABLE – MARINE PARADE WASTEWATER UPGRADE

*Jason Climo (Veolia), Simon Leary (Queenstown Lakes District Council), Jekabs Rozitis (Veolia)*

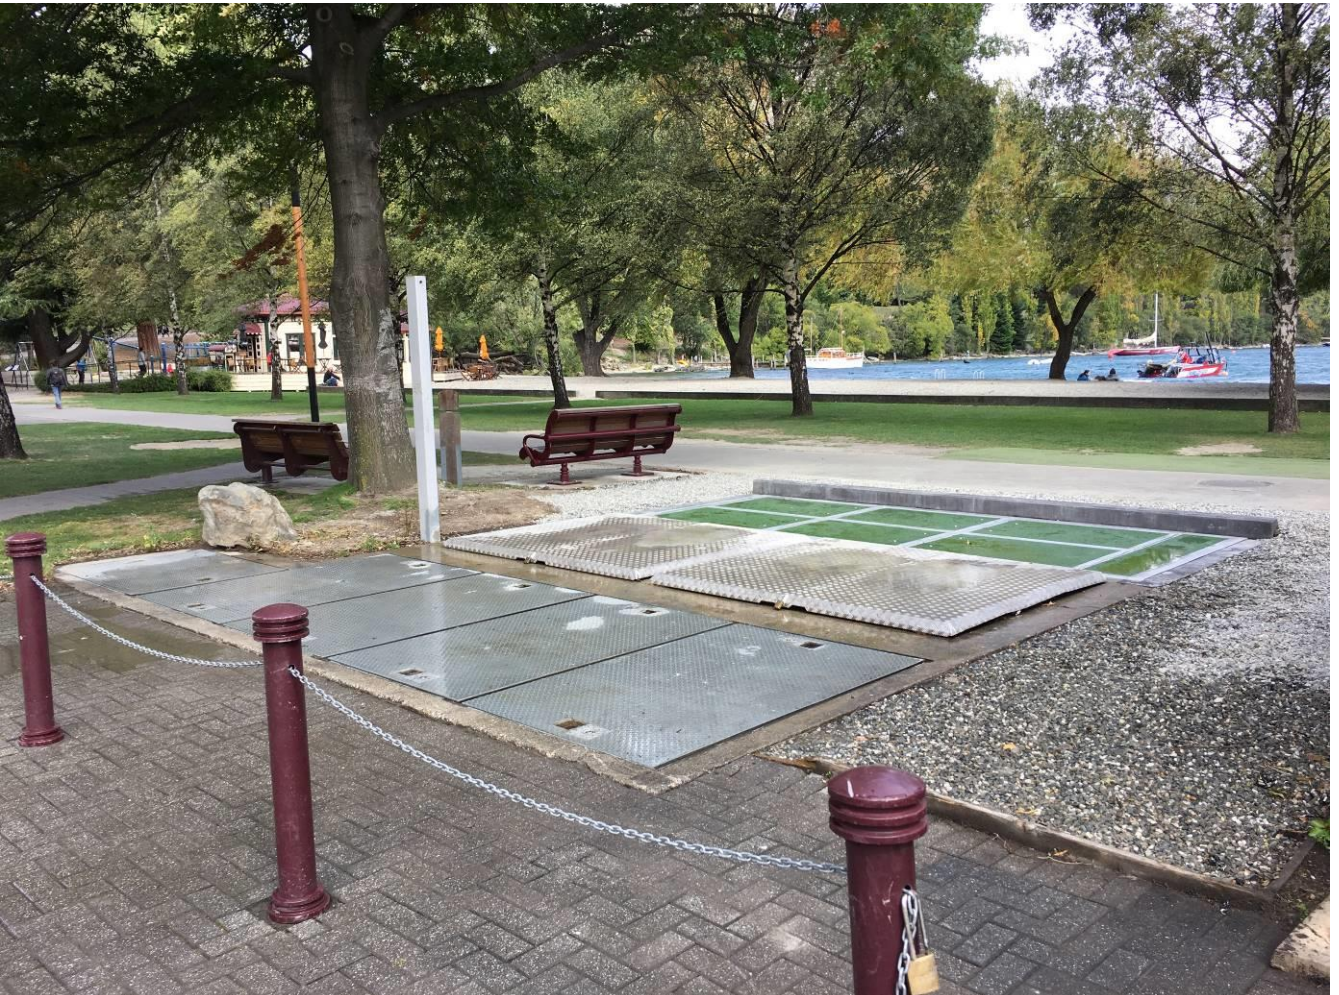
*Figure 13: On completion, hardly a trace that a major, complex project on critical infrastructure has been delivered.*

On the other end of the rising main, and Marine Parade Pump Station, the new valve pit was constructed, and connected to the pump riser tees, and the new main.
