Rehabilitation of Stormwater Culverts

Jonathan Morris, Jayesh Dhanjee

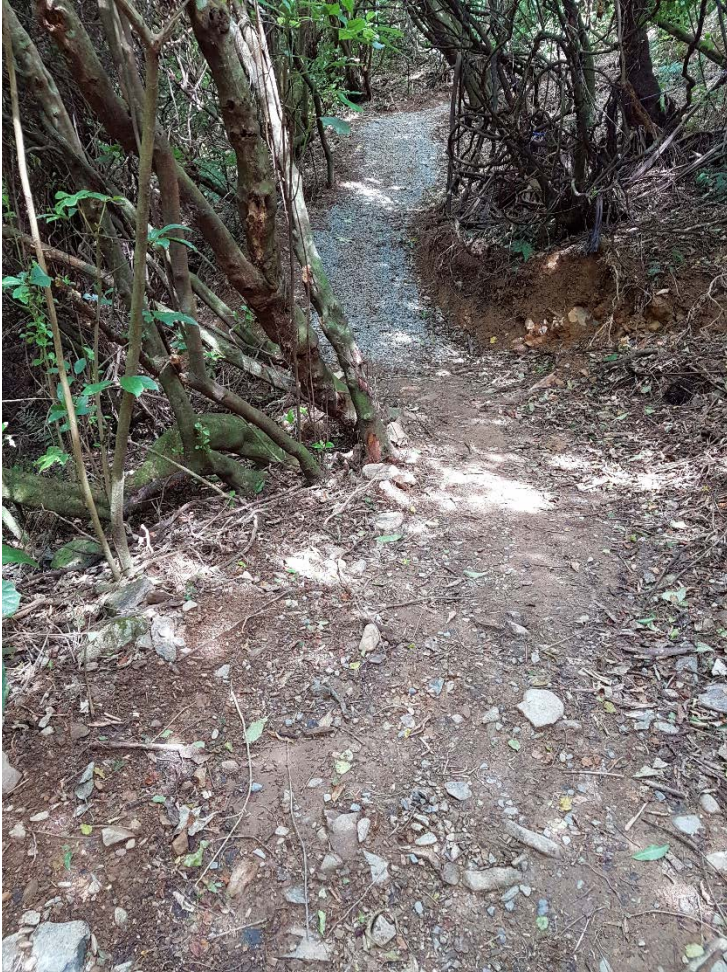
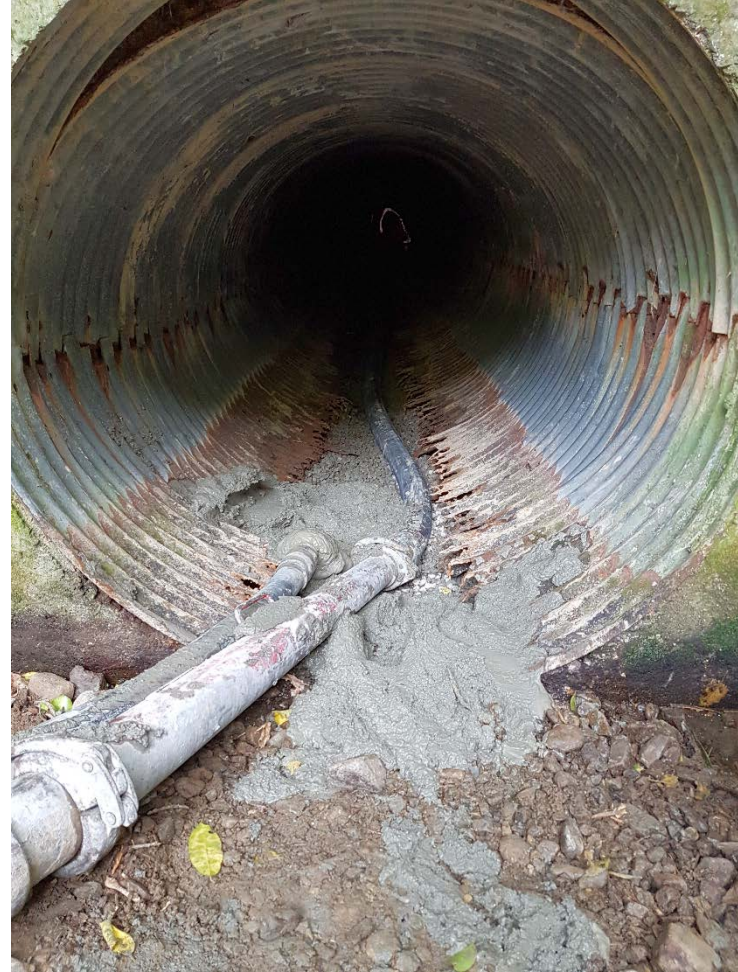
Access

- No advance warning from inspections
- Consequence of failure
- Safety hazards (long, deep, poor condition)
- Difficult access/working space
- Earthquake and legislation change
- Environmental (consents, fish)
