SEISMIC PERFORMANCE OF PLASTIC PIPE SYSTEMS IN 2010/11 CANTERBURY EARTHQUAKES

Bill Noell, Water Services Infrastructure Lead, Pattle Delamore Partners

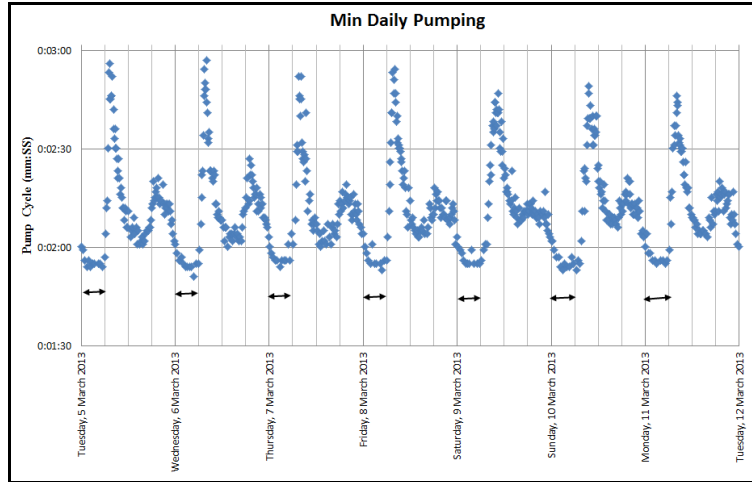
Figure 6 Nightly pump operation

Changes in wastewater flows are assessed from 7-day average dry weather pump hours and nightly pumping hours assessed between midnight and 6:00 am as a measure of base infiltration. Dry weather days are defined as days with less than 0.5mm rainfall over the two preceding days. Figure 6 below demonstrates the records show consistent diurnal pumping patterns that may be relied on to assess night time infiltration flows.

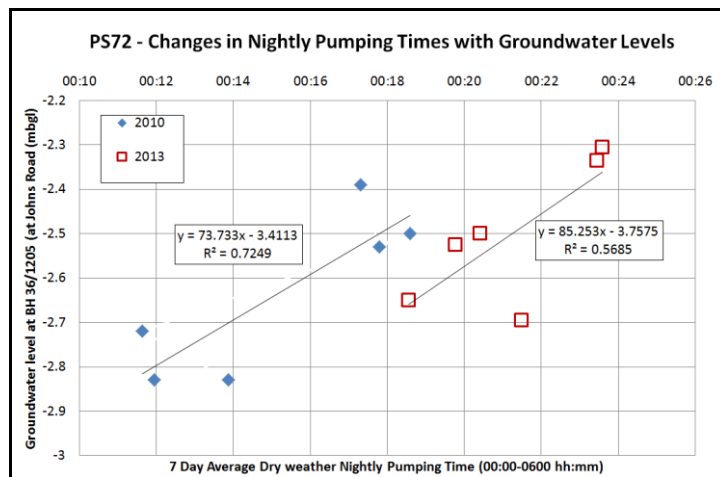
Figure 7 ADFW fluctuations with Groundwater and rainfall

Infiltration into wastewater systems is also often related to groundwater levels. Relevant groundwater data is limited in availability for the catchment area. The response of the PS72 wastewater flows to groundwater levels is shown in figure 7. This shows different relationships prior to and after the earthquakes between groundwater level and average dry weather night time pump operation.
