# NON DESTRUCTIVE PIPELINE CONDITION ASSESSMENT – HUTT VALLEY MAIN OUTFALL PIPELINE

*S.J. Hutchison*

*R.J. Mascarenhas*

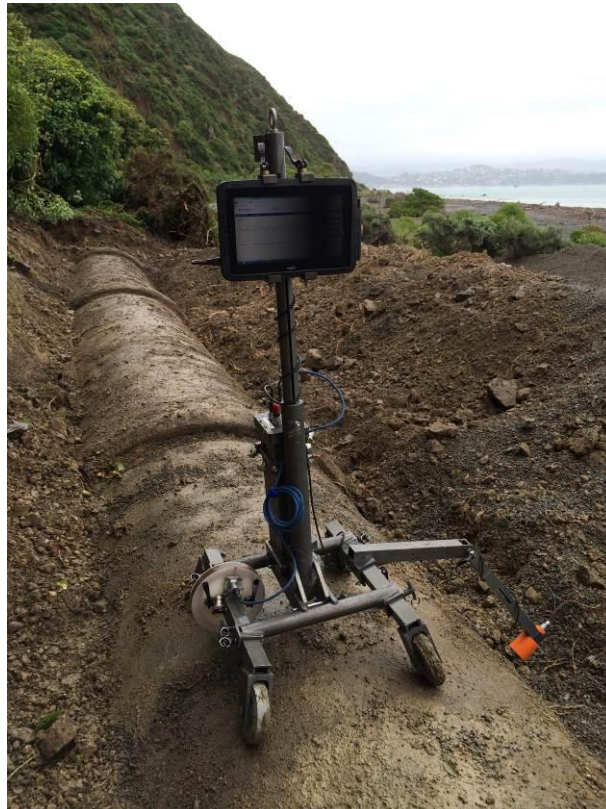
*Photograph 4: External PureEM (PipeScanner)*

Subsequent tests were performed on the Main Outfall Pipeline in November 2013 to help calibrate and validate the PureEM results. For these tests, 11 pipes were selected of varying levels of distress and pipe class. Once each pipe was excavated, an external PureEM tool (PipeScanner) was used to scan the pipes once more as a method to verify that the right pipes were excavated.

A strip of external shotcrete coating was removed from the top of each pipe to expose the prestressing wire, then resistivity tests were performed on each pair of wire wraps to determine the actual amount of distress. In all cases, the validation tests correlated very well with the PureEM results in estimating the quantity and location of distressed wire wraps.
