# DAM BUSTERS! – THE DECOMMISSIONING OF THE HISTORIC RESERVOIR CREEK DAM

*M. Roberts, MWH NZ Ltd.*

## ABSTRACT

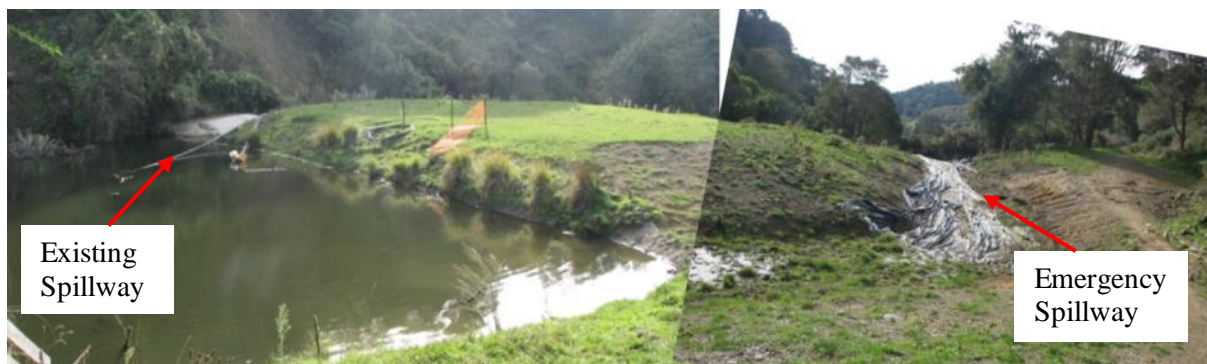
The dam was approximately 12m high from the toe to the crest and the crest was 30 m long from bank to bank and 13 m wide. A concrete spillway ran down the true left hand side of the dam against the hillside and an emergency high level spillway had been recently cut into the true right side of the crest. Access to the dam was through a private farm track.

Photograph 1: The reservoir and dam crest looking toward the north, taken in 2013 before decommissioning. Note the existing concrete spillway on the left and the emergency spillway on the right.

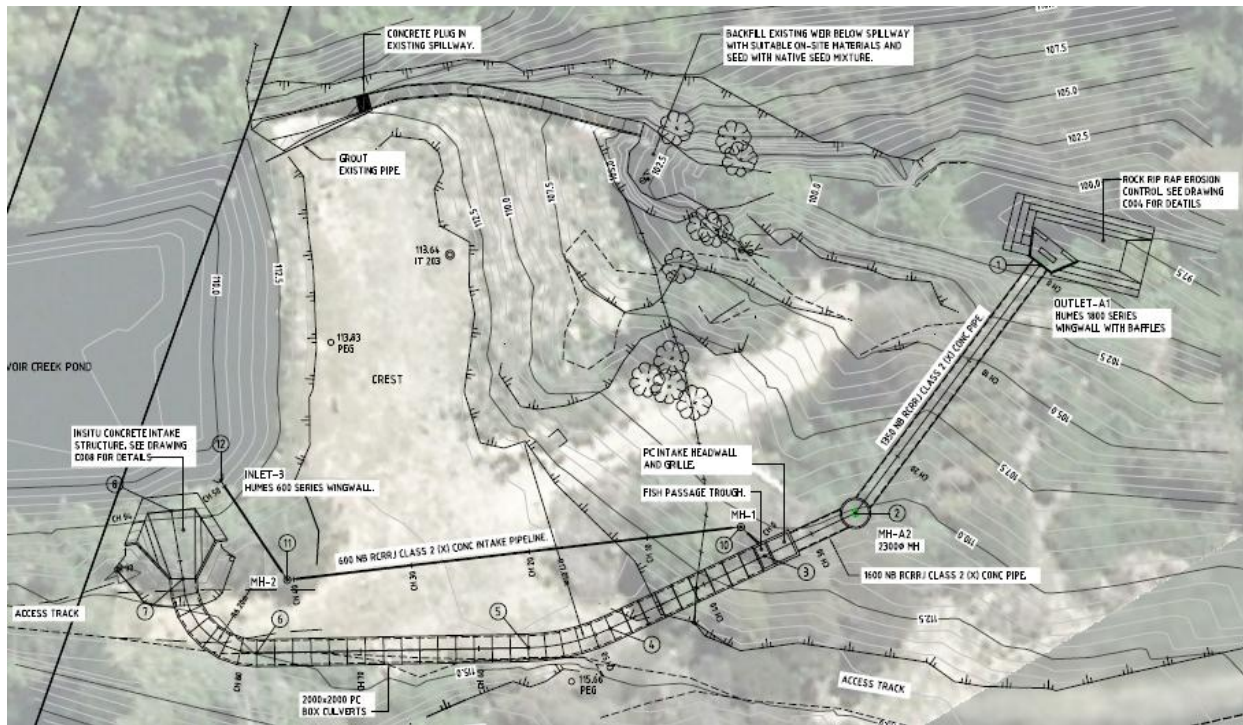
In late 2010 a design was completed, consented and HPT Authority granted. The design was for the installation of a new spillway on true right bank with high level and low level outlets (Figure 3). Due to delays with the negotiations for the purchase of the land around the dam this work had yet to start when a severe rainstorm event hit the top of the South Island in December 2011.

Figure 3: Site layout plan of the design completed in 2010 with high and low level spillways.

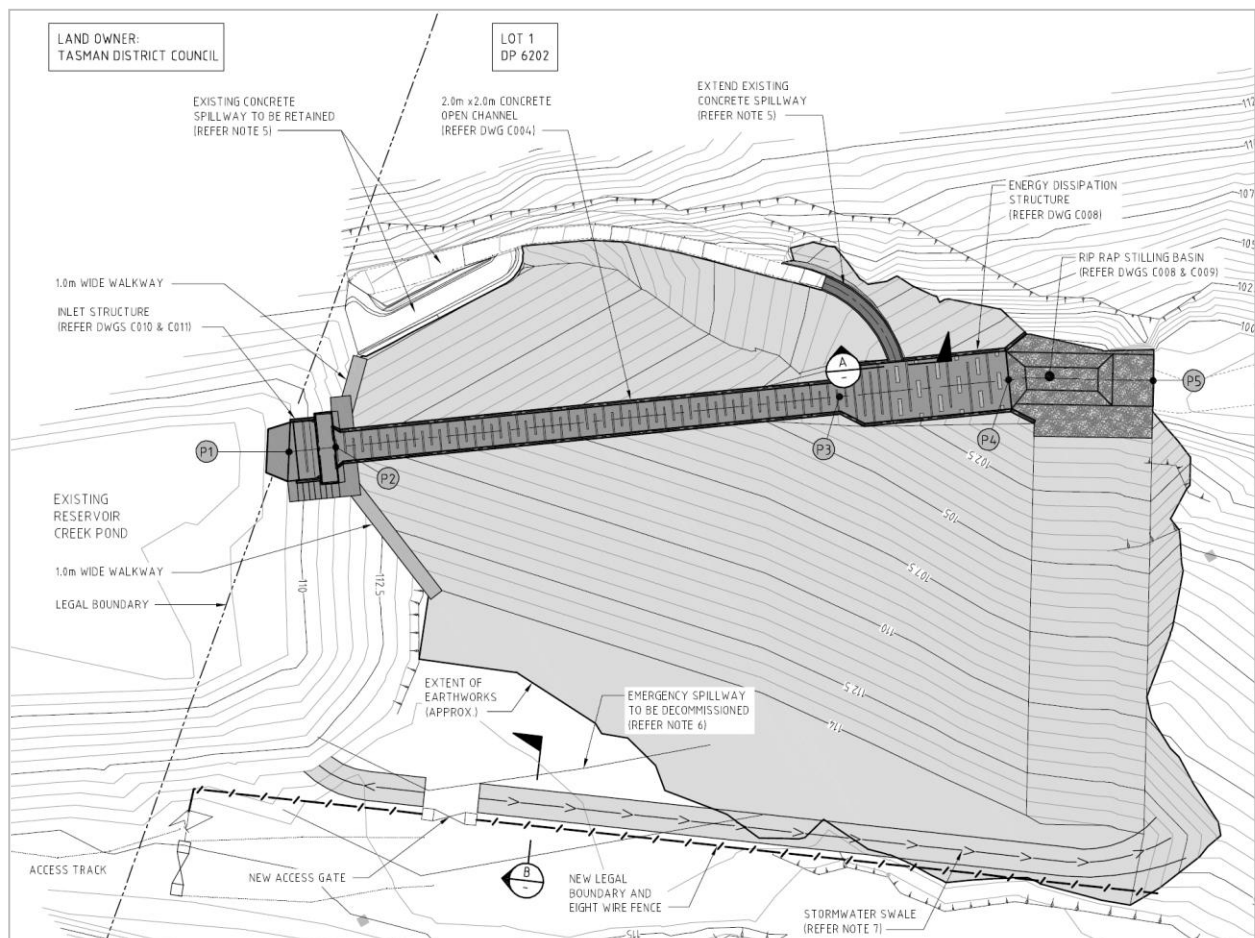
The resulting design was a spillway with a total length 50 m; including the inlet and energy dissipation structure (Figures 5 and 6). The energy dissipation structure is a wider section 4 m wide by x 2 m high x 12 m long with concrete baffles 250 mm wide x 350 mm high x 1140 mm long. At the outlet, a 5 m long riprap lined stilling basin was design to remove any residual energy in the flow before it continues down the creek bed.

The existing spillway was to be utilised as a cut-off drain to collect water running off the steep western hillside and run this via an extension to the existing spillway into the new spillway.

Figure 5: Layout plan of the decommissioning design.

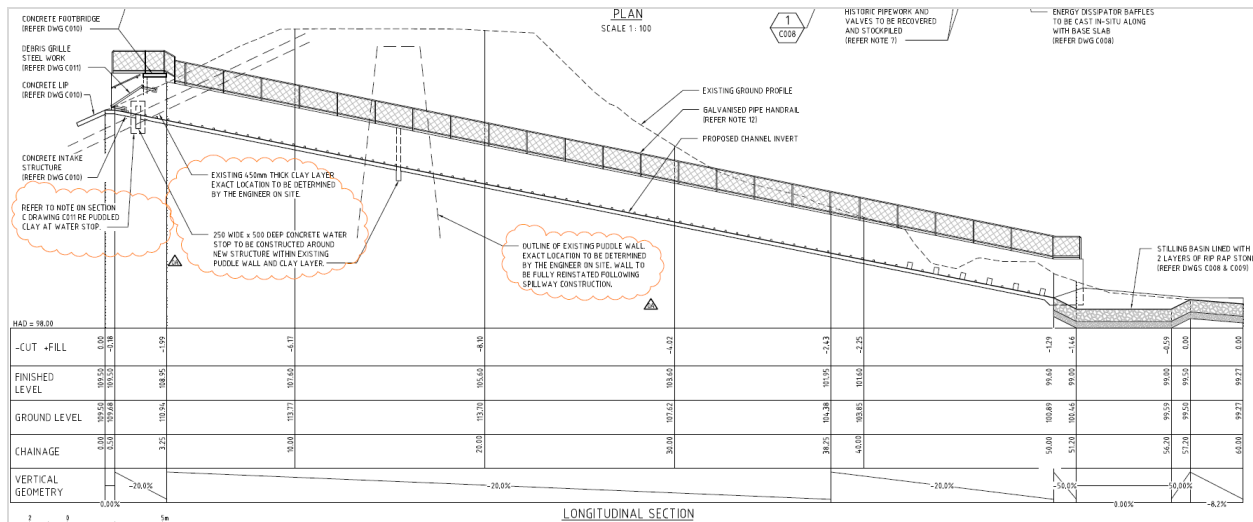
Figure 6: Long section of the decommissioning design.

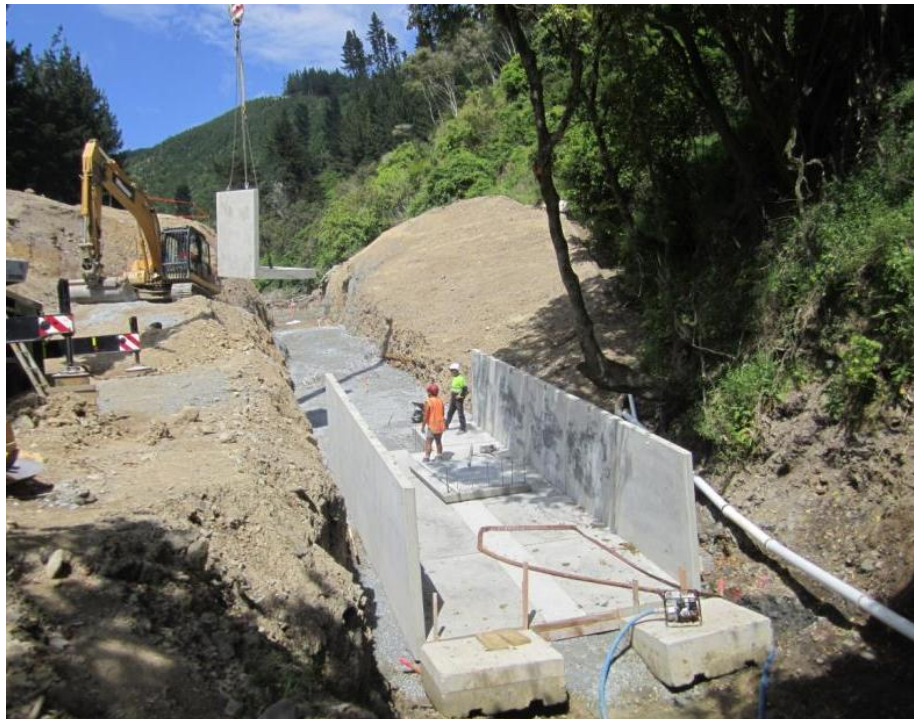
With the worst of the wet weather over, the Contractor formed a platform for the crane and the sub-contractor started installing the downstream section of the spillway. Each panel was lifted into position and levelled, followed then by the next upstream section was lifted into place and the process repeated. Each pre-cast section was connected to the preceding section with reinforcing bar connected to the downstream panel with a cast in insert and grouted into the upstream panel. A gap of approximately 20 mm between the panels was later filled with high strength grout. The panels were also connected together at the top of the walls with bolted steel plate.

*Photograph 9: installing the last of the L-Panels for the energy dissipation structure.*

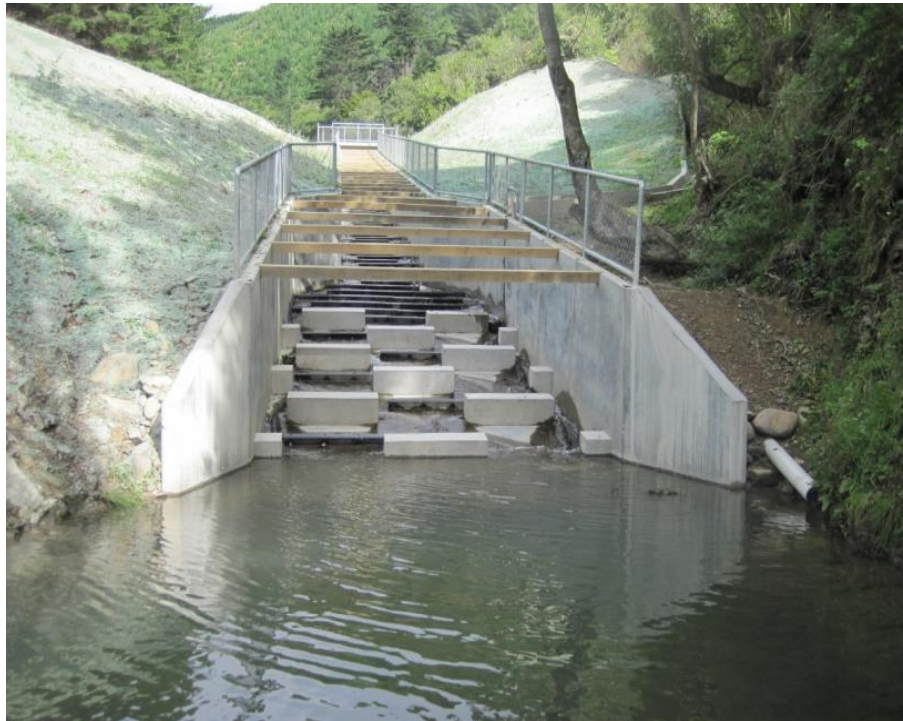
*Photograph 11: The site at Practical Completion, showing the batters hydroseeded, timber props in place, energy dissipation blocks in the foreground and the black fibreglass fish ladders.*

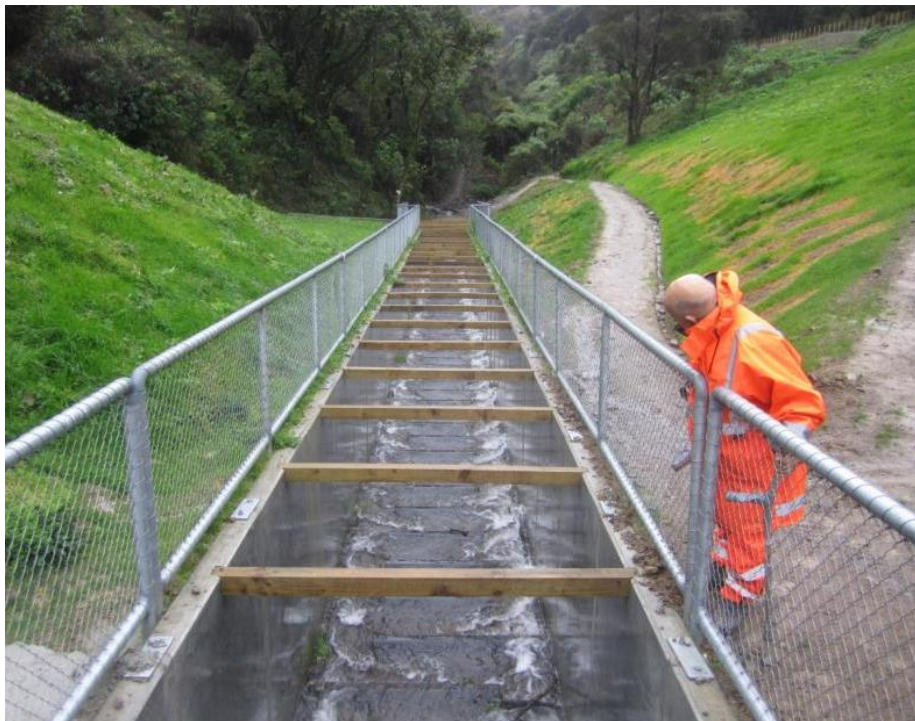
Local volunteer groups were quick to integrate the dam into the ever expanding walking track network in the hills of Richmond. The new track was formed by volunteers to the bottom of the stilling basin on the western side of Reservoir Creek. The track then crosses the creek via the boulders forming the outlet of the stilling basin and joins a walking track benched into the batter slopes of the dam past the information board and continues beyond the reservoir. The spillway sides and the bridge above the inlet are fenced to protect people from falling.

*Photograph 12: Spillway with the walking track to the right and guard rails to protect the public.*

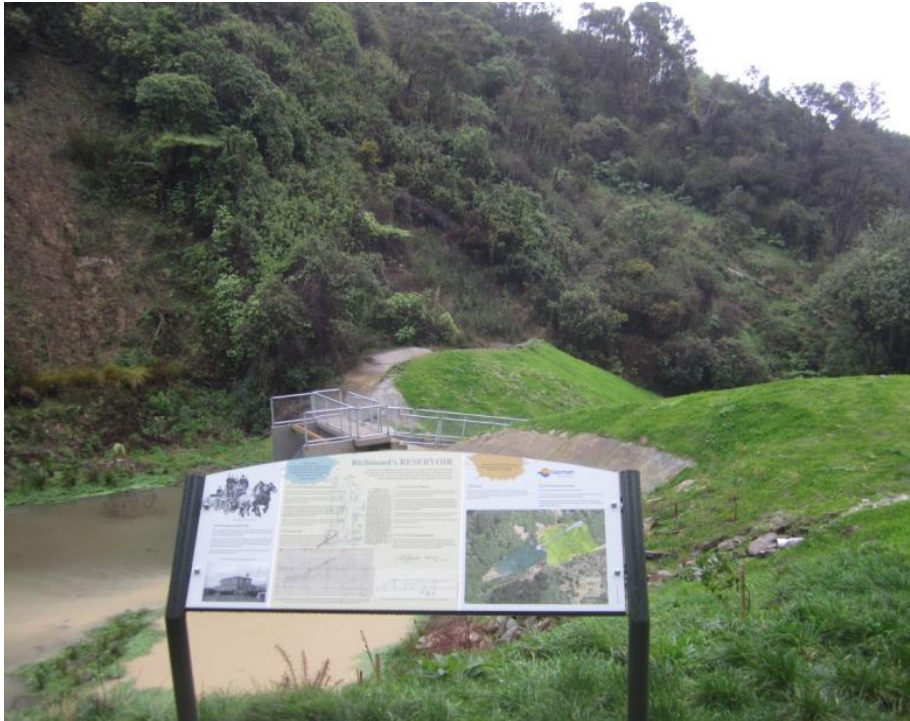
*Photograph 13: The information board overlooking the reservoir and spillway intake.*
