GET THOSE TURD TAXIS OFF OUR STREETS! – A STORY OF SLUDGE PIPELINE REPAIR IN WELLINGTON

Elliot Altham

1 MT ALBERT SLUDGE LINE REMEDIATION

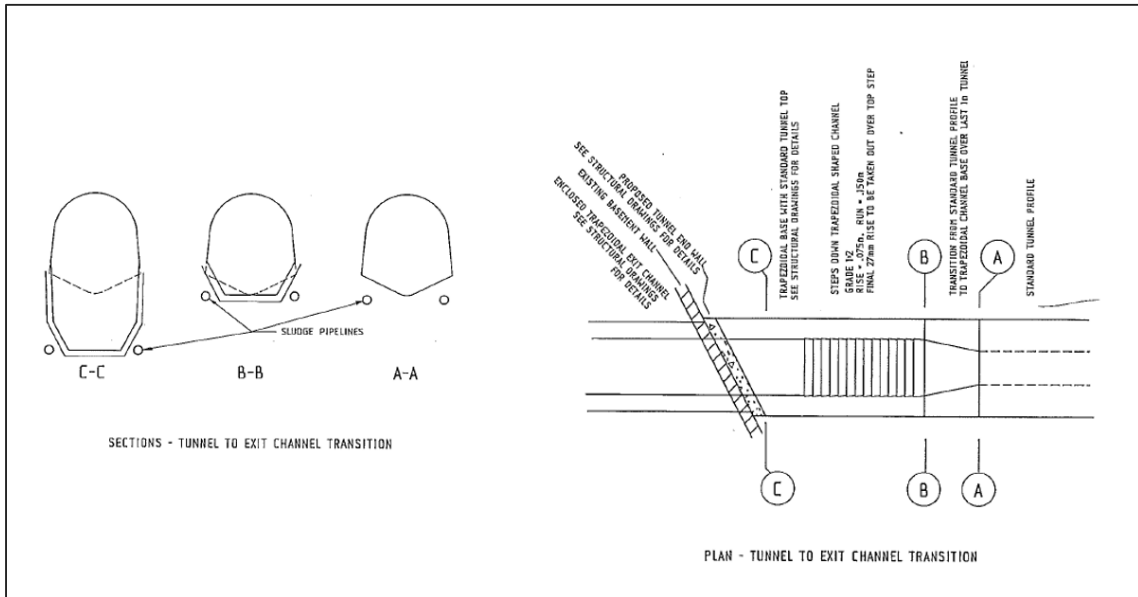
Figure 6: Kilbirnie Tunnel Transition

The very end of the tunnel, located beneath the Wellington City Council owned community garden situated between Queens Drive and Leonie Gill pathway, was assessed as a better location to expose the pipelines. At this point the tunnel transitions to a trapezoidal section via a tumbling bay.

The sludge pipelines were exposed by breaking out the tunnel benching and a stainless-steel sleeve used to transition the liner through the headwall of the tunnel. The headwall, which includes a steel plated access opening, is normally buried. The Wellington Water Customer Operations Group (COG) requested that a chamber was provided around the headwall opening for future tunnel access and to locate the SaniGrips within, this was added to the design.

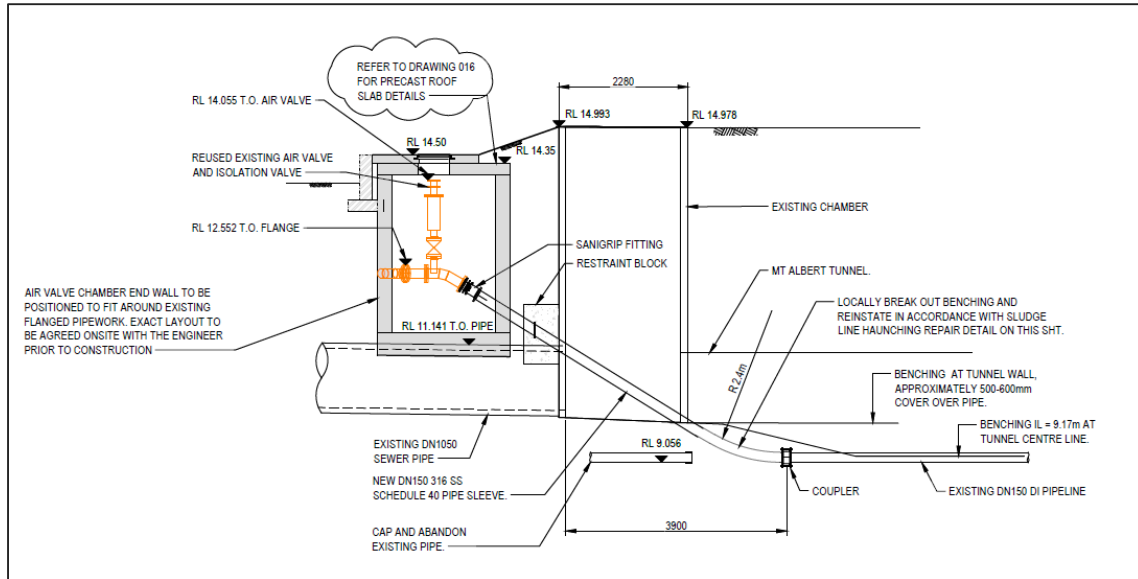
Figure 8: Island Bay Tunnel Access Chamber

The limited as-built drawing information for this site indicated that the sludge pipelines passed from the tunnel into the base slab of the 2x2m access chamber where they turned horizontally to clear the chamber footprint before turning vertically to transition to a shallower depth. Air valves and the Adelaide Road pigging station are located immediately downstream of the vertical transition.

The benching concrete was broken out at the mouth of the tunnel to expose both pipelines and stainless-steel sleeve pipes used to transition the liner out through the wall of chamber either side of the incoming DN1050 sewer.
