***E. COLI* CONTAMINATION IN “SECURE” GROUNDWATER SOURCED DRINKING WATER SUPPLIES**

*PF Callander¹, C Steffens¹, N Thomas¹, S Donaldson², M England³
Pattle Delamore Partners Ltd¹, Marlborough District Council², Selwyn District Council³*

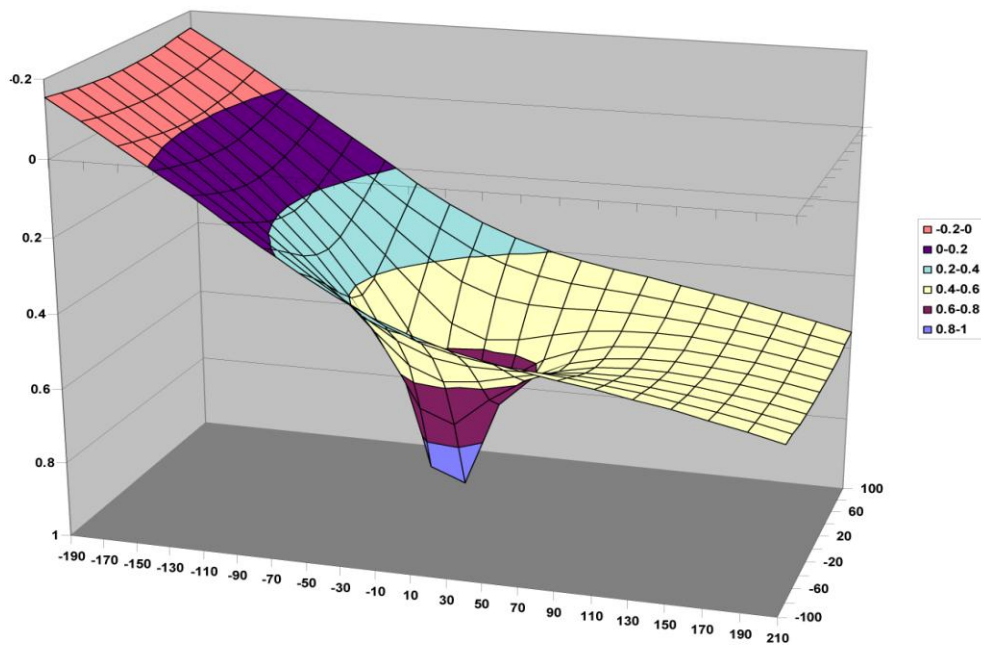
Figure 3: Three-dimensional Representation of Drawdown Around MRR Well Field Superimposed on Regional Water Table Gradient (PDP, 2008)

The lateral gradient for groundwater movement in this area is generally from west to east. Therefore, the water that enters the bore screens is likely to mainly be water moving laterally from the area to the west of the bores in addition to a smaller zone of water that is captured by the drawdown cone around the bores, which will create some downwards and eastward flow in the vicinity of the bore head, due to the combined pumping effect of the three MRR bores, as demonstrated by the modelled drawdown cone shown in Figure 3.

Static groundwater levels in the area are around 1 – 3 m deep and the pumping from these bores creates a drawdown at the bores amounting to an additional decline of around 1 – 2 metres.
