WASTEWATER PUMP STATION 15 – A CASE STUDY IN ASSET REUSE AND RESILIENT DESIGN

*W Jacobson, Designer at Stronger Christchurch Infrastructure Rebuilt Team (SCIRT),
Water and Waste Engineer, MWH, GIPENZ*

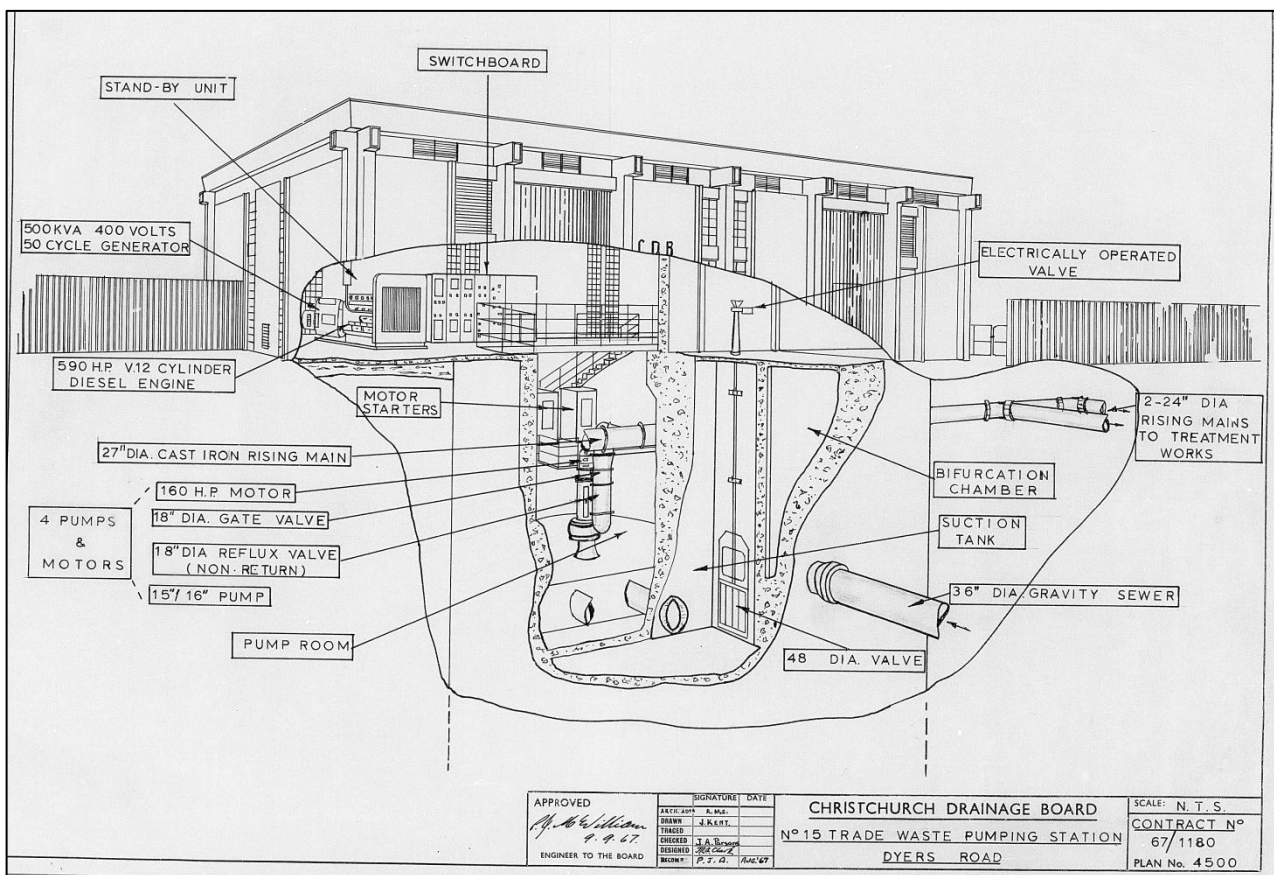
Figure 2: Pump Station 15 1967 For Construction Perspective Plan

was part of the station superstructure but was designed to be supported by a separate pad foundation. This configuration is summarized in the 1970's For Construction Schematic depicted in Figure 2.

To enable repairs to the pressure mains, the concept design highlighted the need to isolate the pump discharge manifold at the midpoint between Pump No. 2 and No. 3 (refer Figure 2). This will be done by installing an electrically actuated knife gate valve during a series of controlled station shut downs. This valve installation will enable PS15 to remain in operation while a second caisson pressure pipe outlet is installed. This additional outlet will allow for replacement of the existing temporarily repaired pressure main outlet, replacement of the damaged valve chamber and connection to the existing pressure mains.
