CHRISTCHURCH COLLAPSED BRICK BARREL STORMWATER REPAIR

Preston, Tim

The Antigua Burke Stormwater rebuild project, undertaken by Stronger Christchurch Infrastructure Rebuild Team (SCIRT) as part of EQ repair for Christchurch City Council, included a section of brick barrel pipe with several unusual features. These provided significant challenges for asset investigation and design, prompting a variety of uncommon techniques for investigation, repair and rebuild, and several changes of direction as the investigation and design proceeded.

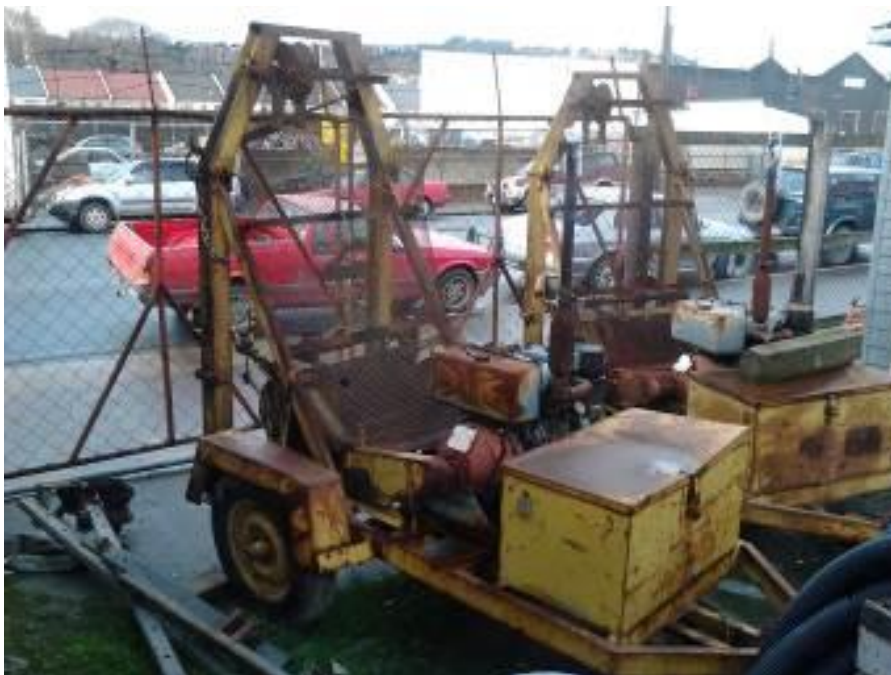
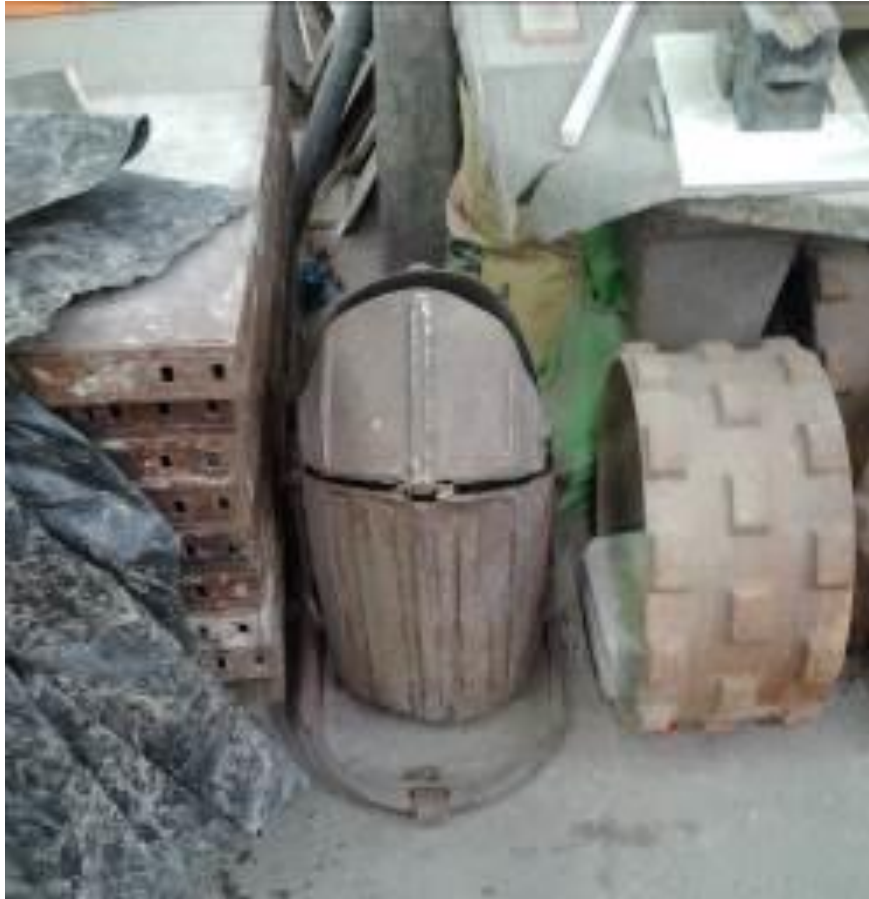
Photograph 8 and 9, Drag buckets and equipment

We learned that drag buckets could reasonably be deployed into either end of the pipe, although up from the downstream end was generally preferred. The bucket would be dragged, using cables and pulleys, mouth open into the debris, filling up as it was pulled in. A bucket lid was arranged so as to close when the pull on the bucket was reversed in order to remove the bucket when full. The operator typically had no visibility of the bucket during this process, therefore considerable skill would need to be developed from experience operating, to gauge how much weight to pull the bucket with and whether (from the feel of the winch) the bucket 'felt' like it was ready to remove. To use this equipment, our operators would have to develop these skills on the job.

Drag bucket cables pull in a straight line, with pulley in the base of the manholes at either end of the pipe. This works well for typical straight sections of pipe. In our case, the curved and bent horizontal pipe alignment meant further challenges with the cables. The curve radius was considered broad enough to have only a minor impact on operations, with the cables expected to run partially along the inside curve of the pipe. The bend midway along was more of a concern, but the angle of cable bend was evaluated and considered small enough that the method still had a reasonable chance of success (refer geometry diagram above).
