Stephen Molineux & Timbi Poon

Asset Management of Brownfield Reservoirs – Opportunities/lessons from a comprehensive condition assessment and remediation programme

WSP & Beca-HunterH20

water
NEW ZEALAND
CONFERENCE & EXPO
17-19 OCTOBER 2023
Tākina, Te Whanganui-a-Tara Wellington

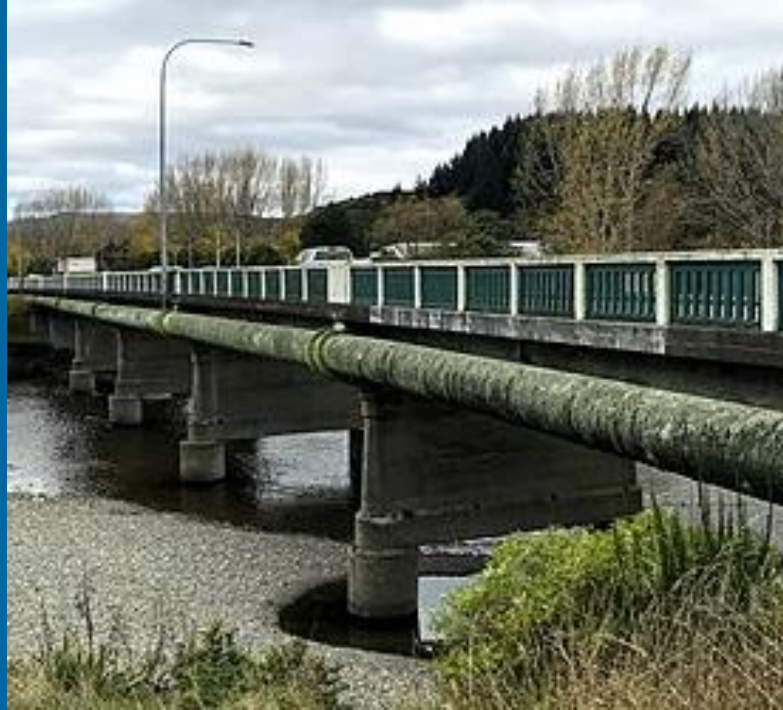
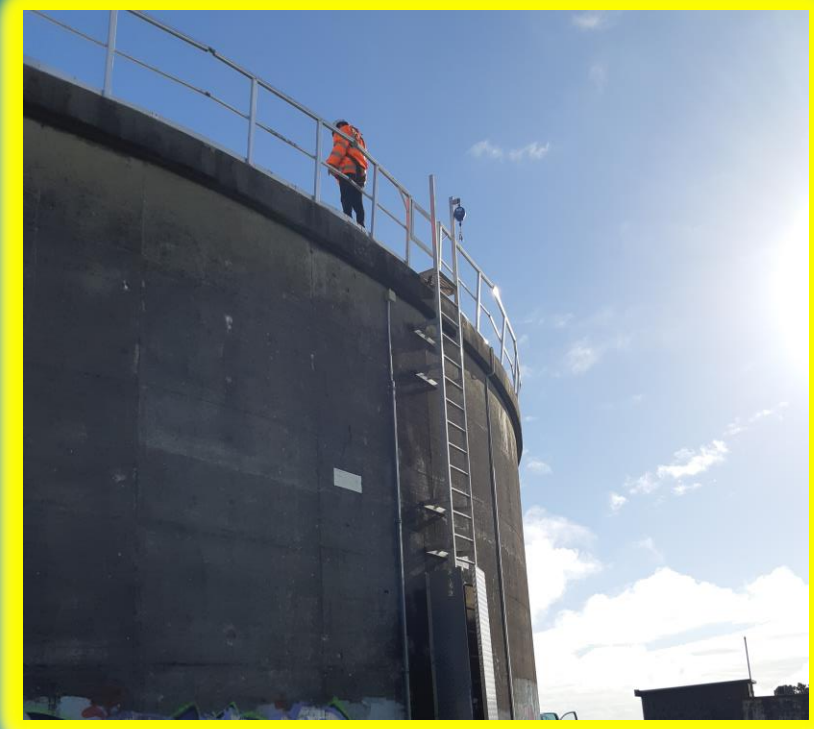
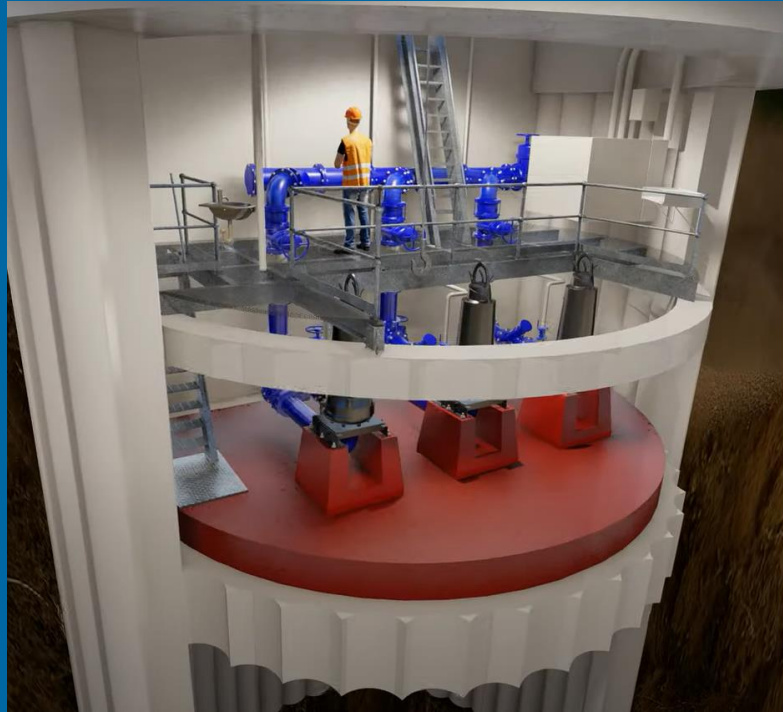
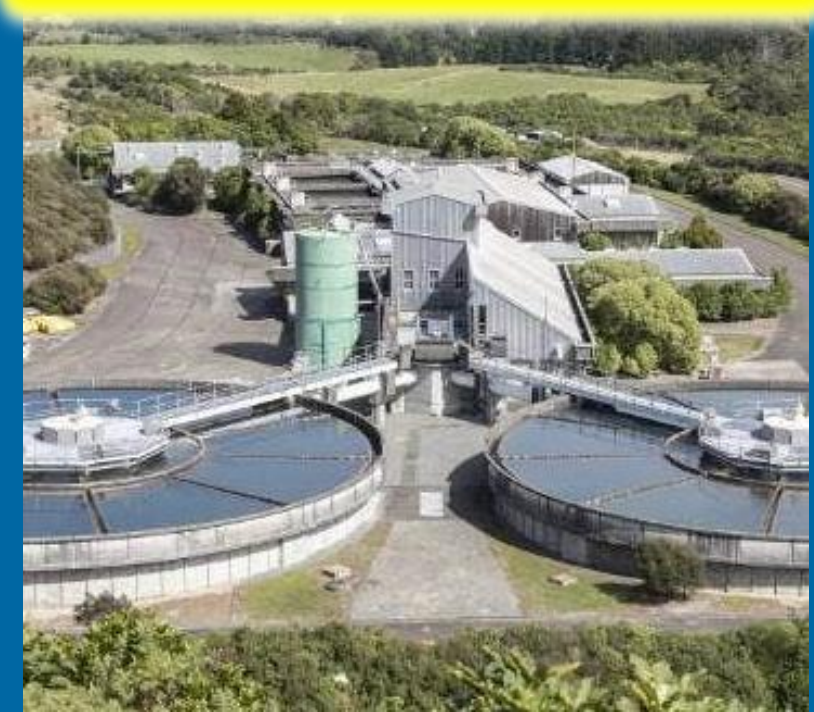
140 Drinking Water Reservoirs External Visual Condition Assessment

1. Health and Safety – Preventing falls from height
2. Structural Durability Failure – Identification of immediate risks and longer-term vulnerabilities. Excludes Seismic.
3. Water Quality – Assessment of contamination resilience.

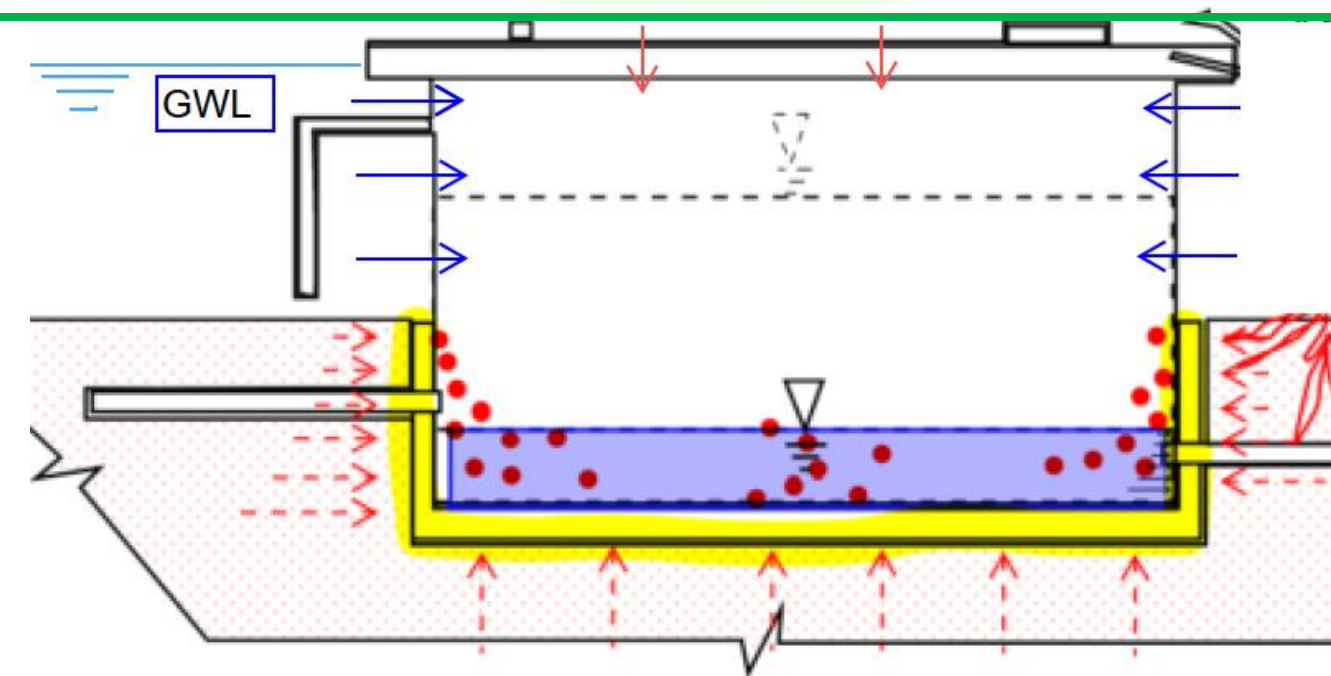
Buried Reservoir

Contamination Resilience – Above ground vs Buried
