A FLOOD TWO MONTHS IN – A WAIĀRI RESILIENCE STORY

Rodney Clark (Tauranga City Council), C Olivier (Beca)

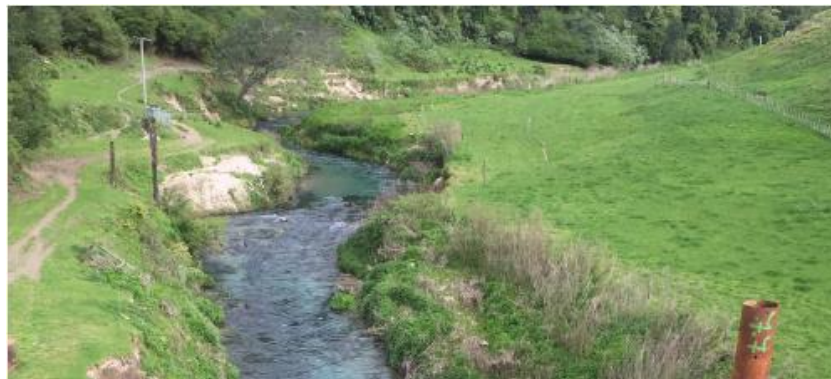
The intake structure is located within a flood plain with soft, liquefiable alluvial materials, underlain by ignimbrite at about 12m below ground level, at the base of a steep, 80m deep gully. The alluvial materials are interspersed with organic materials, logs, and tree stumps to depth.

Photograph 2: Intake site - pre-construction.

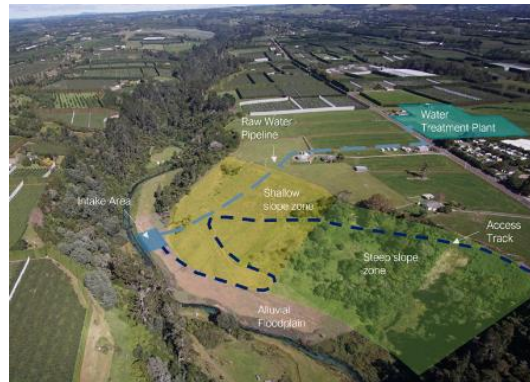
The gully slopes are formed of residual volcanic soils overlying older ignimbrite flows. The slopes are marginally stable with much evidence of historic landslides. The permanent access to the intake site had to be established via this steep gully slope.

Figure 3: Intake site-topography.

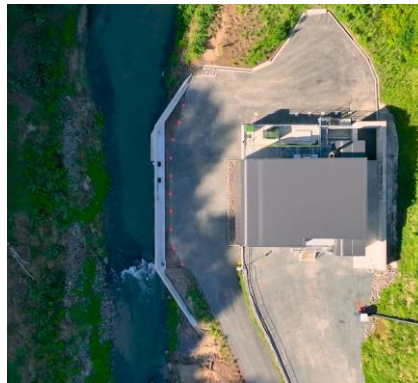
The intake consists of a set of six passive intake Tee Screens. Particular care was taken in the design to avoid the possible entrapment of flood debris. While scour protection of the in-stream training works was based on a flood of annual probability of exceedance of 1:250 year.

Photograph 4: River training works and intake screening structure.

The river training works withstood the flood effects well. The only sign of scour damage was to the screen servicing platform behind the parapet wall and that had no effect on the intake and pump station operation.

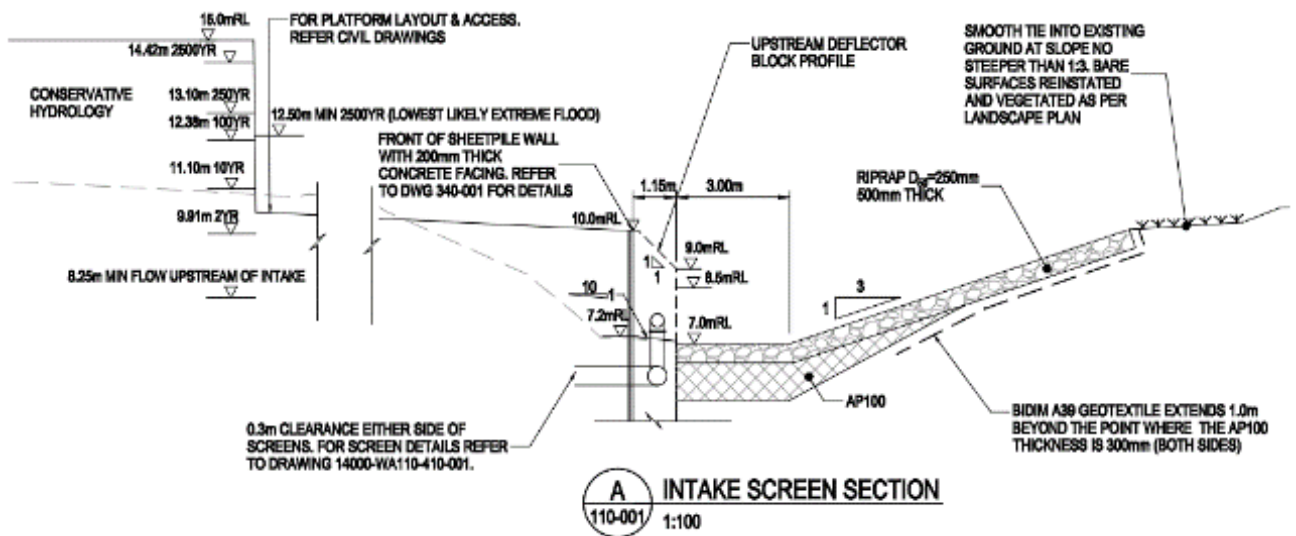
During the resilience workshops it was agreed that this area be categories as being non-sensitive to flooding. This was on the basis that during a flood event this area would not need accessed by operators and that the flooding of this area would also not inhibit the ability of the intake to operate. To achieve a balance between minimizing impacts on adjacent properties, achieving operational maintenance reach, and flood impacts, an annual probability of exceedance against flooding was set as 1:10 years. A focus on keeping the area clear of protrusions to avoid debris hang-up was implemented although a solid parapet wall was set as a prerequisite by the operational team as an operational H&S requirement.

Figure 5: Flood level design criteria for intake and platforms.

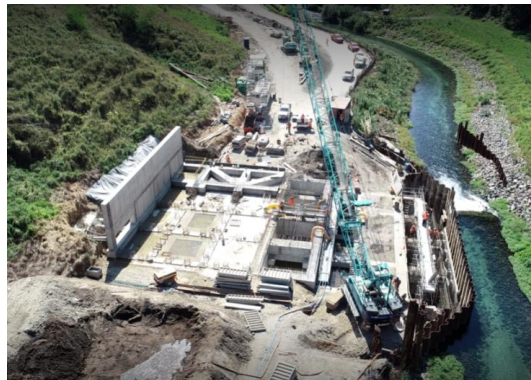
Significant ground improvement and foundation work was required to achieve the design standards with a lattice of CFA piles installed to prevent liquefaction.

Photograph 5: Ground improvements and deflector wall under construction.

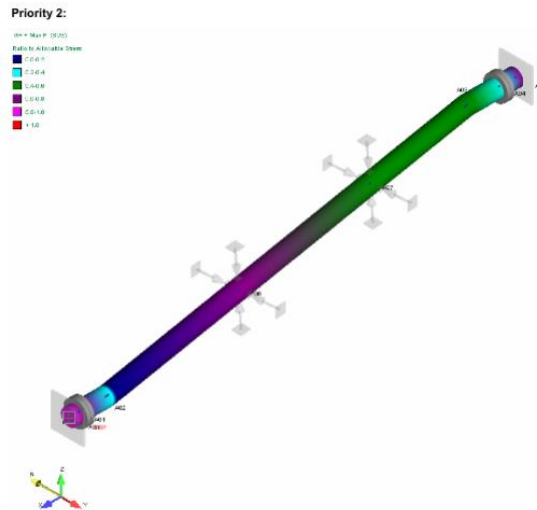
Notwithstanding the significant ground improvements and foundations to intake building it was still anticipated that the building could have a movement of in order of 500mm towards the stream in a 1:2,500 earthquake event. The pipelines and services ducts were therefore designed with "soft connections" between the building and the directional drill exists, providing the pipelines the same resilience standard as the main pump station building.

Figure 6: Pipe stress analysis of "soft connections".
