# USING MODERN TECHNOLOGY TO SOLVE PROBLEMS TAURANGA'S WASTEWATER OCEAN OUTFALL

*M. Mooney (Bay Dynamics NZ), C. Thomas (Tauranga City Council)*

This paper will provide insight into some of the problems facing TCC with its existing Ocean outfall asset and some of the mitigations currently underway to investigate these.

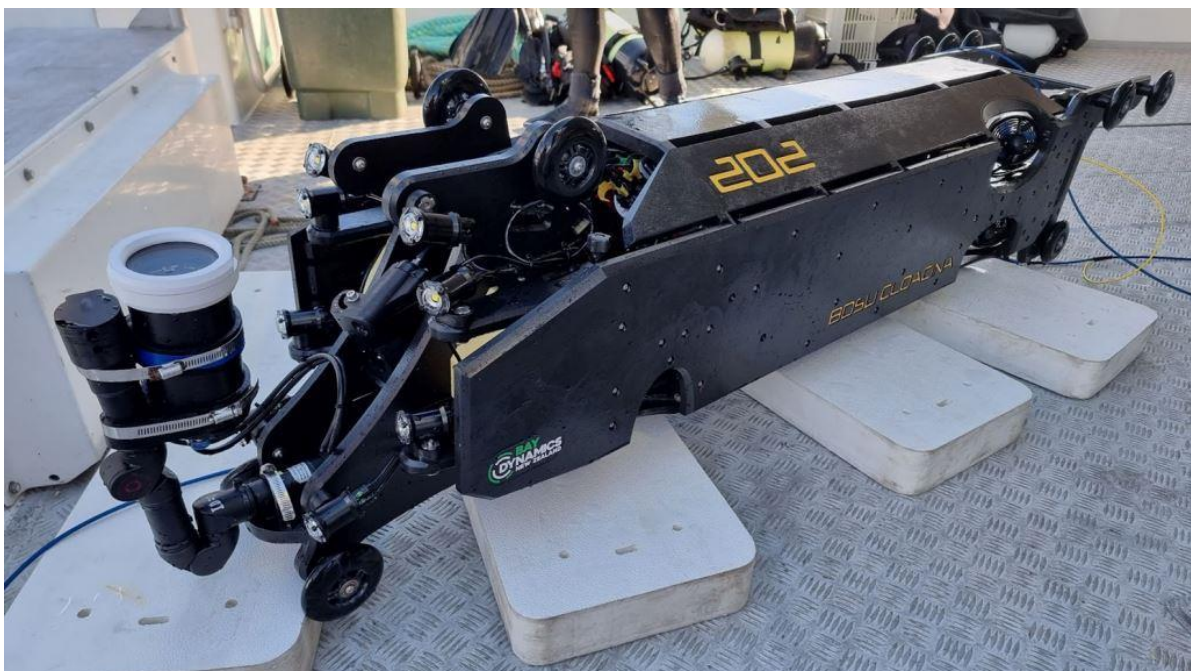
*Photo 10: ROV with Inspection Payload*

The second operational phase involved using the high resolution camera to inspect the internal pipe wall and joints. This inspection established that a significant number of joints had excessive grout protrusions into the pipe.

The inspection yielded very good images and detected some type of anomaly on almost every one of the 316 joints. The most common anomaly was the excessive grout protruding into the pipe.
