THE CHALLENGES OF RELINING A BRICK CULVERT IN AN URBAN ENVIRONMENT

Branko Veljanovski, Principal Design Specialist, Auckland Council

Sarah Sinclair, Chief Engineer, Auckland Council

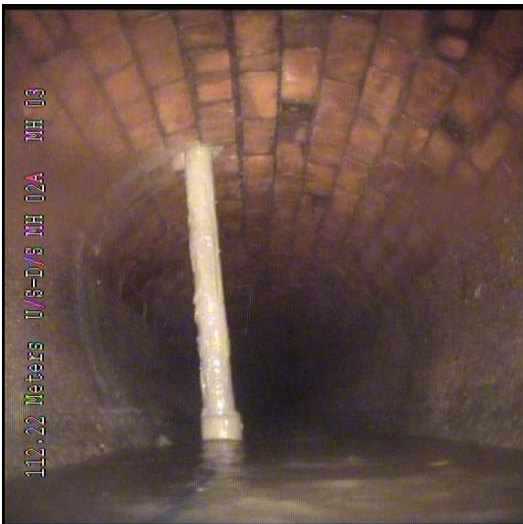
Fig. 17 Establishing the centre of the culvert

The position of the shaft above the brick culvert was determined by probing an 80mm core into the culvert to verify the centre and depth of the pipe, whilst this was monitored internally by CCTV camera from within the culvert. Once the centre of the culvert had been verified (Fig. 17), four additional bore holes were drilled to the soffit level of the culvert. These four holes ensured that the subsequent layers of fill material placed over time were free of large obstructions placed in the fill that could prevent the installation of the shaft.

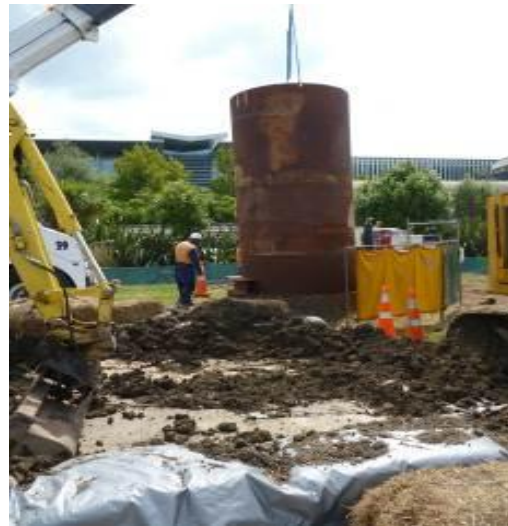
Fig. 18 Installing the steel casing

The shaft site was initially excavated to a depth of 1.0m to remove topsoil. The excavation was approximately 3.0m x 3.0m in area and it formed the capping level for the primary shaft. An initial 1.5m diameter auger was used to bore a hole to a depth within 0.50m of the brick work of the pipe. The 2.0m diameter primary steel casing was installed simultaneously with the auger (Figures 18 and 21).

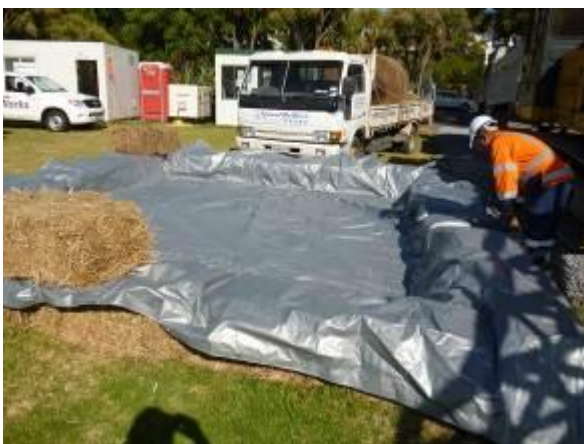
Fig. 19 Site Preparation for soil management

Figures 19 and 20 show the site preparation for management of the contaminated soil.

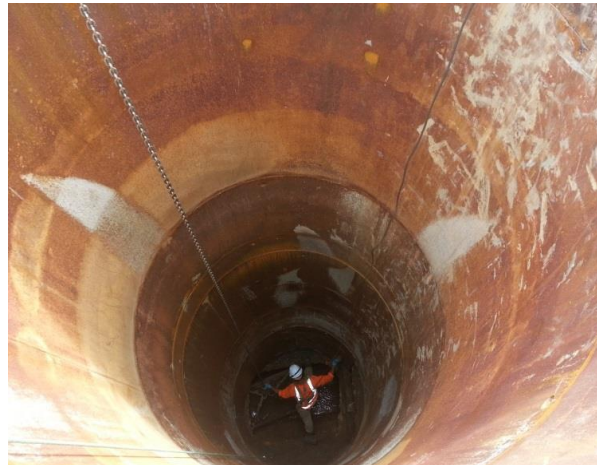
Fig. 21 Access shaft with steel casing

At the capping level, two waler beams were welded to the top of the primary shaft to support the shaft, and prevent any applicable loading being transferred onto the culvert beneath.

The shaft provided safe access to the culvert for the purpose of installing the CIPP liner. An additional 2.5m diameter top shaft section was fitted above the primary shaft. This also formed a safety barrier around the shaft while still allowing easy access to the shaft through the opening gate. A protective bead was welded around the top edge to prevent any damage or injuries from the exposed steel edge.

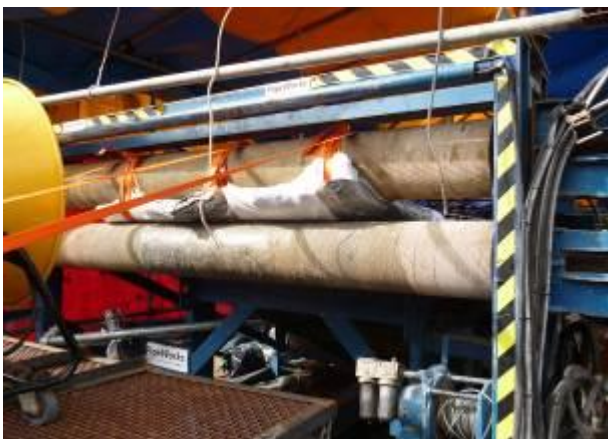
Fig. 22 Sealed Liner laid out on the roller system

The 1350mm diameter liner was laid out on the roller system approximately 48hrs before the over-the-hole wet-out process was commenced (Fig. 23). A 12 tonne excavator was used to facilitate this operation, with extra special care taken in order not to damage the liner whilst it was being laid out.

Vacuum 'cups' were placed at 3-4m intervals along the laid out liner to vacuum the line for at least 12 hours prior to the wet-out process to eliminate any air pockets that may inhibit uniform resin migration through the liner.

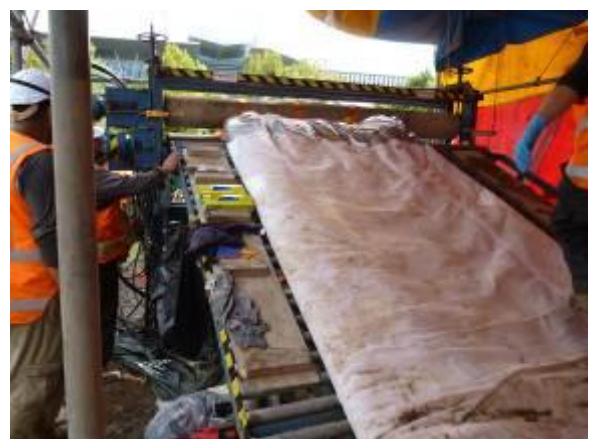
Fig. 23 Liner impregnation conveyor

The resin was transferred to the liner via air pump while vacuum controls on the liner continued for the duration of the wet-out operation. After the first batch had been added to the liner, the liner was sealed and then rolled through the roller system at the pre-set gap measurement, ensuring that the liner had the correct volume of resin per lin.m for the thickness required (Figures 22 and 25). The liner was inverted directly into the host pipe from the wet-out roller utilising the "Over-the-Hole Wet-Out" technique (Figures 25 and 27).

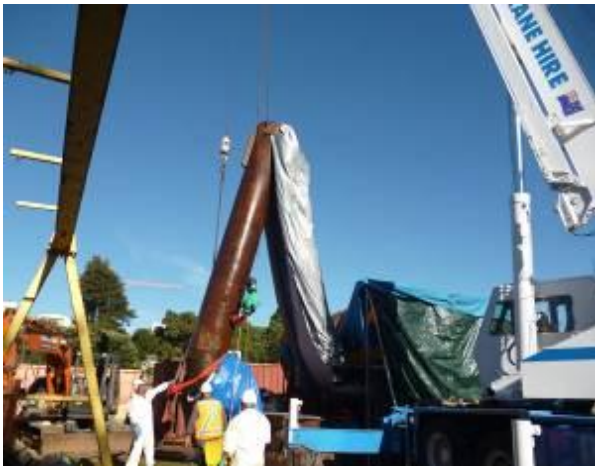
Fig. 24 Liner Insertion

Figure 24 shows the crane lowering the liner attached to the custom-made steel chute (90 degree return at bottom end) into the new access shaft before the insertion starts.

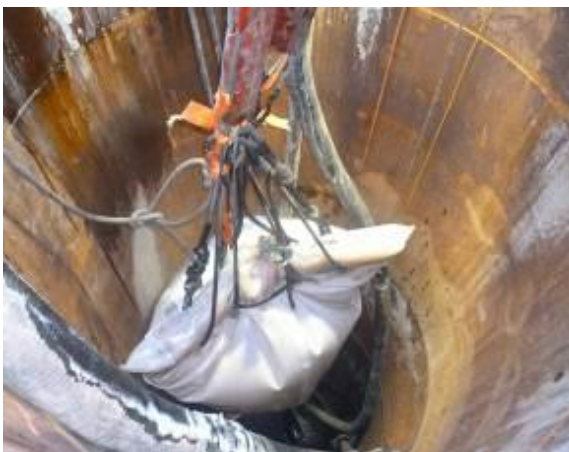
Fig. 26 Liner inversion setup, top of access shaft

Displaced water at the upstream end-point was drawn off with pumps and discharged to a nearby sewer manhole. A pre-manufactured liner bag end was attached to the tail of the liner; a holdback rope was attached to this bag end which enabled an effective control of the inversion speed. The holdback rope was run through a suitable bollard. Figure 26 shows the liner inversion setup viewed from top of the access shaft.
