RESPONDING TO A 100 YEAR STORM – AN ACTUAL EXAMPLE IN AUCKLAND

Frank Tian, Barry Carter, Nick Brown, Dukessa Blackburn-Huettner and Mark Thomson – Auckland Council, New Zealand

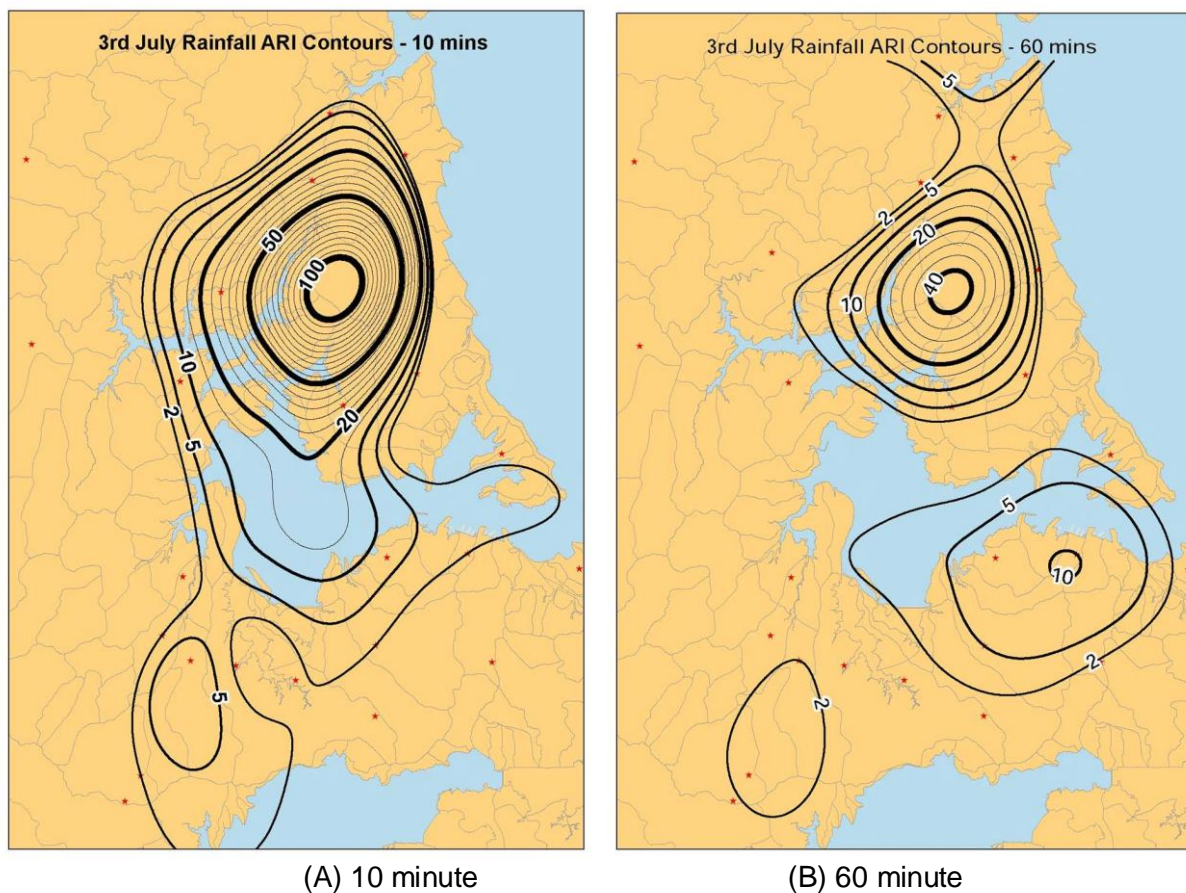
Figure 1 Rainfall intensity of 10 (A) and 60 (B) minute duration

As discussed in detail by Carter (2013) and Irvine (2013), a narrow band of rain moved onto the Auckland area from a northwesterly direction at approximately 12:30 pm on 3rd July 2012. The entire rainfall process lasted for less than 120 minutes and the heaviest period was shorter than 30 minutes. The worst hit area was around Albany in northern Auckland, and the 10 minute duration intensity was about 1% AEP. Figure 1 shows the distribution of 10 and 60 minute duration rainfall intensity over the northern Auckland area.
