# RESTORATION OF STORMWATER INFILTRATION BASIN PERFORMANCE

*Richard Brunton and Andrew Brough (Pattle Delamore Partners Ltd)*

## ABSTRACT

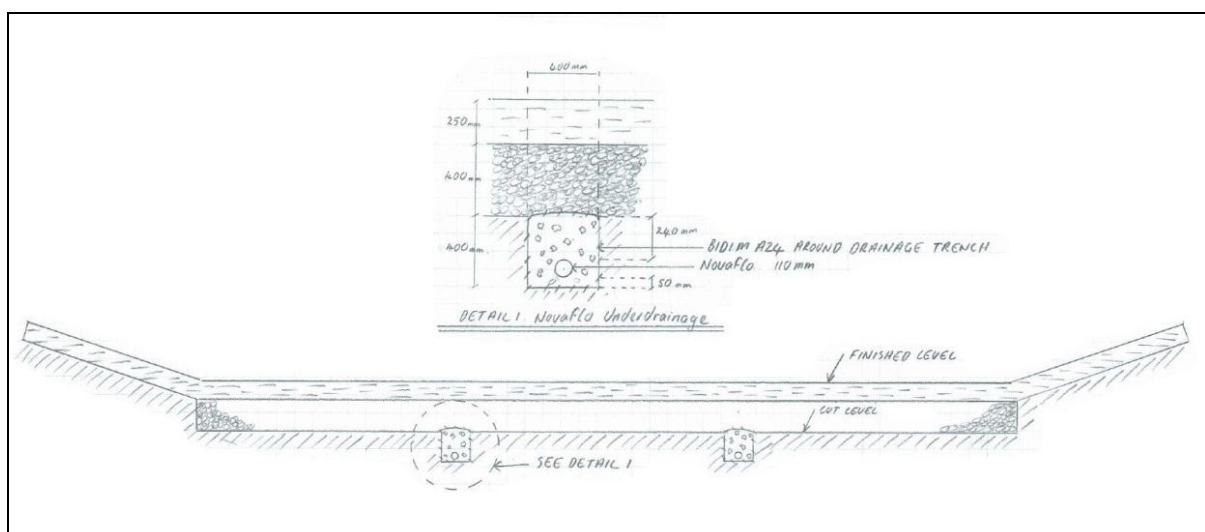
Figure 1: Typical infiltration basin design

Care must be taken not to over mix the infiltration media components as this may break up the natural "clods" resulting in poor drainage through the topsoil. For example the use of rotary hoes should be avoided when combining the components. Once mixed the infiltration media top soil is placed on the floor and sides of the basin and minimally compacted (to the extent necessary to allow sowing of grass). Vehicle movements on the basin floor and sides should always be avoided to prevent over-compaction of the infiltration media. Once the media is in place the basin is generally grassed with hydroseed. Figure 1 shows a typical cross section of an infiltration basin with under drainage.

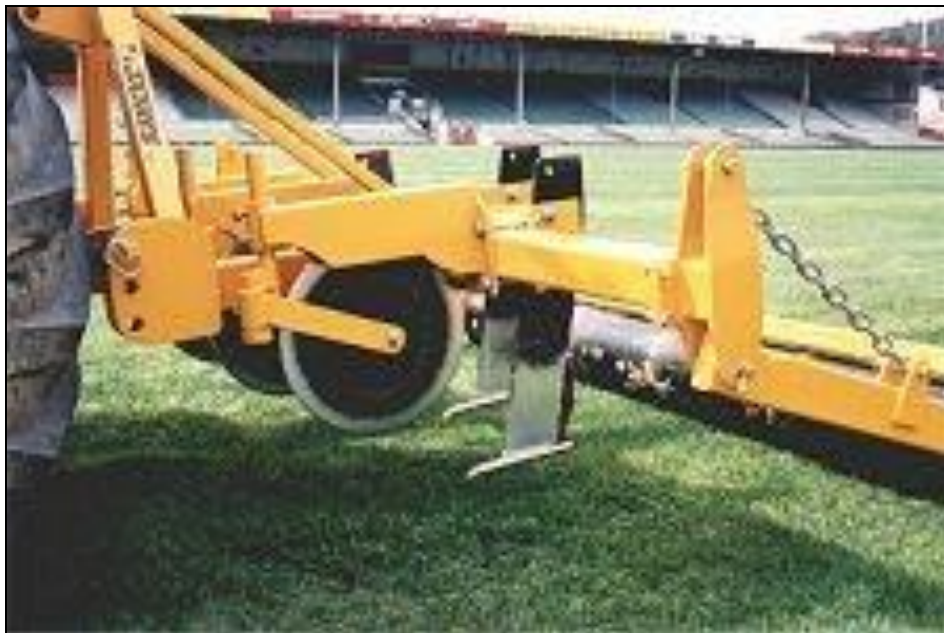
*Figure 3: Turf aerator*

Aeration was initially carried out within the media as it was suspected that the media that was re-laid immediately after the earthquake may have been over compacted. In this case soil aeration was considered to be a significantly cheaper option than replacing the media layer. In this case a turf aerator for sports fields was considered suitable. Figure 3 shows a photograph of a similar aerator.

The aeration of the basin resulted in no notable increase in infiltration rates and the basin condition continued to decline. The media layer appeared to be uniform and therefore it was considered that further aeration at different depths within the media would also be ineffective.

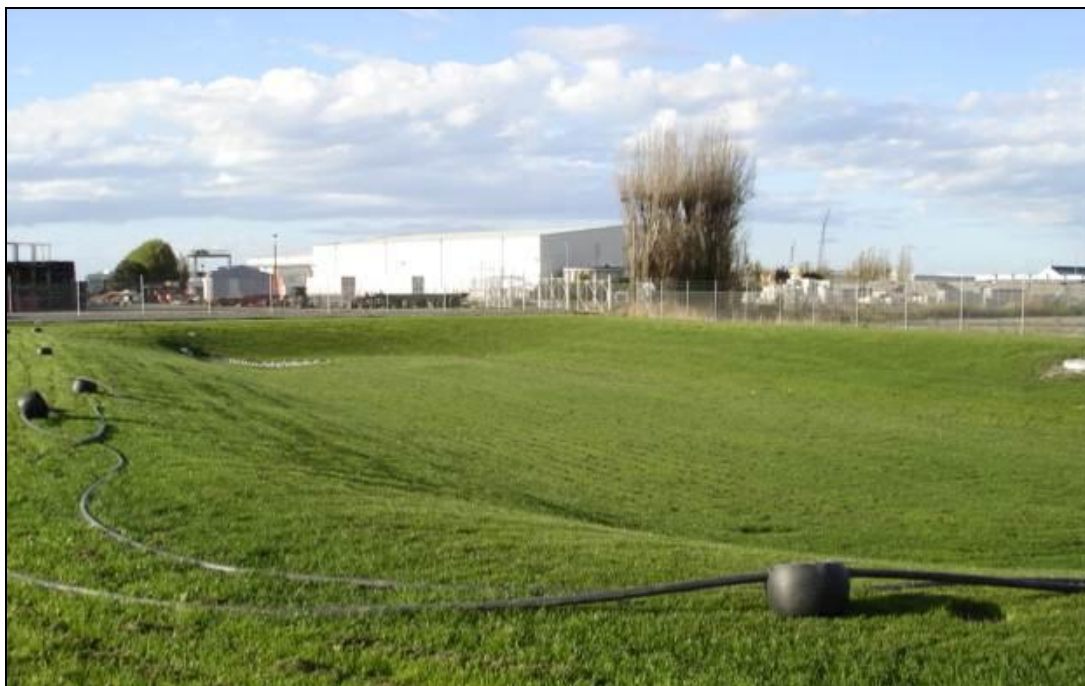
*Figure 9: Basin after construction*

Initially after construction of the basin was completed the basin showed healthy grass cover. Due to the low rainfall during, and soon after construction, the infiltration performance of the basin was unknown. Figure 9 shows the basin in a healthy looking state three months after construction.

Once rainfall increased after the summer months significant ponding and grass die off was observed in the basin. Infiltration testing was carried out in July 2007 which showed very low infiltration rates of 0 - 6 mm/hr in four different locations within the basin.

Soil aeration similar to that described in the previous case study was carried out to break up the soil structure and increase infiltration rates. Subsequent infiltration tests confirmed rates between 10 and 80 mm/hr in four different locations within the basin. As
