CHRISTCHURCH BRICK BARRELS SEWER REHABILITATION

Maurice Lubbock Principal Engineer, AECOM New Zealand Ltd
Philip McFarlane Principal Engineer, Opus International Consultants Ltd

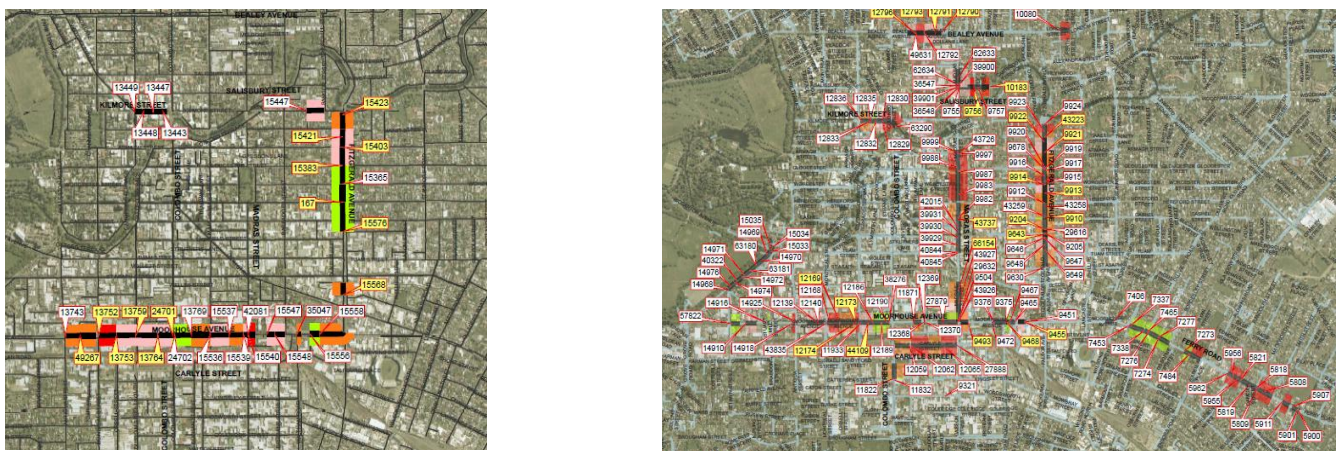
Figure 16 Stormwater and wastewater sewer surveys completed by mid-July 2012

Figure 16 shows the results of this classification, as of early July 2012.

Approximately 5km of wastewater sewers and 15km of stormwater sewers had been surveyed and assessed by July 2012. The stormwater total greatly exceeds the wastewater total.
