FIBREGLASS PUMP STATIONS: 10 YEARS EXPERIENCE IN NEW ZEALAND

Holyoake, K.M.; ARMATEC Environmental Ltd, and Guthrie, B.C; ITT Water & Wastewater NZ Ltd

ABSTRACT

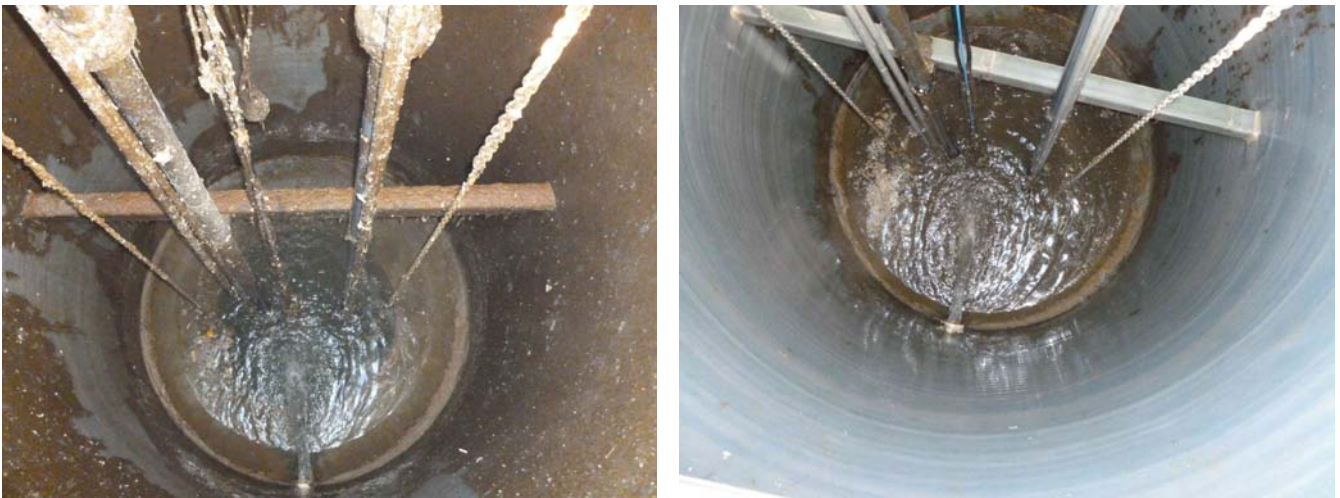
Fibreglass manufacturing techniques result in smooth sidewall finishes on the inside of the vessel. Wastewater solids can still stick to the walls, but are easily and quickly cleaned down with a standard hose or well washing regime.

Photographs 5 & 6. Fibreglass pump station before and after 5 minutes cleaning with hose.

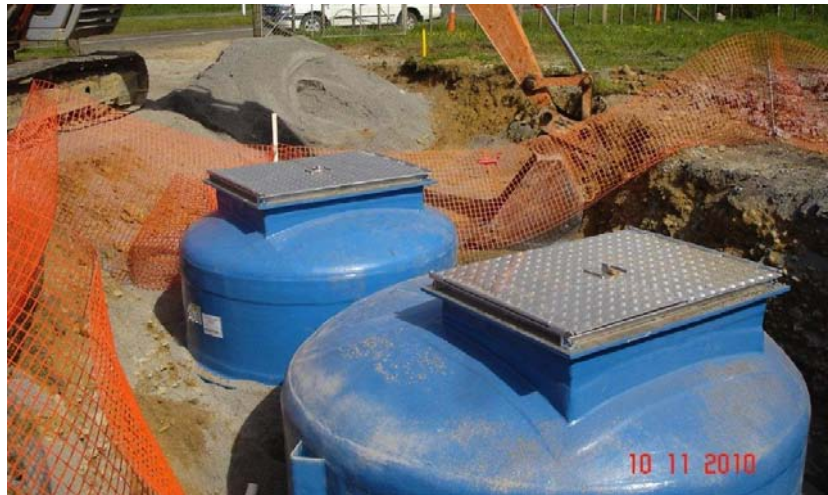
The Eketahuna pump station was installed in 2010 to handle wastewater from the lower parts of the rural town of Eketahuna. The installation included a fibreglass valve chamber. The supervising engineer from the Tararua District Council stated (Bonny, 2011) that the installed cost was about the same, or a little lower, than building it in traditional all concrete. He stated that there were huge savings in reduced health and safety costs, as no one needed to enter the pump station during construction. These savings in time, resources, supervision, and labour are often difficult to quantify. Total project cost analysis showed that the costs of the fibreglass vessels were only 30 percent of the total pump station and valve chamber project cost.

Photograph 18: Eketahuna Fibreglass Pump Station and Fibreglass Valve Chamber
