USING TRENCHLESS TECHNOLOGY TO SEAL PRIVATE LATERAL CONNECTIONS TO MAINLINES-POST REHABILITATION (LATERAL JUNCTION REPAIRS)

by Dinesh Satija, Project Engineer, ProjectMax Ltd., Auckland

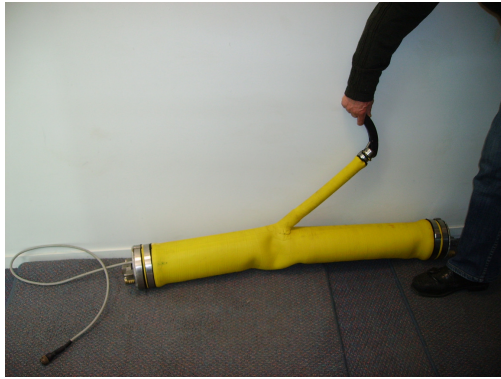
Figure 4: LJR Packer

A LJR packer is typically around 1.2 to 1.5m long made up of steel tubes covered with a special rubber on top. The inside of a packer would generally contain a steel skeleton and inflatable rubber tubes with air hoses. The packer inflates like a balloon when the air is blown inside.

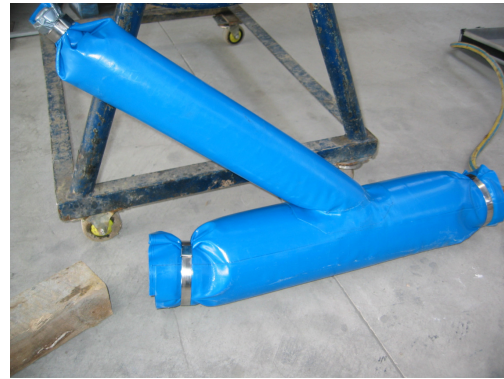
Figure 5: LJR Packer

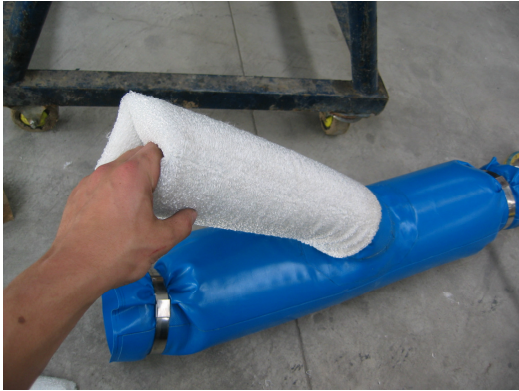
Figure 6: Inverted liner inside the lateral

A quick CCTV will confirm the appropriate sealing of the junction. While, in the second method of installation the packer is pulled by ropes between manholes and once it has reached the lateral's point, the felt is inverted inside the lateral using compressed air. In both situations, the felt is held tight up against the inner wall (of the host pipe) and then cured till the resin is hard enough for the felt to hold in its place.

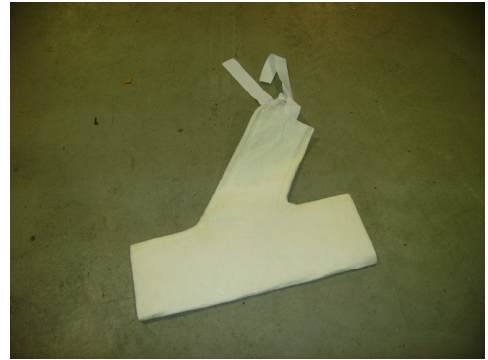
Figure 7: Y-Junction Felt Sample

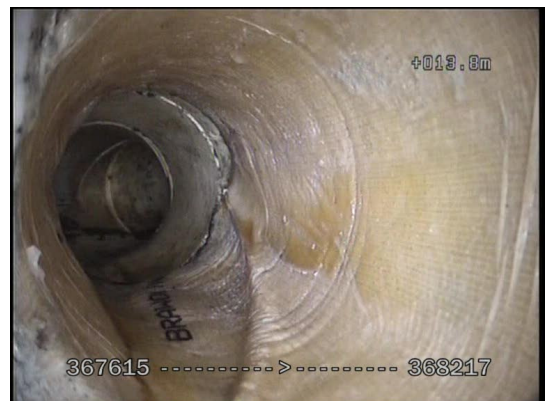
Figure 9: LJR with a small wrinkle caused due to RI

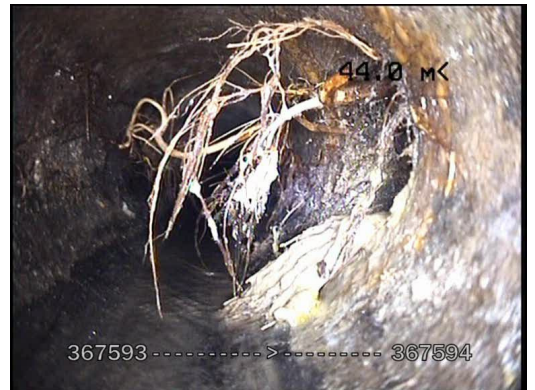
Figure 10: RI should be removed before LJR

4. Often roots are observed at the connection coming from inside of the lateral. Such roots must be removed and dealt with prior to installation of the LJR.

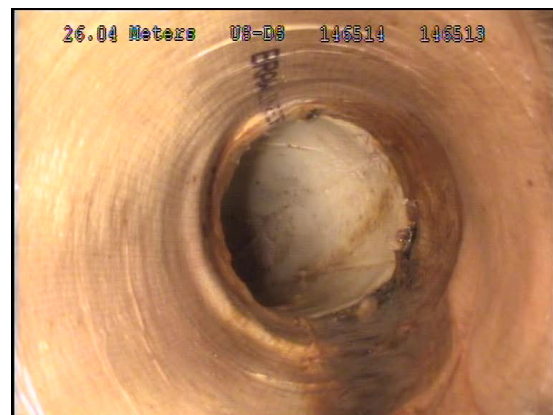
Figure 12: View inside the lateral connection
