Climate Change Amongst Other Flood Hazard Uncertainties; Marlborough Case Studies

E B Williman, Rivers and Drainage Engineer, Marlborough District Council

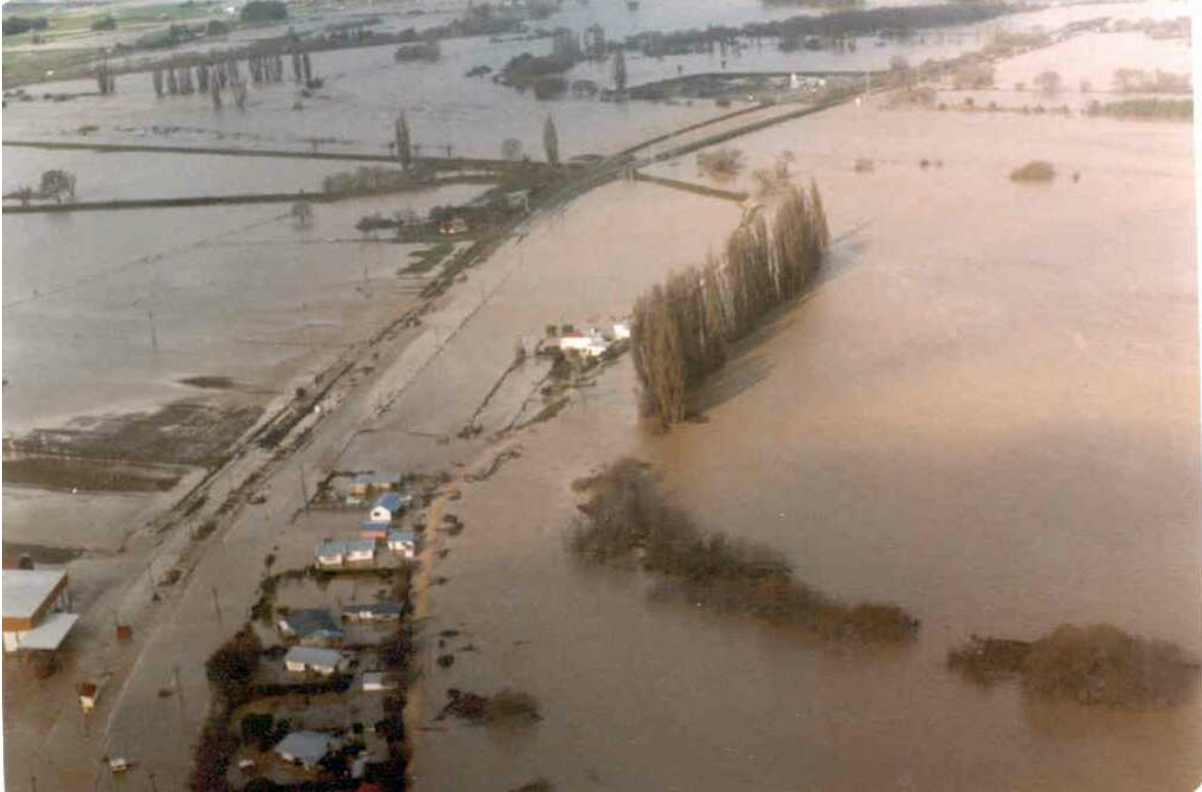
Wairau July 1983 flood at Tuamarina

The July 1983 Wairau flood is the largest known flood since at least 1868. It caused stopbank overtopping, failure and flood breakout at four major locations and a dozen minor locations.

However assessment of its size proved difficult. This was because of uncertainty of the rating curve at high stages, and the difficulty of measuring flood breakouts.

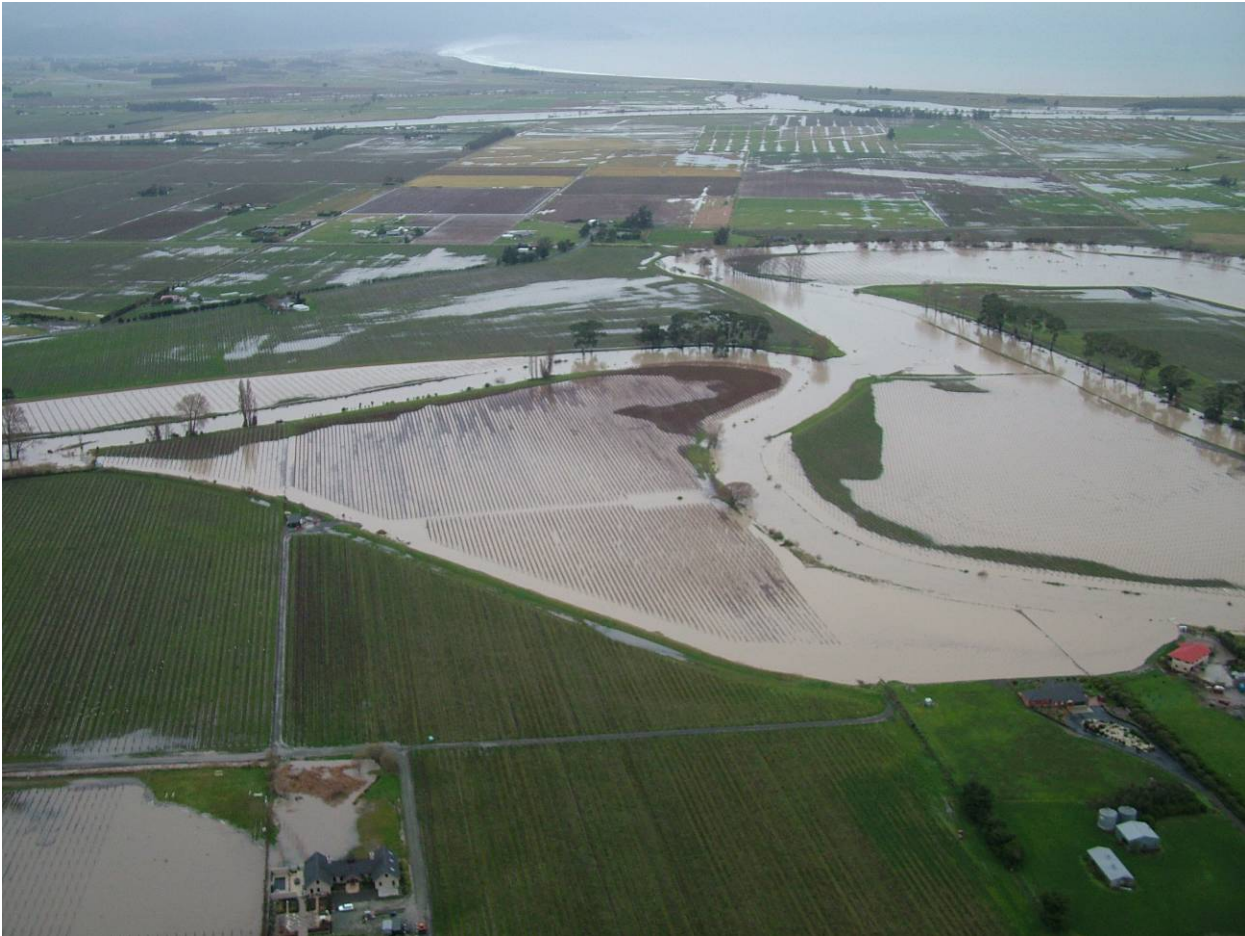
Complex channel and berm flow hydraulics of the Lower Opawa floodway in July 2008 flood

The Taylor/lower Opawa is tidal for the full 18 km, and its flood slope is only on a grade of 1 in 5000. The channel is a narrow deep and meandering. It is flanked by berms that slope away from the bank edge to stopbanks set well back from the channel. In large floods the berms could provide up to 40% of the floodway capacity; and provide short cut paths across the meander bends.

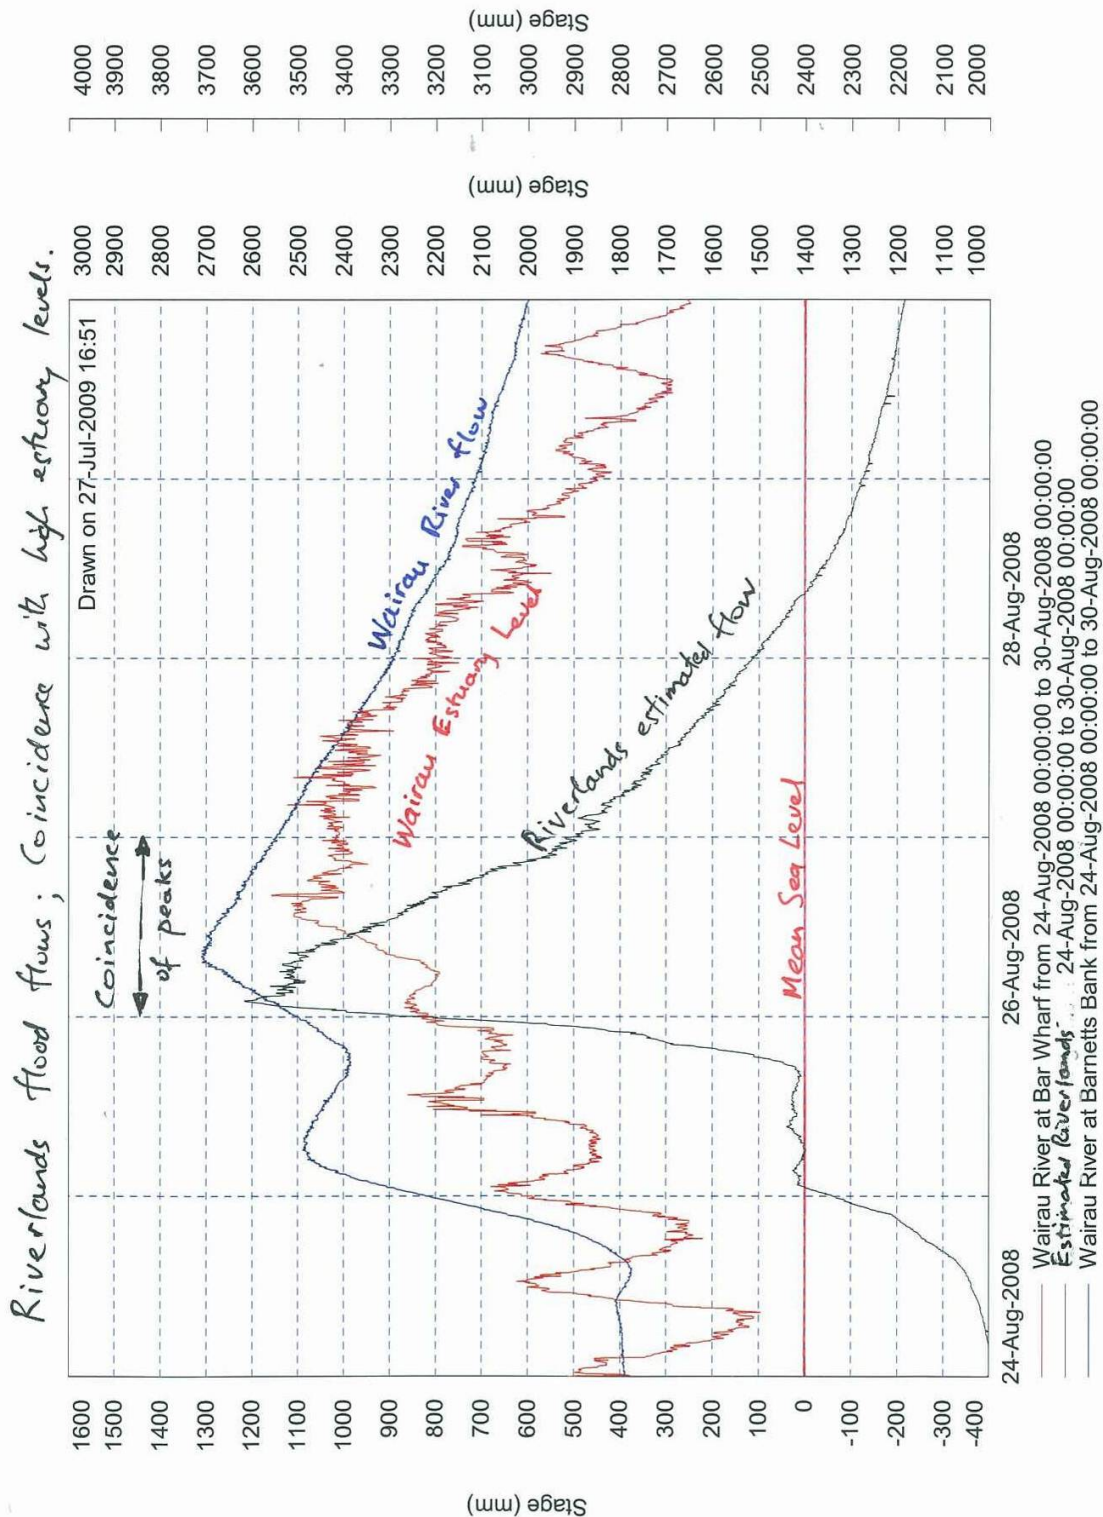
The main reason for the poor performance of the floodway was due to high estuary levels persisting for over 2 days. This was caused by coincidence of the Riverlands flood with a Wairau flood, an inefficient river mouth to the sea, and high tide.

This is shown on the below plot.

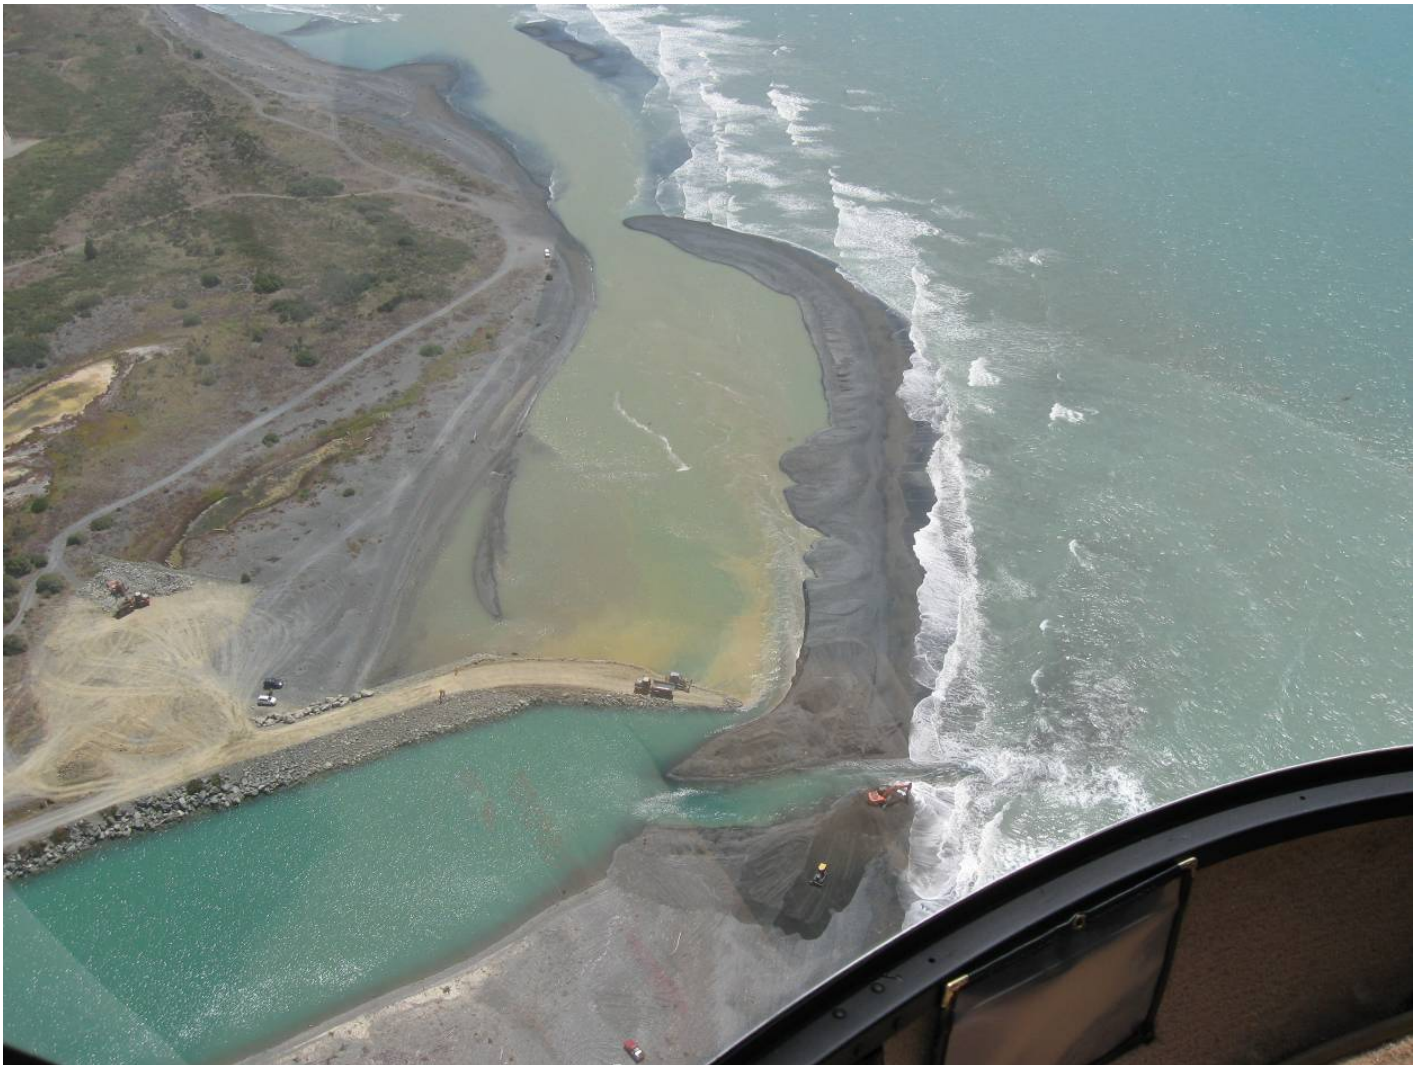
Wairau River mouth Jan 2009, cutting new mouth through bar, and blocking old mouth

Subsequent to the flood in Jan 2009 Council upgraded the existing rock guide bank at Wairau river mouth to improve the efficiency of the outlet to the sea.

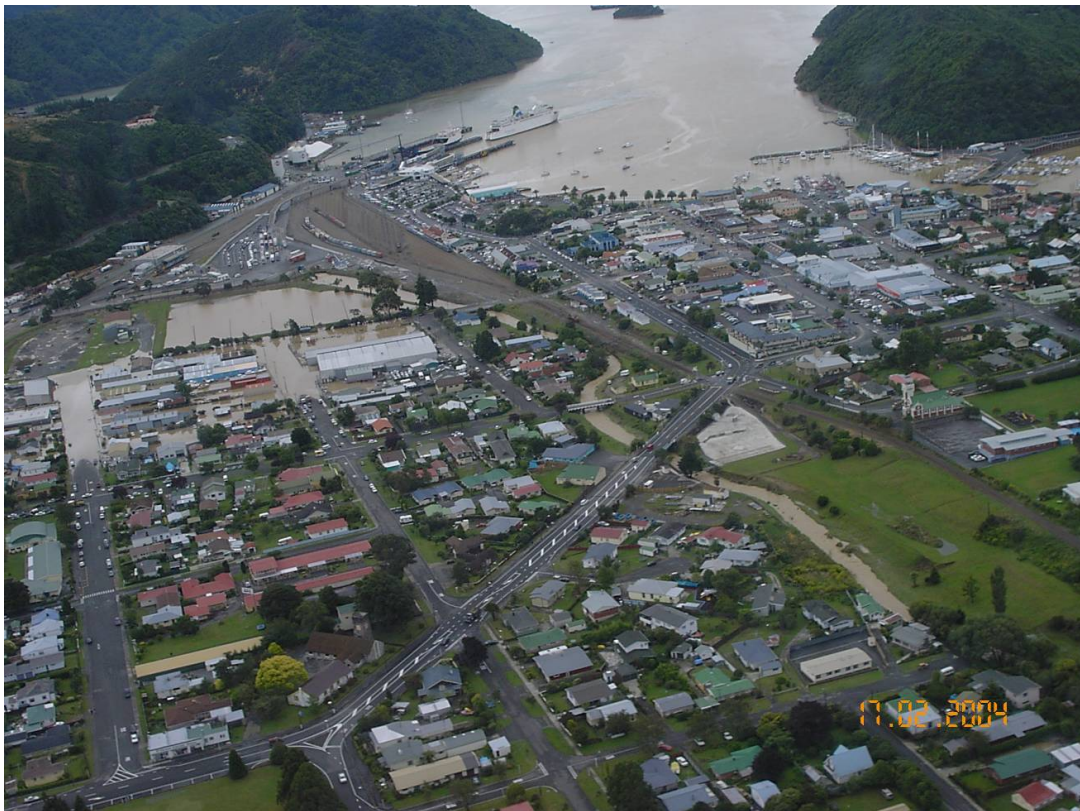
Picton February 2004, Industrial area flooded due to inadequate size of culvert under wharves

The culvert was not large enough for the floods of 1998, 2004 and 2008. The water backed up behind the culvert and flooded the industrial area of Picton. There is no secondary overflow path, and water can build up behind the culvert flooding an area of 8 ha by up to 1.5 metres.
