A SEISMIC SHIFT IN DESIGN – EMBEDDING SAFETY, RESILIENCE AND VALUE INTO POST-EARTHQUAKE DESIGNS

Ian Macbeth, Iain Partington, Gavin Hutchison (all Beca Ltd, Christchurch) and John Moore (Christchurch City Council, Christchurch)

ABSTRACT

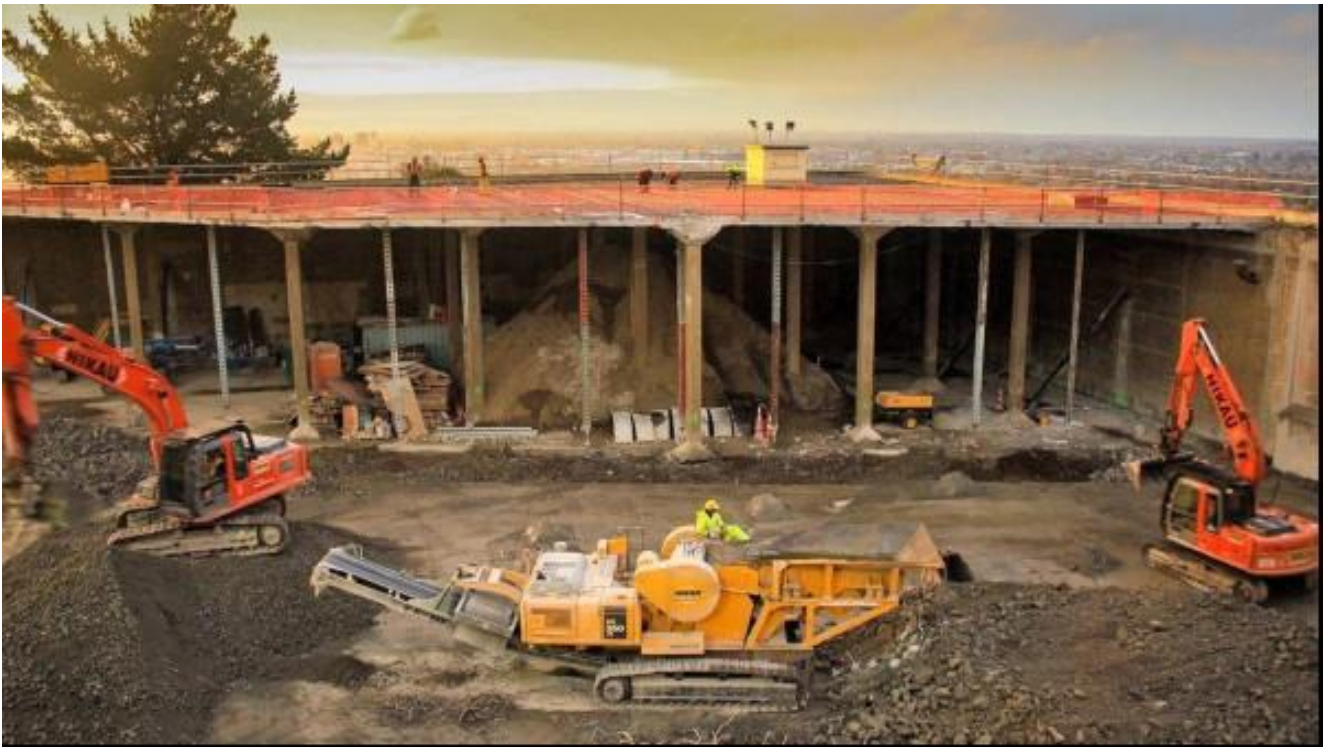
Figure 2: Construction activities at the Huntsbury Reservoir site in 2011, with machinery working in the area between the two halves of the 'new' reservoir.

Because of its significance in the network, it was critical to restore water capacity rapidly, with a target of a partial restoration by December 2011, in time for peak summer demand. Although other sites were investigated, none were found to be suitable, so the focus was on working with the existing site. Repair of the entire reservoir was not considered feasible, utilising the existing structural system, taking account of the predicted horizontal and vertical movements along the shear zone in the event of a future earthquake. With the time pressure, combined with the need to work with the existing site, an innovative solution was devised whereby two corner trapezoidal sections of the existing rectangular structure would be repaired; maximising the available space on either side of the shear zone. The area of reservoir over the shear zone could be demolished and used for access to the two halves of the 'new' reservoir (see Fig. 2). Whilst providing a lesser capacity, CCC accepted a long-term storage capacity of 15,000m³ as workable.

The design required a new floor slab overlaid on the existing concrete slab, a new reinforced concrete foundation and walls adjacent to the shear zone, re-use of the existing perimeter walls of the reservoir and a new reinforced concrete roof. The existing roof column supports were reused, while the new roof slab was designed to allow a crane to operate on it during construction. A design feature of the roof slab was an overlay of a fibreglass-reinforced PVC sheet membrane to prevent leakage into the reservoir due to either post-construction shrinkage at construction joints or seismic cracking. Because the city's water supply is unchlorinated, integrity of storage structures is important to avoid contamination (Hunt, Clifton & Christison, 2013).

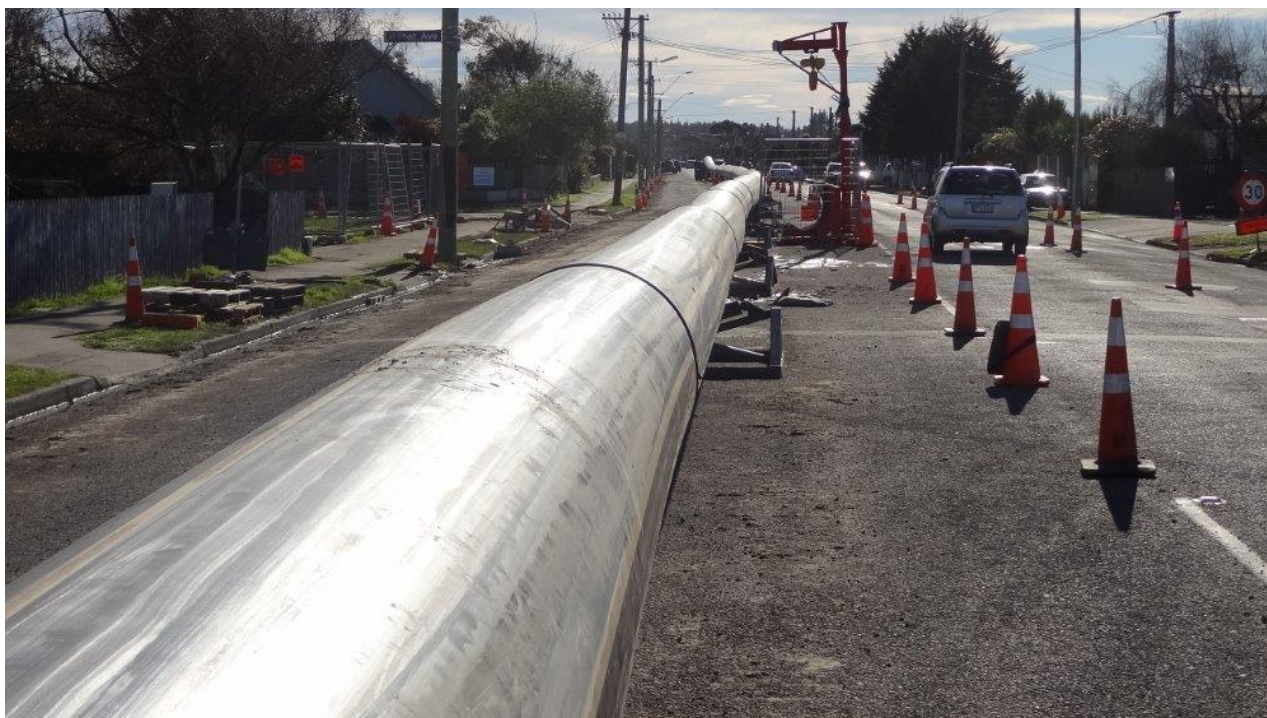
Figure 3: The DN800 PE PM 128 pipe running along Bower Avenue prior to installation by directional drilling.

Working in similarly poor ground conditions in the eastern suburb of Aranui, Mirza (2013) describes the design of the 2.9km PM 128 which, being a DN800 PE pipe, is the largest directionally-drilled pressure main in the city (see Fig. 3).

The PM and associated PS 128 replace a gravity sewer and pump station (PS 63) which were both badly damaged as early as the 4 September 2010 earthquake, and scheduled to be abandoned on completion of the new works. The pipe runs along a new route to avoid replacement of the large diameter gravity sewer and taking account of better ground conditions along the chosen route option. During the ECI process, the decision was taken to directionally drill the pipe at up to 3.5m depth, to minimise the risk of clashing with a number of existing services. Having made this decision, the route was further refined to allow for the required drill pits and positioning of associated drilling equipment. The pipe's structural design was based on empty pipe and no side support (related to the directional drilling), as well as the poor ground conditions, high traffic load and high expected groundwater table. PN12.5 class PE pipe was specified for the majority of the route, although PN16 was used at the crossing under the Avon River. A key identified risk was pipe jointing; both butt-welding and electro-fusion joints were used in the installation. Mitigating this risk, numerous meetings were held between designers and the pipe welder to establish the welding parameters and testing of joints was undertaken.

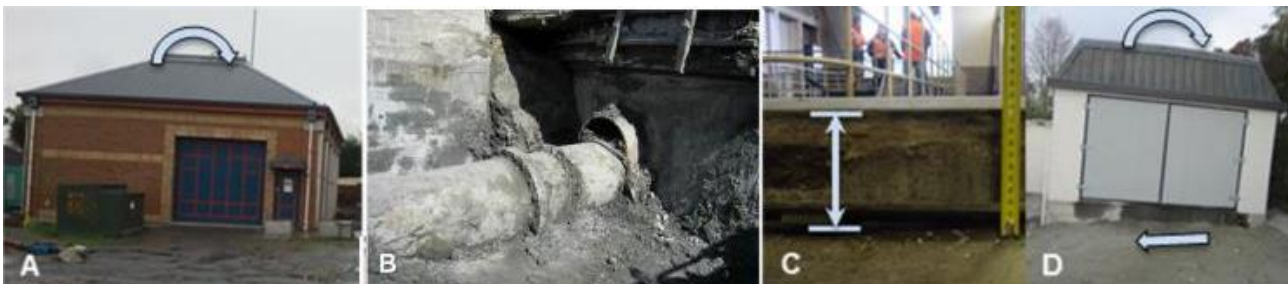
Figure 4: Common failure mechanisms at pump stations

A: Rotation of PS 36, resulting from differential seismic settlement across the pump station and differences in founding depth for the pump station wet well and building.

C: Differential settlement and shearing between sections of Terminal PS 1 building (not specifically discussed in this paper), associated with differential seismic settlement between one half of the building founded on shallow foundations and the other half at depth.

D: Rotation of PS 63 resulting from buoyancy uplift, lateral spreading and slope instability, total and differential seismic settlement across the site, and differences in founding depths of the pump station elements.

Fig. 4 illustrates some examples of damage. Of these, Hunt & Hutchison (2015) record that the most troublesome were failures at the pipe connections (see Figure 4B); caused through ground settlement and, in some instances, reversing the grade of gravity inlet pipes. Where discharge pipes failed, repairs were often hampered by their depth; requiring significant temporary works and dewatering.

Built in 1980, Terminal PS 36 (see Fig. 4A) in Aranui transferred around 16% of the city's wastewater directly to the CWTP, at a maximum capacity of 700 l/s. On 22 February 2011, it suffered from all of the damage types listed in the bullet points above, reflecting the lack of ground improvements and its asymmetric structure. With complete replacement required, a nearby site was selected for the new PS 136, reflecting both the need to keep the existing station operating and the identification of an old river channel running under the existing site – explaining some of the site's damage. Ground conditions are such that liquefaction is expected to 10 – 20m depth in an ultimate limit state (ULS) event. Ground improvement, in the form of 600mm diameter continuous flight auger (CFA) piles of unreinforced concrete was chosen. The 410 individual columns are positioned in a rectangular lattice at 1.5m centres, extending approx. 10m around the wet well structure; the configuration designed to mitigate liquefaction and limit the extent of settlement. A key design feature was that the pile depths taper from 6m length under the wet well, reducing towards the periphery of the ground improvement area. Any seismic settlement will be gradual, allowing flexible sewer pipes to bend, rather than imposing a shearing action at the connection points at the structure (Kerr, 2013). Even so, restrained pipes (welded PE in this case) were selected over socket and spigot jointed pipes where expected ground movement exceeded the allowable rotation. The new PS 136 has an increased capacity of 1,000 l/s, with submersible pumps in duty/assist/ standby/standby configuration. It is a substantial structure- the wet well is 9.4m x 8m in plan, founded around 9m below ground

Located in the eastern suburb of Bexley, PS 63 (see Fig. 4D) was built in 1983 as an Archimedes-screw lift station, conveying up to 470 l/s of wastewater to Terminal PS 36. Positioned alongside the Avon River, it was damaged due to lateral spread, exacerbated by its asymmetric structure, resulting in differential settlement. Considering replacement, a completely new site in North New Brighton was selected; partly reflecting catchment changes through the Red Zone, but also positioned at a site with better ground conditions. CFA piles in the same configuration as those at PS 136 were used. The new pump station, known as PS 128, has a capacity of 625 l/s, with three submersible pumps in duty/assist/standby configuration.

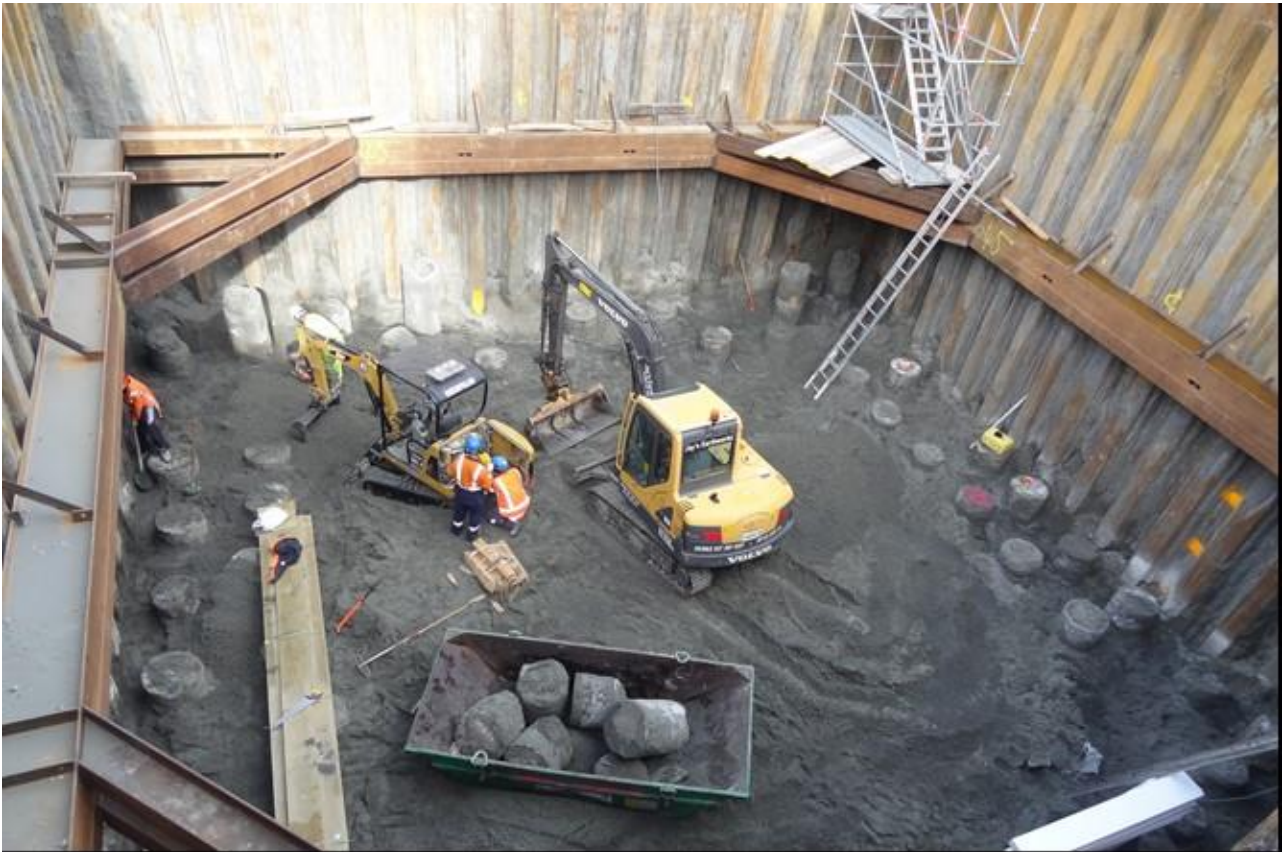
Figure 5: Construction work at the base of the wet well for PS 136, showing the tops of the 600mm-dia. CFA piles.

level and topped with a 7m-high building. A separate underground valve chamber, as well as a separate control room and a separate generator are adjacent. The pump station excavation during construction is shown in Fig. 5.

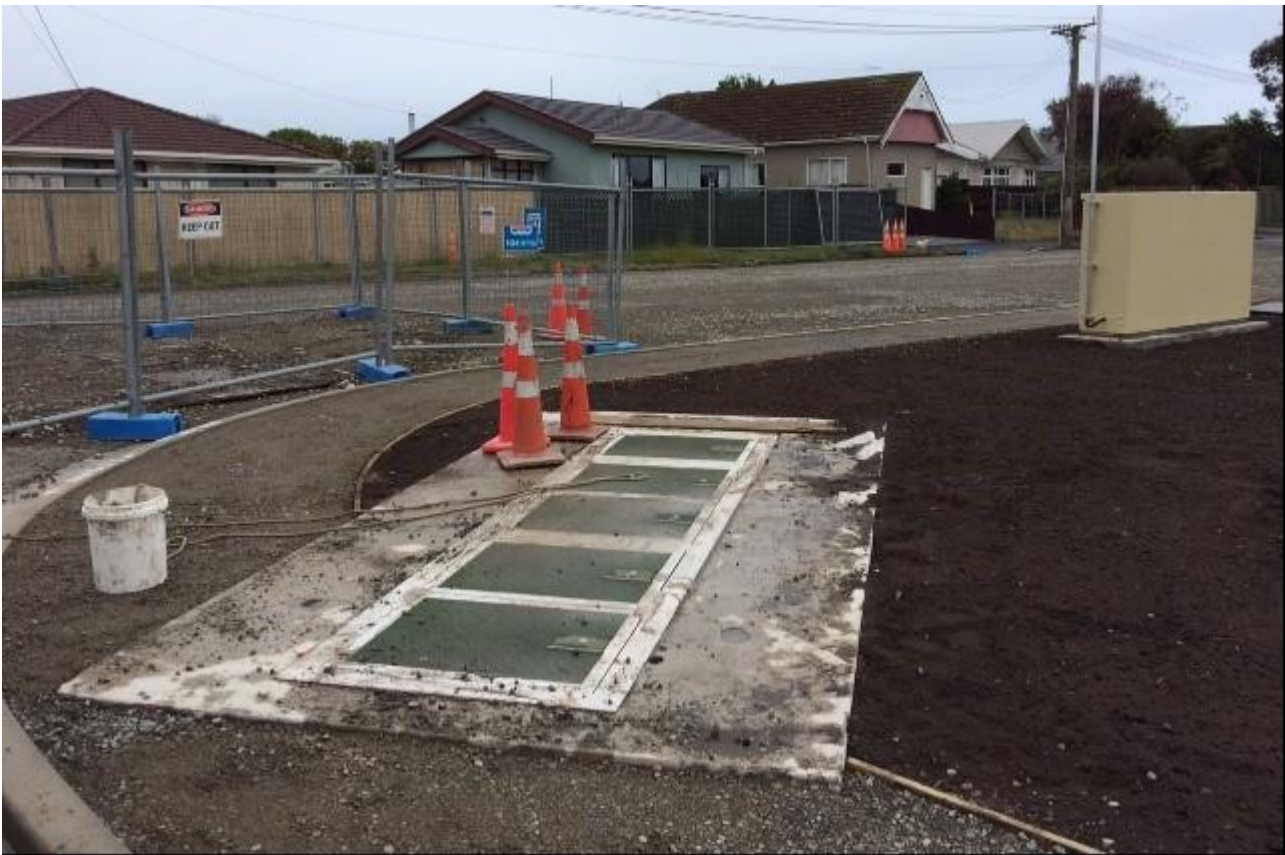
Figure 7: The near-complete horizontally-mounted PS 230 installed in the road verge at Owles Terrace.

Solving the conveyance issue was relatively straightforward: pumping capacity needed to be close to the existing gravity outfall. Constructing the pump station itself required more lateral thinking, with concepts discussed with geotechnical and structural experts, along with contractors in ECI workshops. The innovative solution developed utilises a horizontally-mounted axial-flow pump. Rather than a conventional wet well of approx. 5m depth, requiring significant ground improvements, the horizontally-mounted pump station is 2.5m deep. This orientation has enabled another innovative feature; the wet well structure is a lightweight pre-cast concrete box installed with minimal ground improvement. The pre-cast box is of a standard design, fixed to a concrete base, with the benefits of minimising site construction time (providing cost and safety benefits) and enabling removal of the box to facilitate re-levelling following a seismic event. A removable pre-cast concrete lid is positioned over the box, incorporating McBerns safety access lids for access and pump removal (see Fig. 7). The standard box is based on a 1m³/s design flow, adjustable through benching to reduce flows, or installing parallel pump station modules where higher throughput is required. Utilising a raft foundation with a light,

shallow structure limits differential settlement following a seismic event and, should it eventuate, excavation around the structure allows it to be lifted and re-levelled within a short period. The station is designed to settle with the surrounding ground, accommodating movement, rather than resisting it.

It is understood that, while horizontally-mounted stormwater pumps are used in Europe, the only other examples in NZ date from the 1970s. Identified overall cost savings were \$3.6M, compared to a conventional pump station design, achieved through reduced pump station construction costs and reduced requirement for stormwater network upgrade. Overall, the project has achieved the objective of balancing affordability with an appropriate level of resilience (Hutchison & Mirza, 2013).
